Memorandum

Re: San Jacinto River Channel Slope Maintenance Completion Report

Re: Revised Plan for Armor Rock Placement Adjacent to the Time Critical Removal Action
Armored Cap, San Jacinto River Waste Pits Superfund Site, Channelview, Texas

July 2016 Quarterly Inspection Report

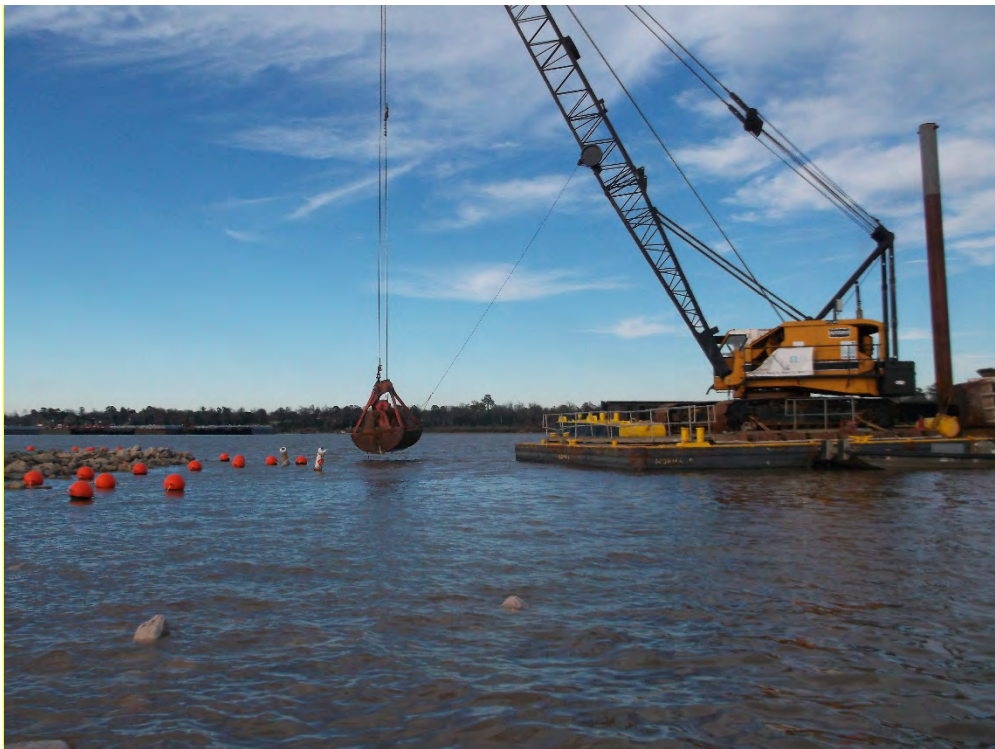
Photograph 3: Orion beginning placement near northern end of placement area.

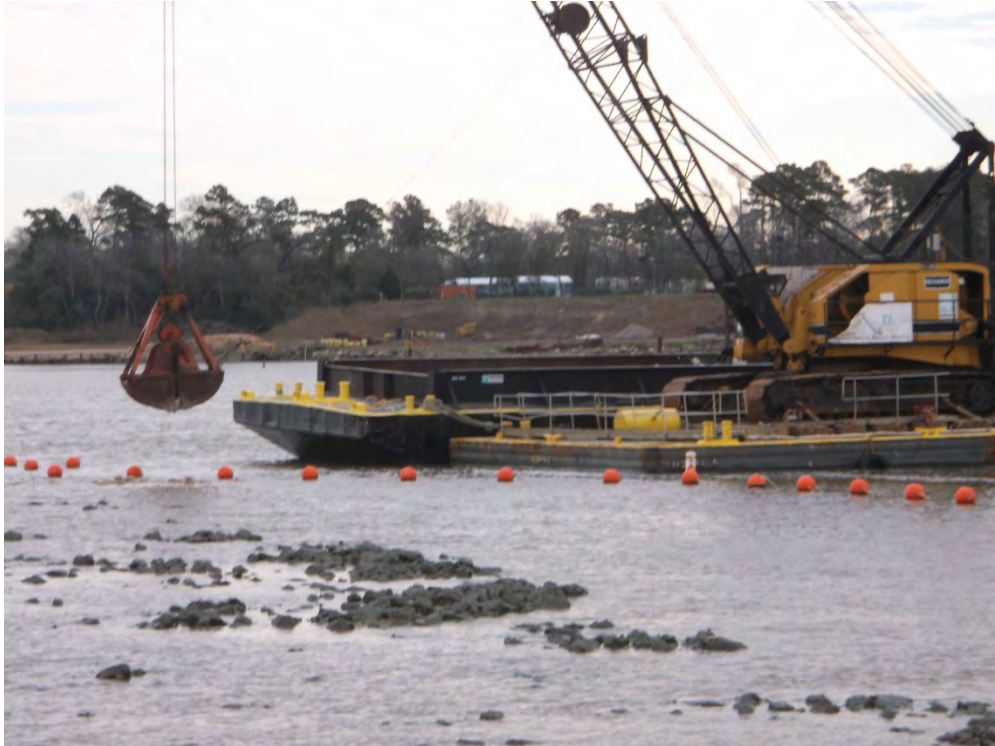
Photograph 1: Orion work barge placing stone near south end of placement area.

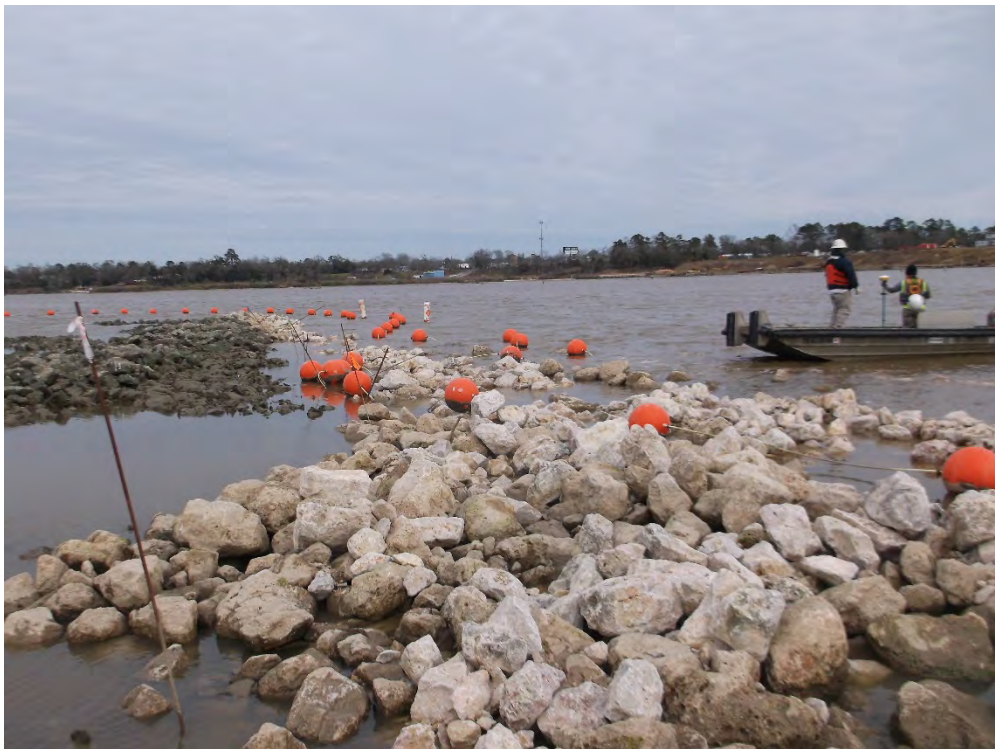
Photograph 2: HCL surveying placement area.

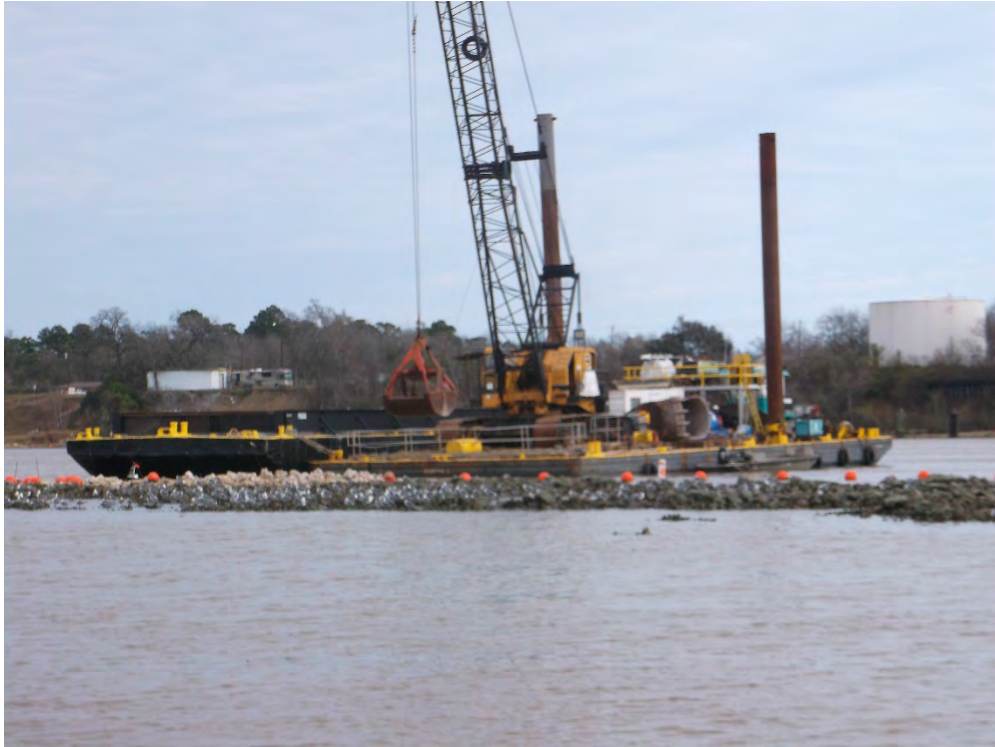
Photograph 3: Ongoing placement near southern end of placement area.
