Memorandum

October 6, 2017

0	
Re:	Post-Harvey TCRA Inspection and Maintenance Report – October 2017		ج د	Ö
		25	PM	\leq
	David Moreira, McGinnes Industrial Maintenance Corporation	ST.	\sim	
сс	Phil Slowiak, International Paper Company			$\overline{\mathbf{O}}$
From	John Laplante, John Verduin, Wendell Mears, and David Kelth		00	m
[rom	John Lanlanta, John Vardum, Wandell Maars, and David Kaith	AF C	7	$\boldsymbol{\Sigma}$
To:	Gary Miller and Anne Foster, U.S. Environmental Protection Agency		_

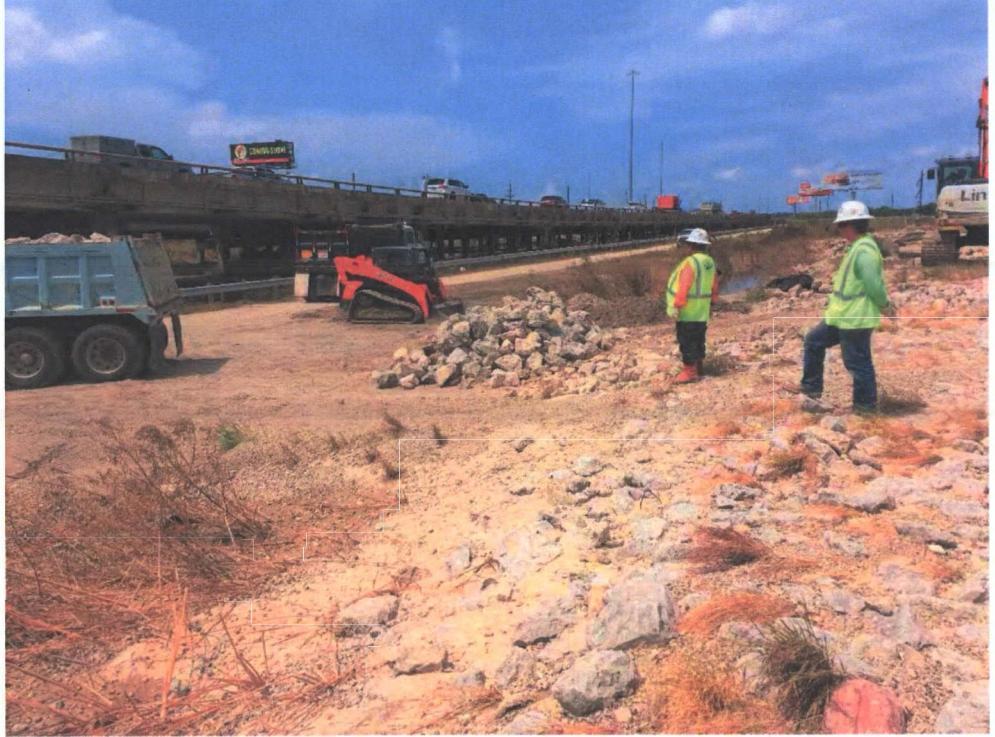
Photograph 1: Receive first loads of rock from Bluebonnet stockpile.

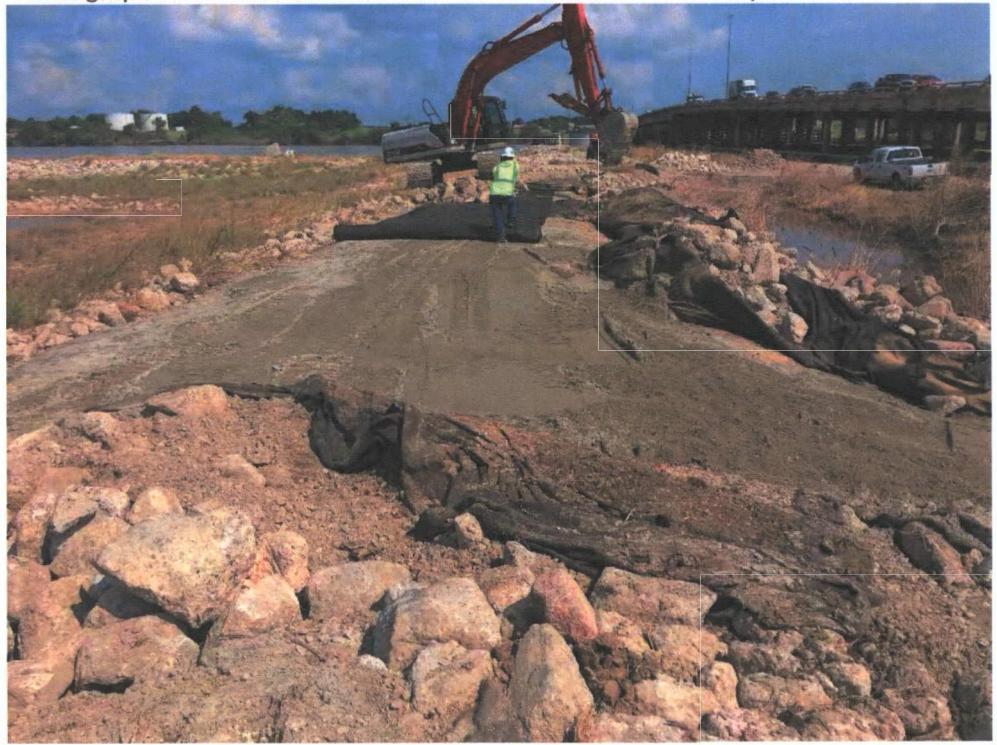
Photograph 2: Stabilized fill installed prior to covering with geotextile.

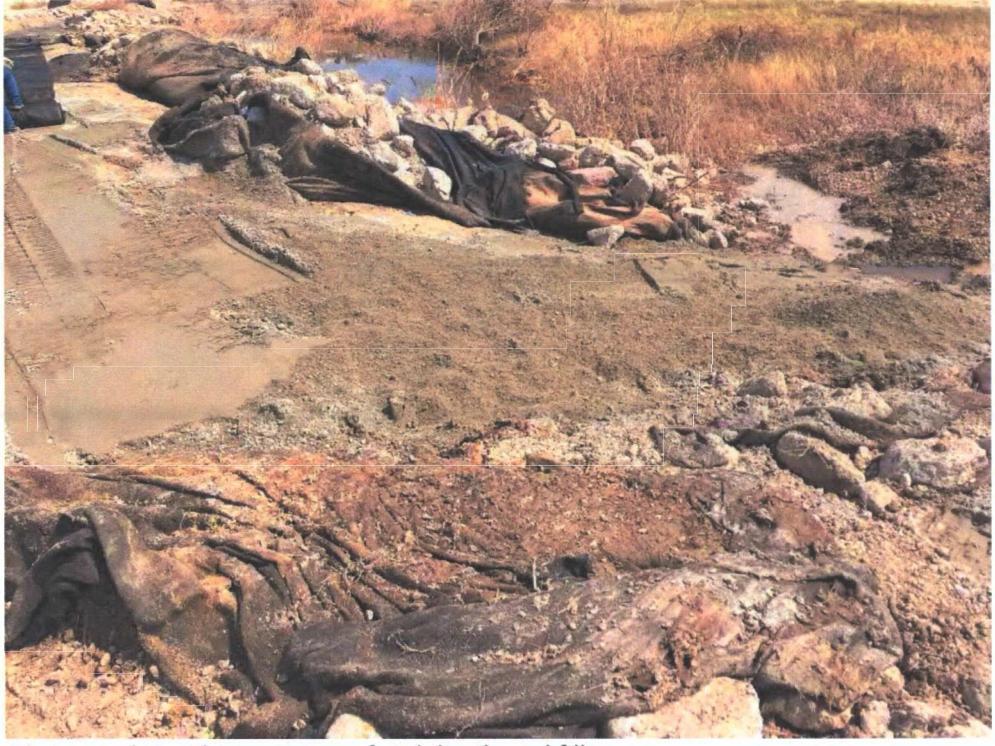
Photograph 3: Close up view of stabilized sand fill

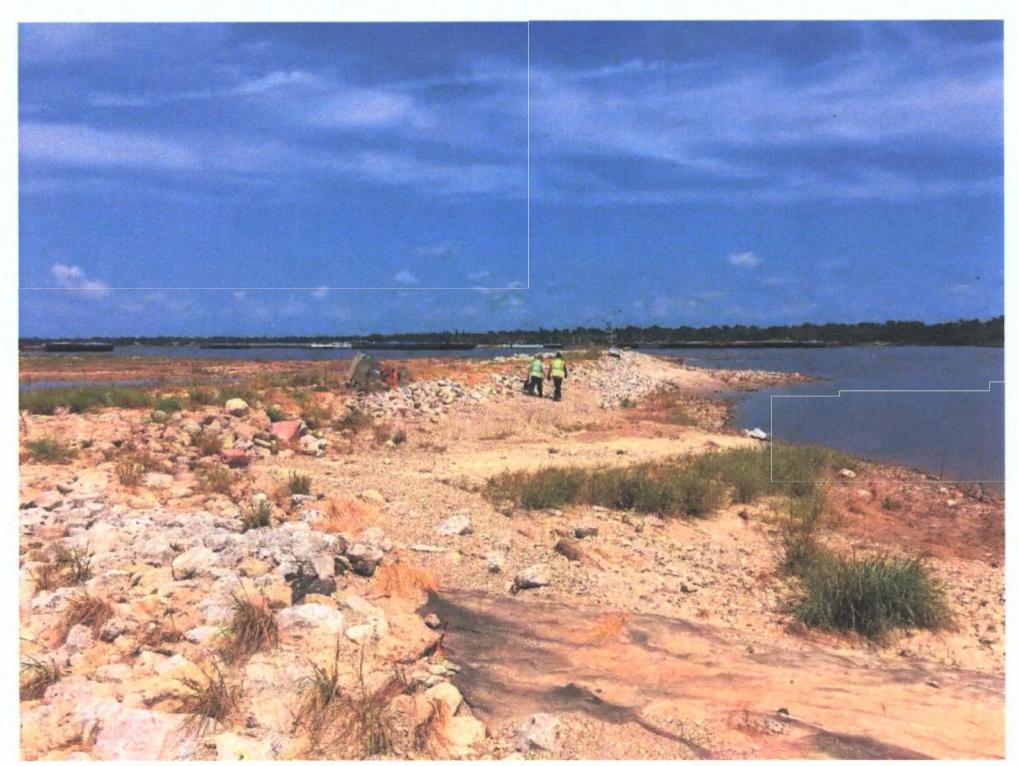
Photo 4: Continued site assessment through the day

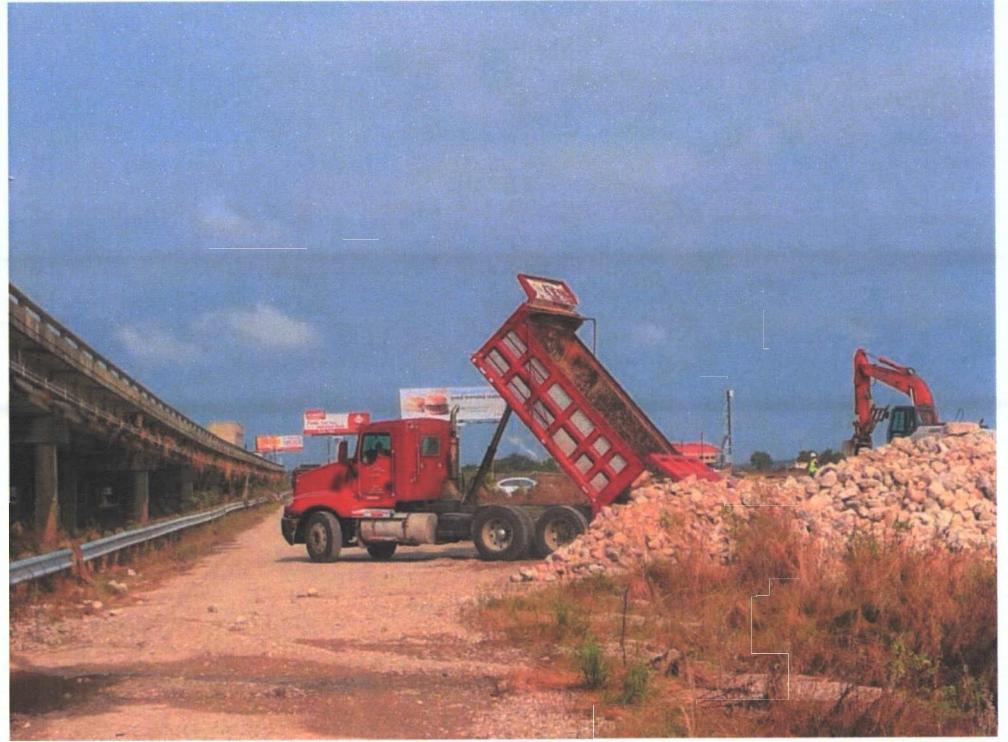
Photo 3 - rock delivery

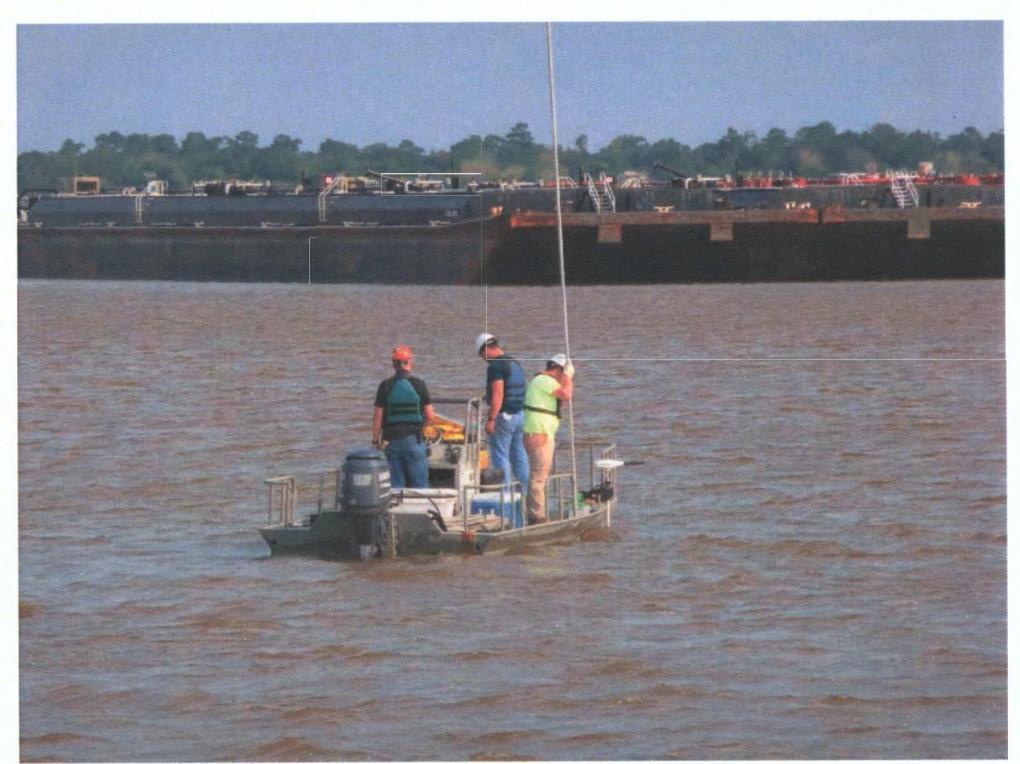
Photo 4 – probing inspection

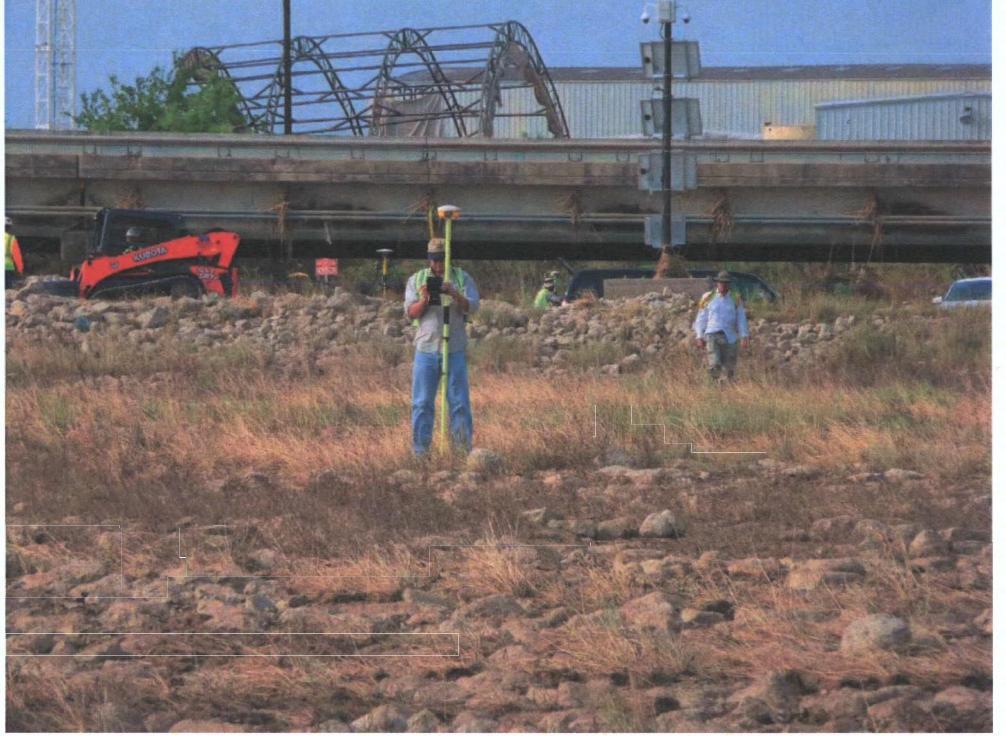
Photo 5 – upland topographic survey activities

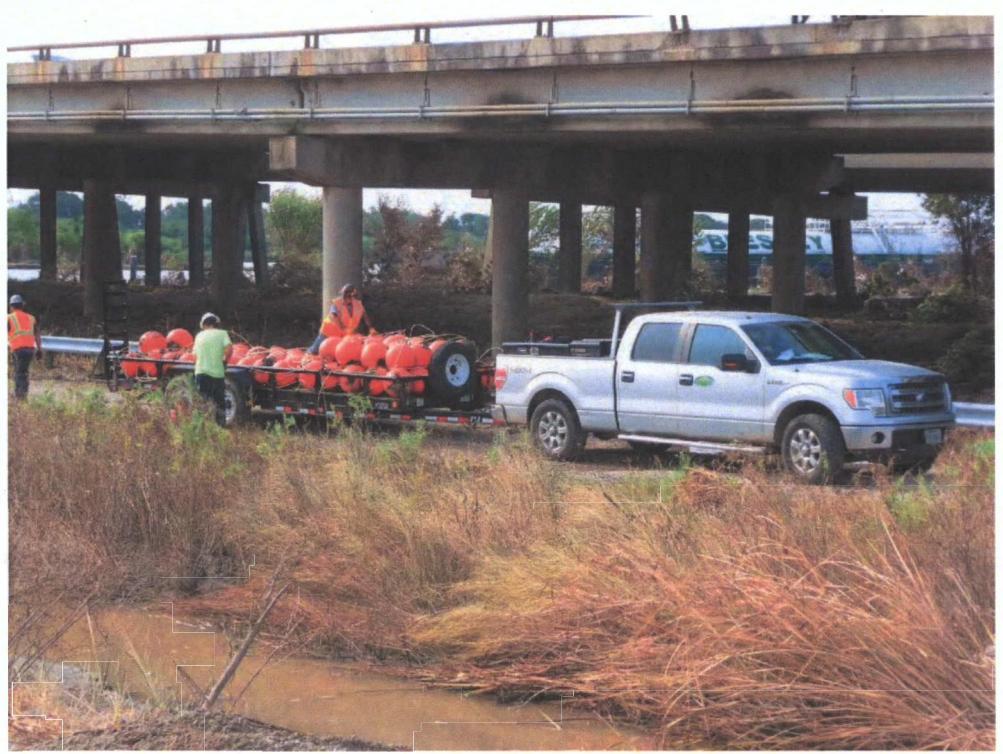
Photo 6 – buoy retrieval

The maintenance activities to replace the buoy system were initiated during the week of September 4, 2017. Approximately 105 of the barrier buoys were recovered, all of which were reusable. Temporary barrier buoys were installed on September 9, 2017. Three of the regulatory buoys were recovered but were not reusable due to damage

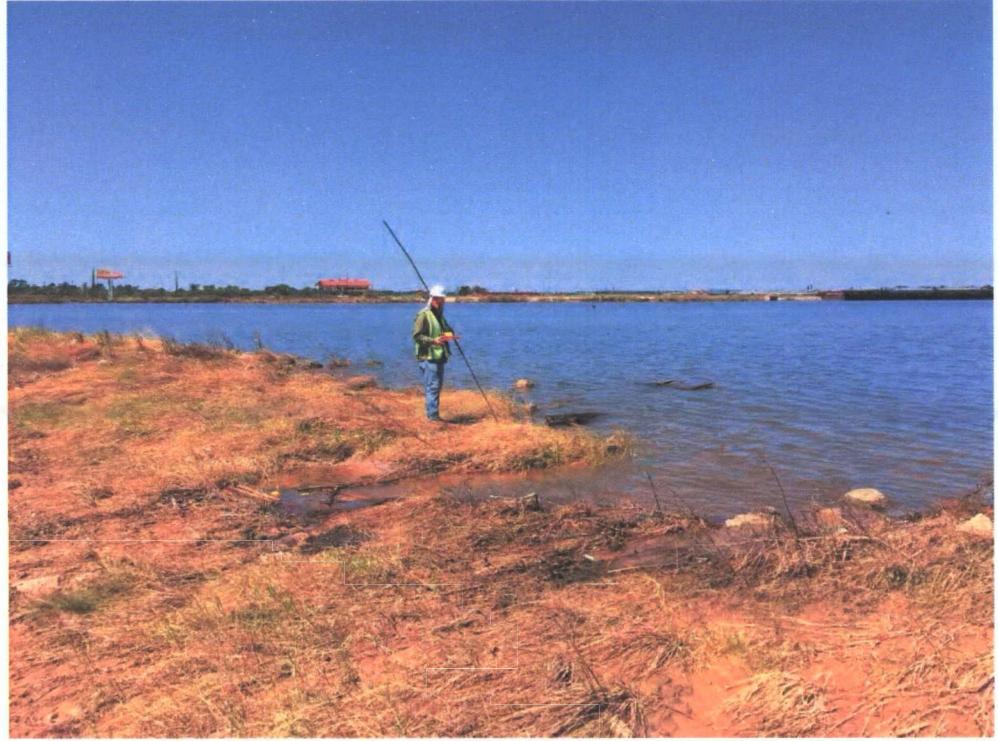
Photo 1 – probing inspection

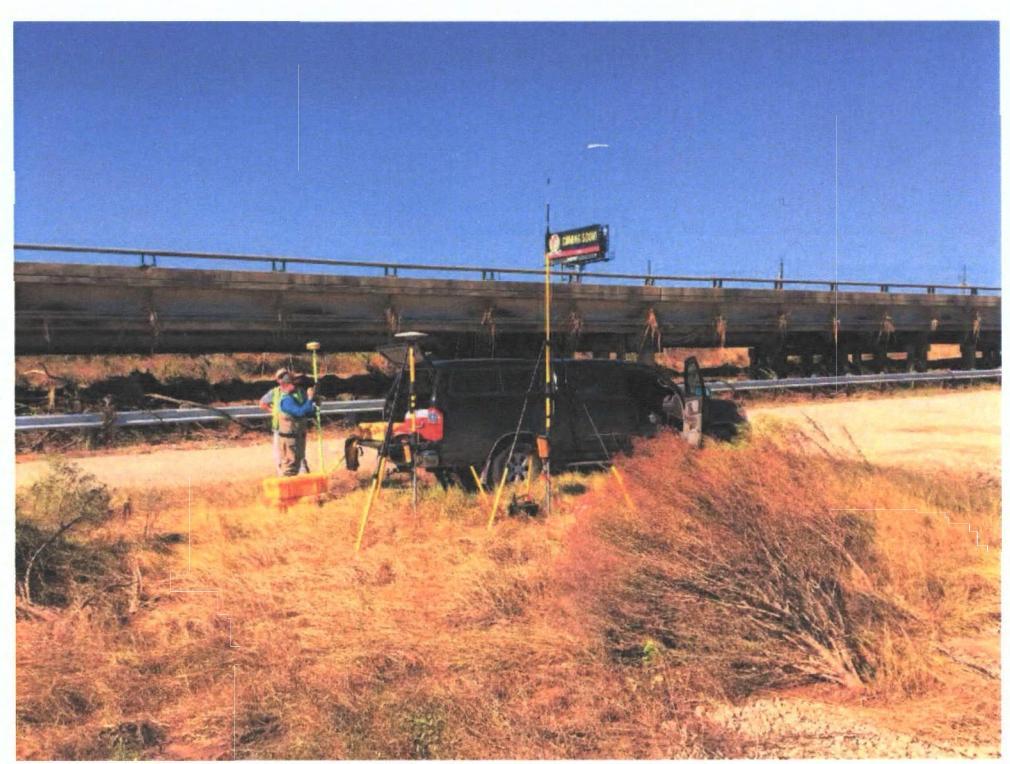
Photo 2 – topographic survey activities

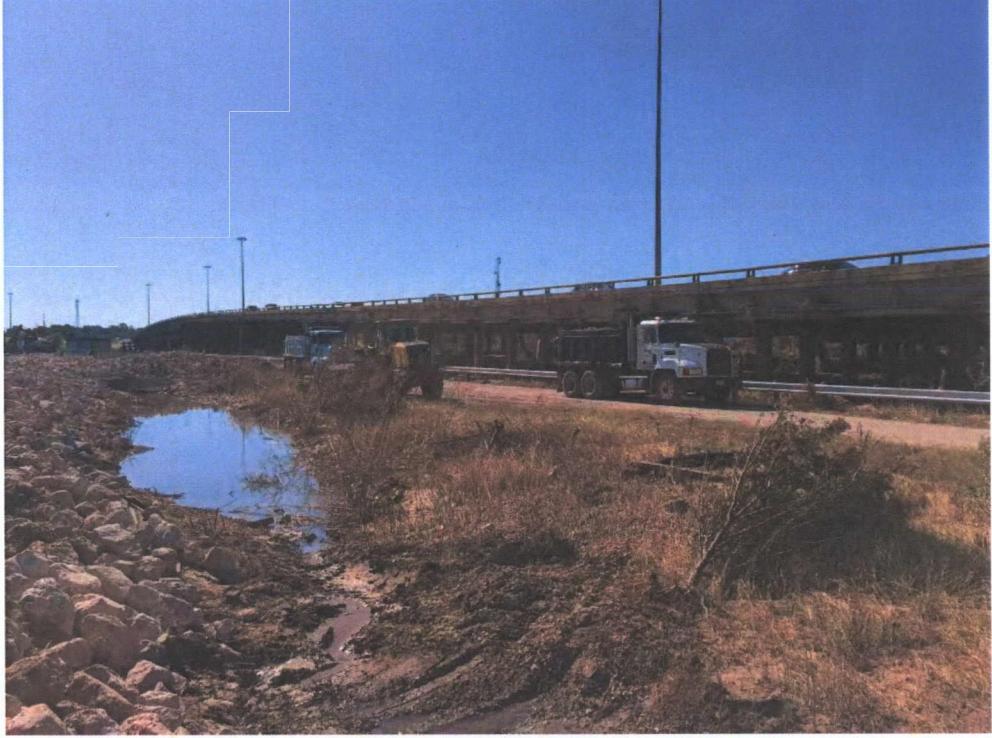
Photo 3 – rock delivery

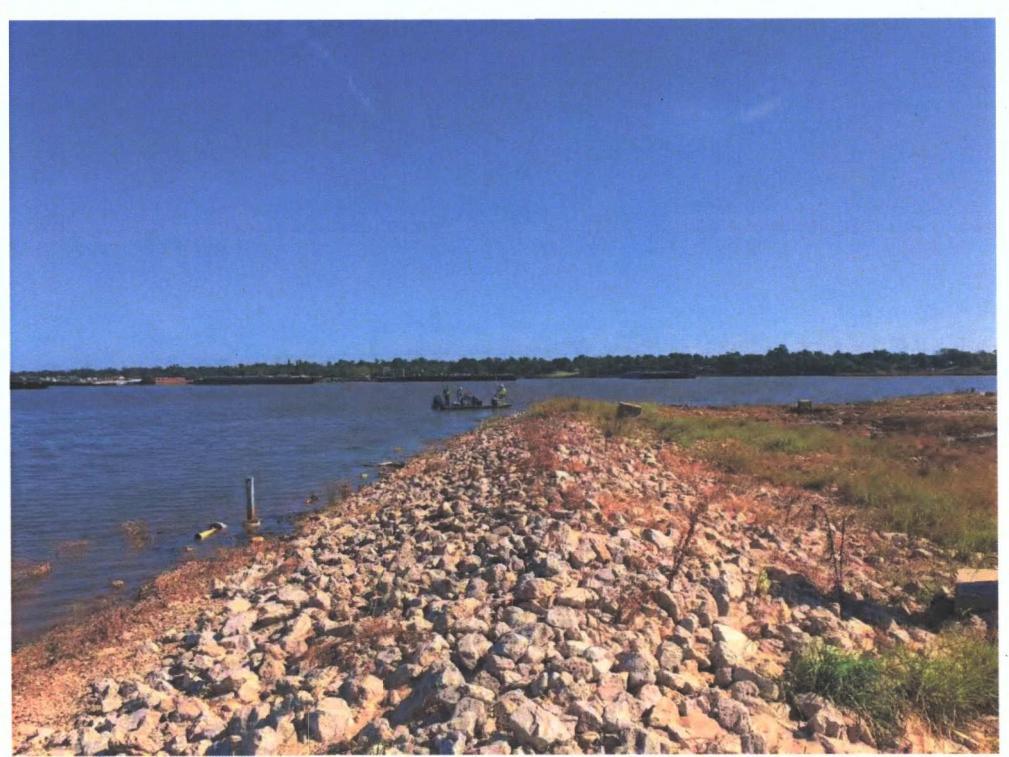
Photo 4 – probing inspection

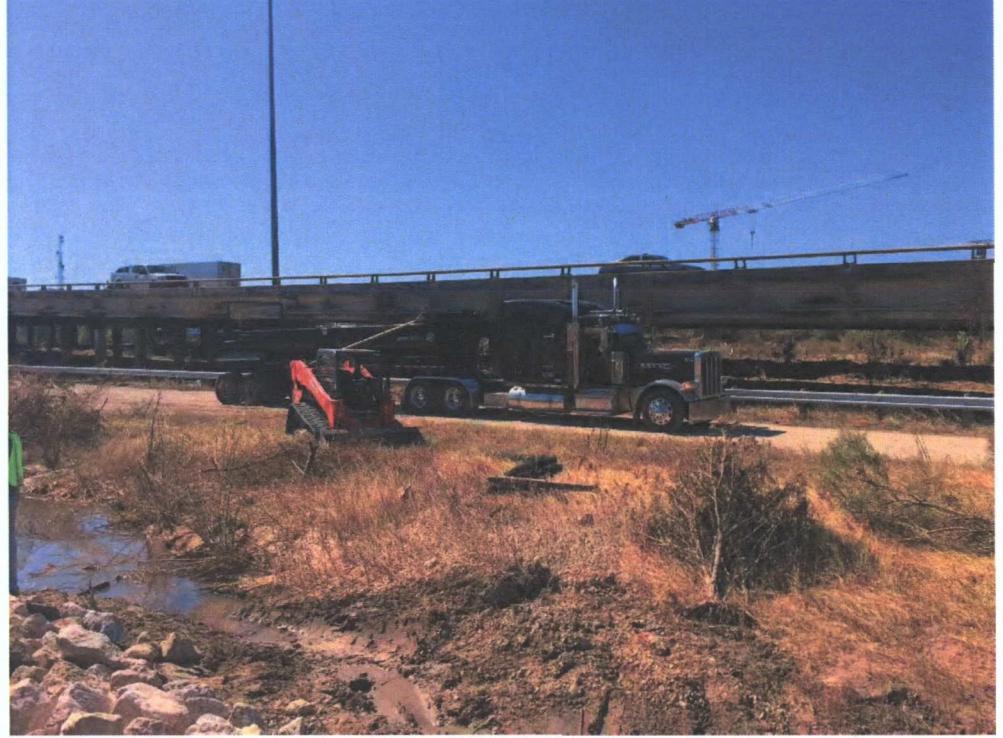
Photo 7 – rock delivery

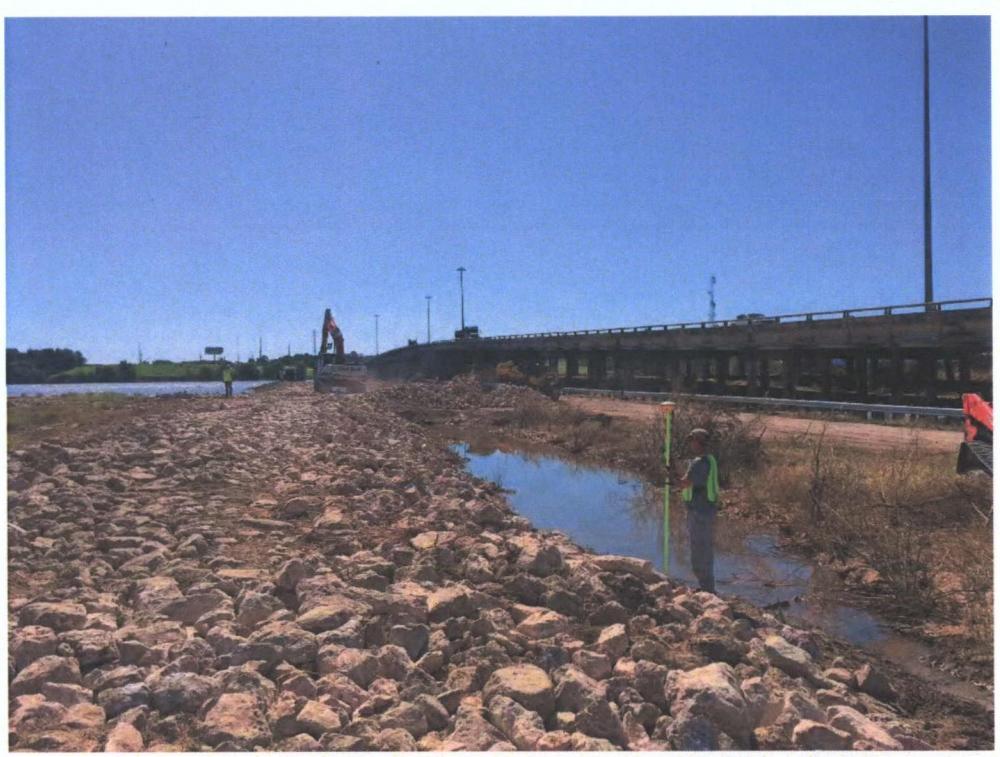
Photo 8 - southern berm crest maintenance; topographic activities

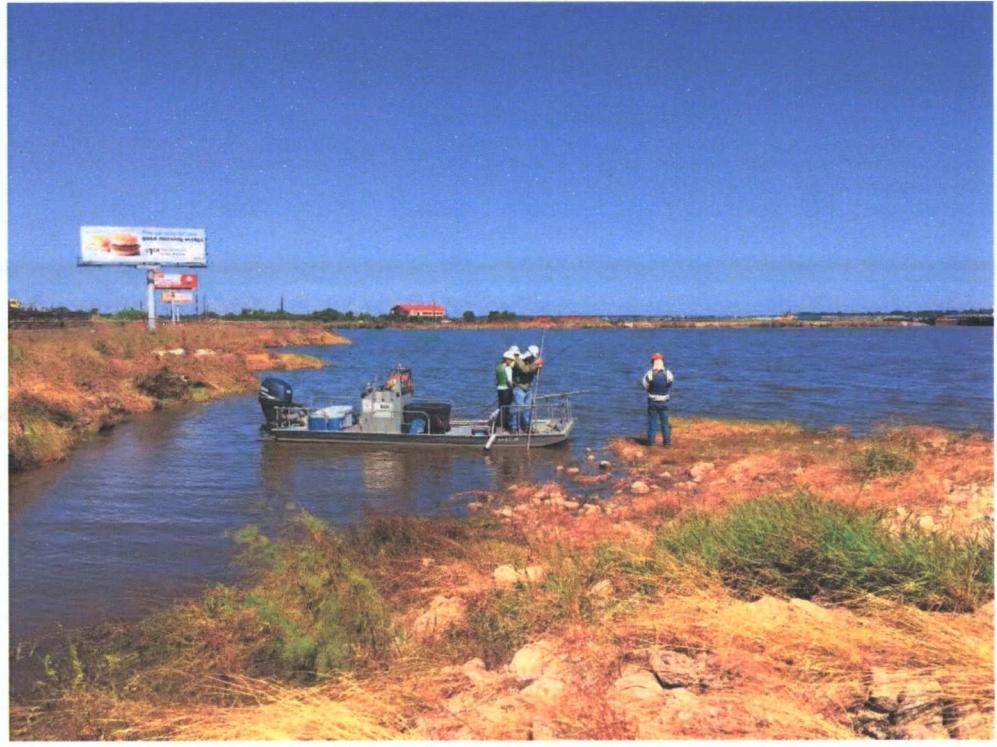
Photo 9 – probing activities

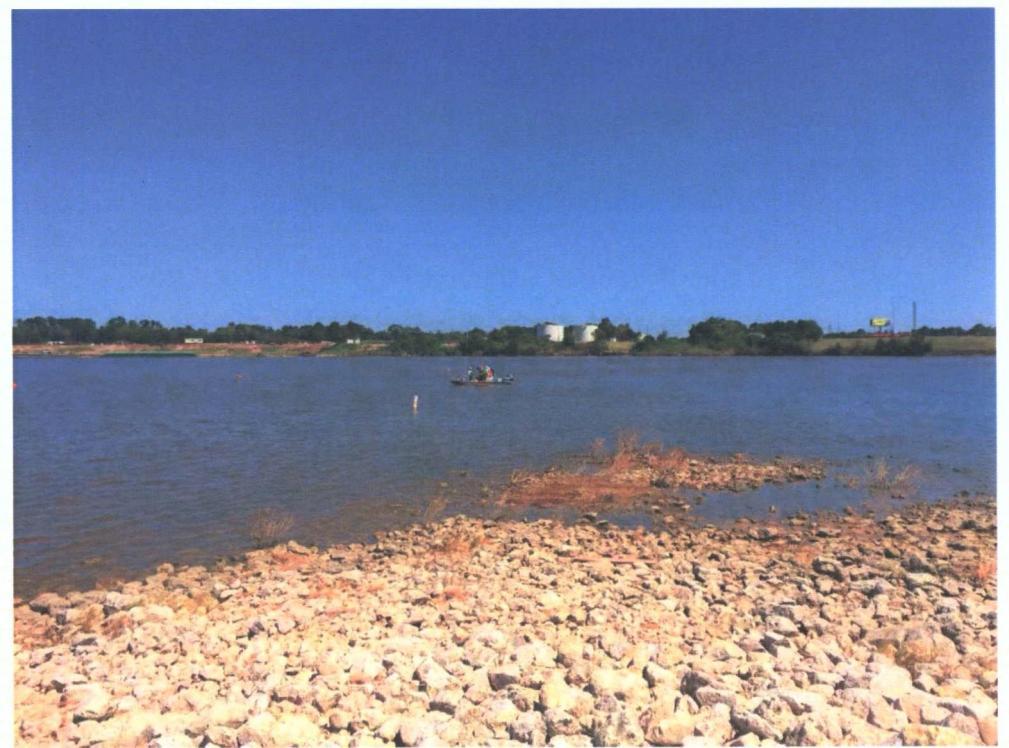
Photo 2 - probing inspection in east area

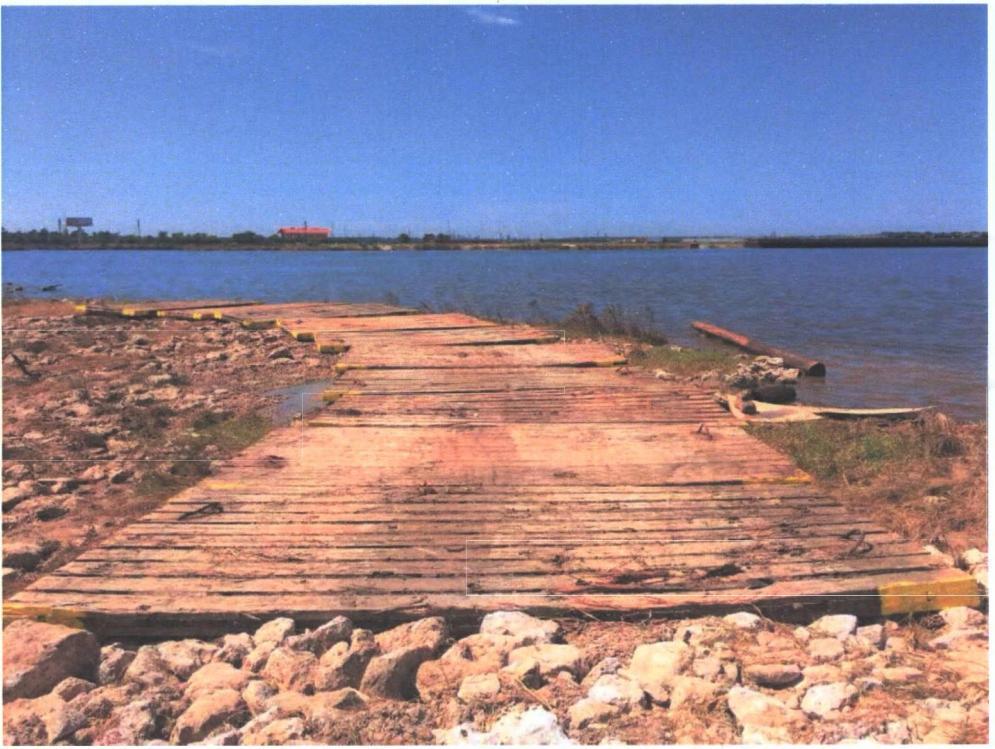
Photo 3 – heavy equipment pads in north area between central and western berms

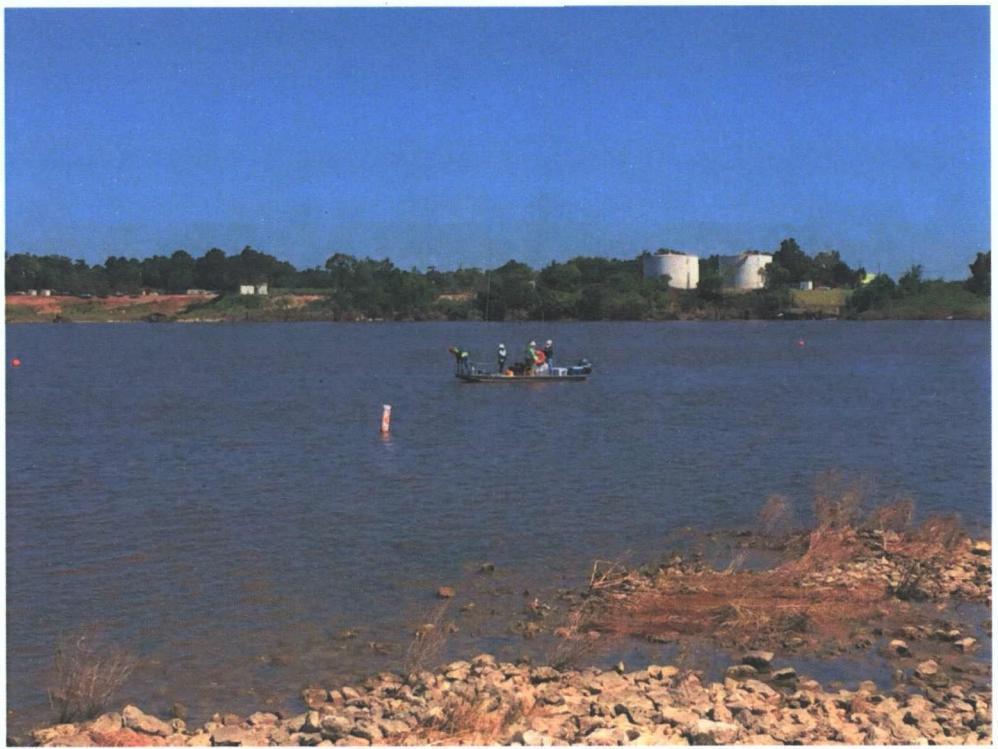
Photo 4 – probing inspection in east area

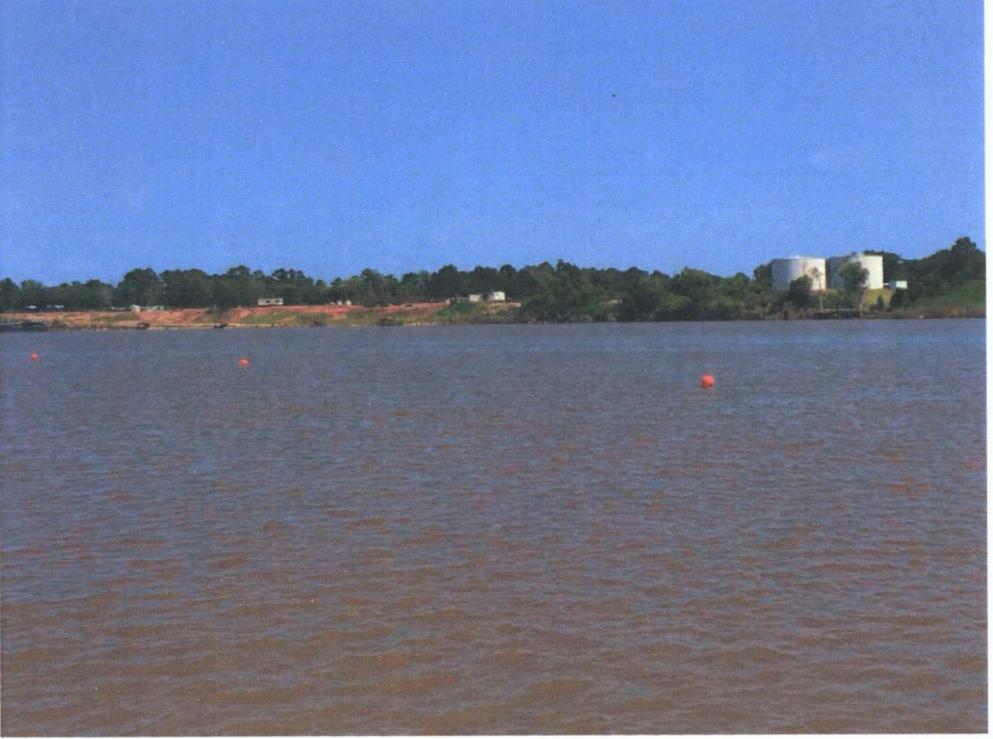
Photo 1 – buoys in eastern area

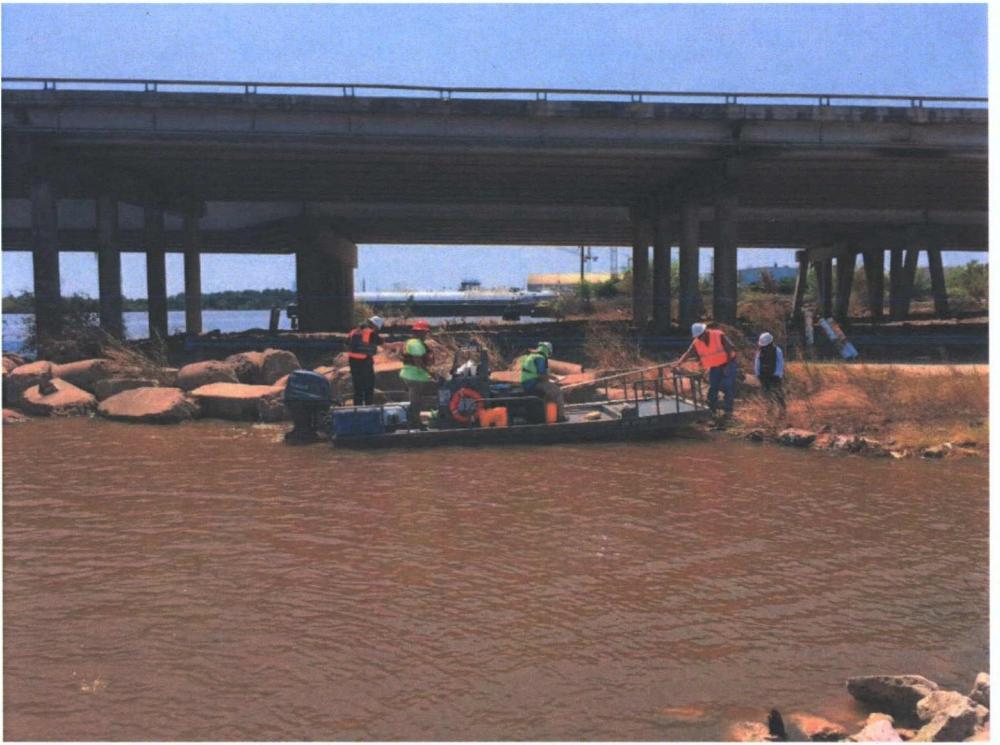
Photo 2 - probing inspection activities in eastern area

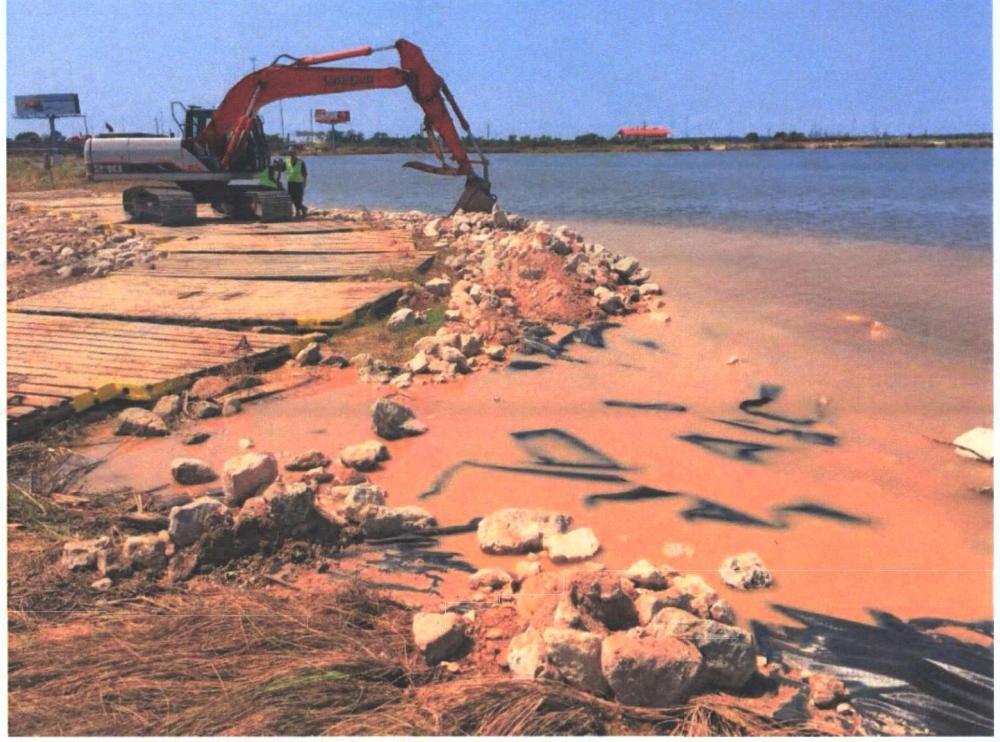
Photo 4 - maintenance of northern area between central and western berms

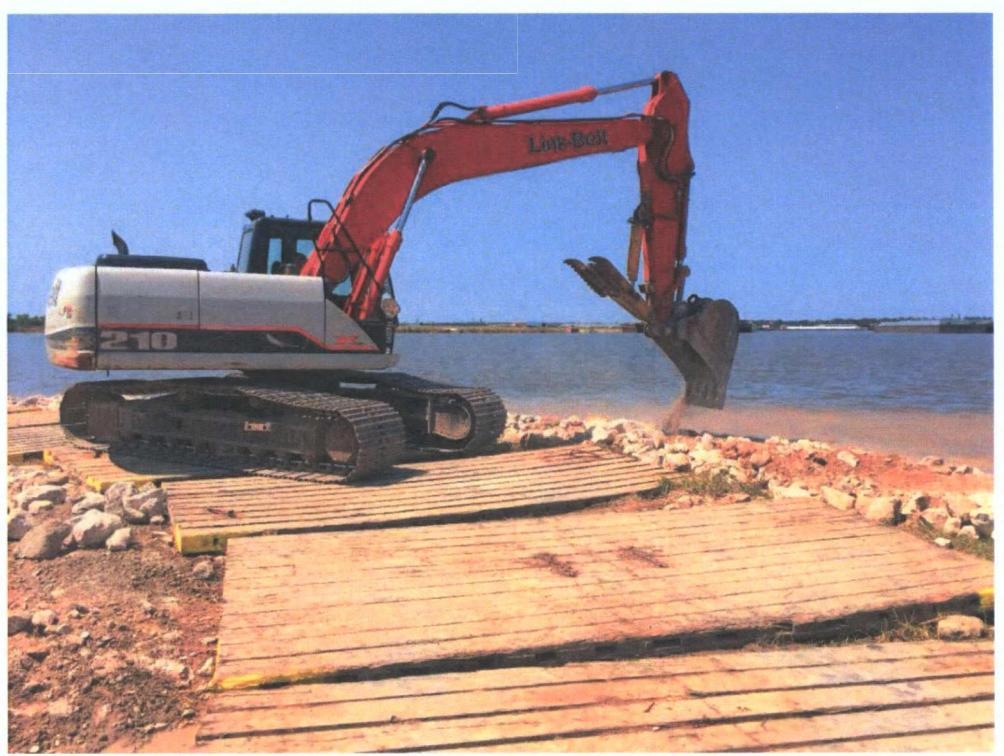
Photo 5 - maintenance of northern area between central and western berms

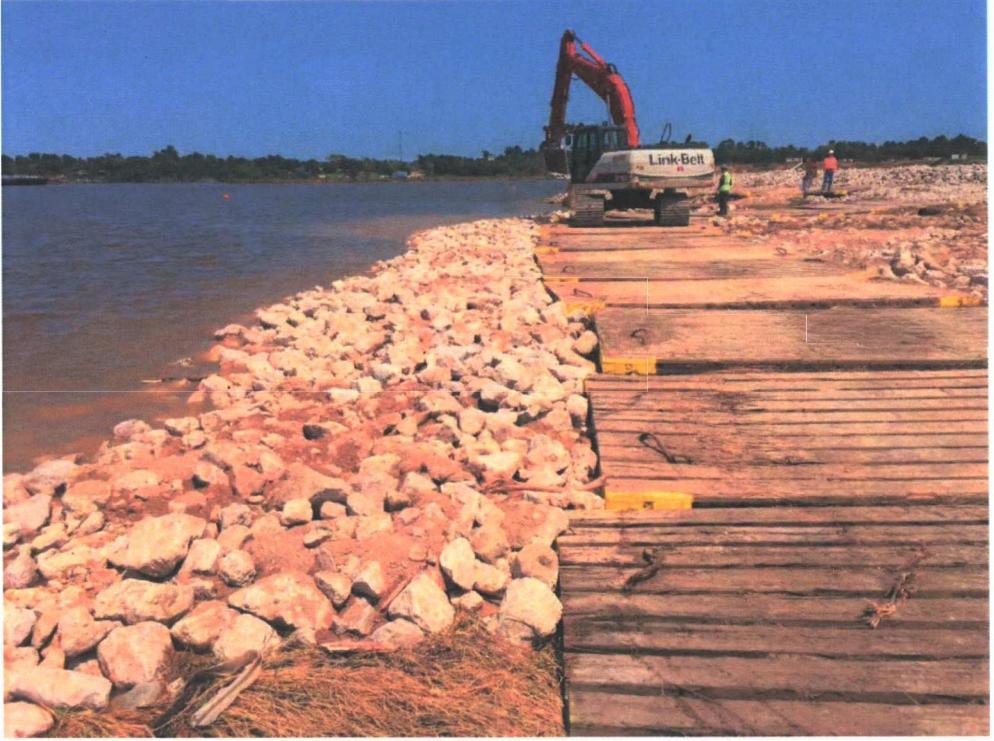
Photo 6 - maintenance of northern area between central and western berms

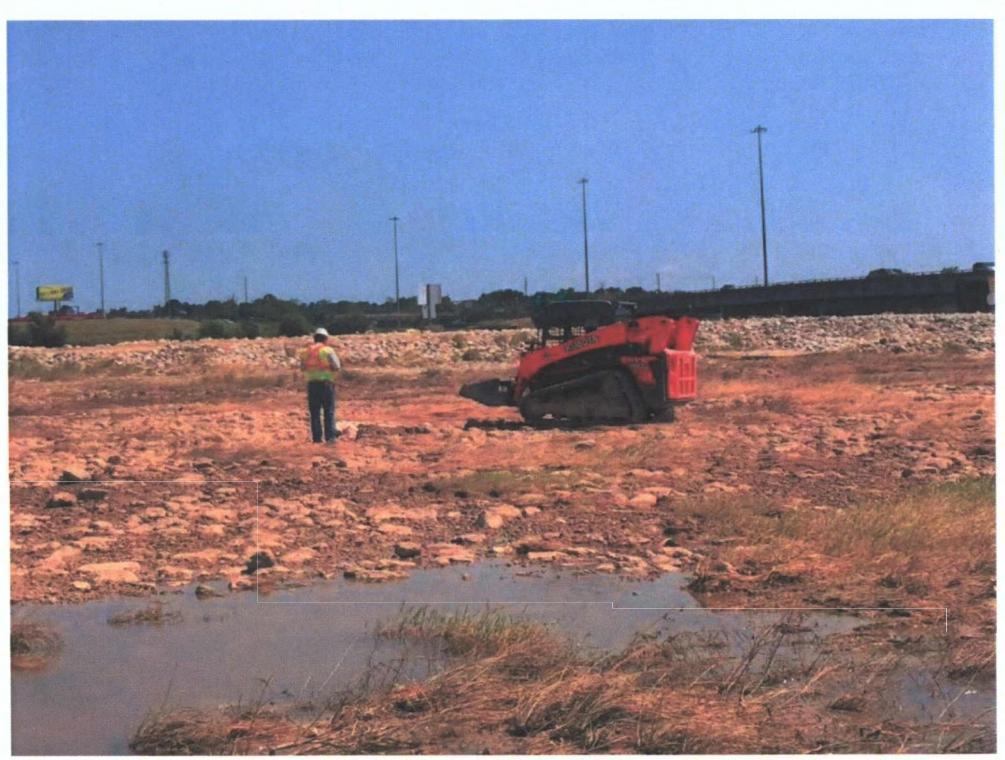
Photo 7 – maintenance of cap in western cell

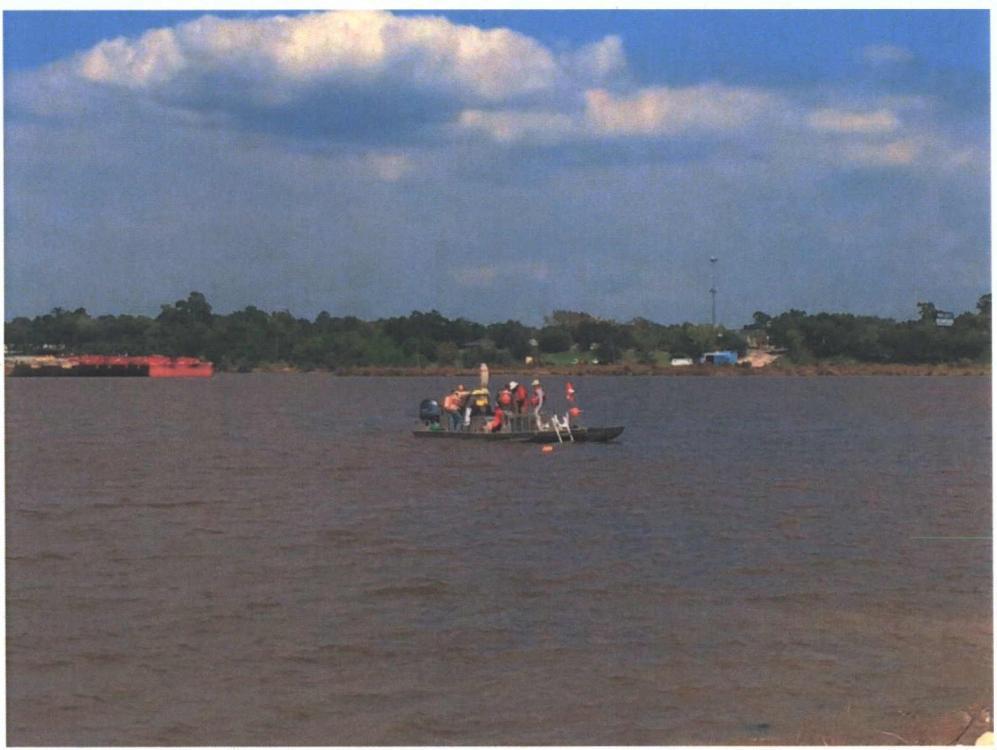
Photo 4 – diving operations in northwest area

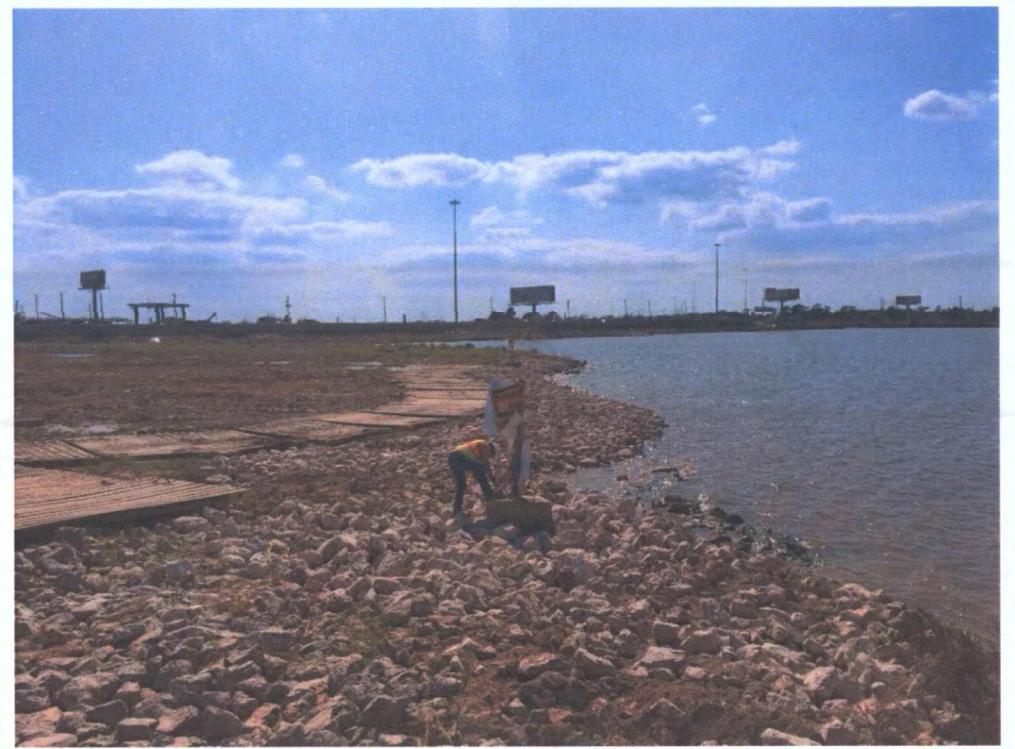
Photo 5 - maintenance of north shoreline between central and western berms

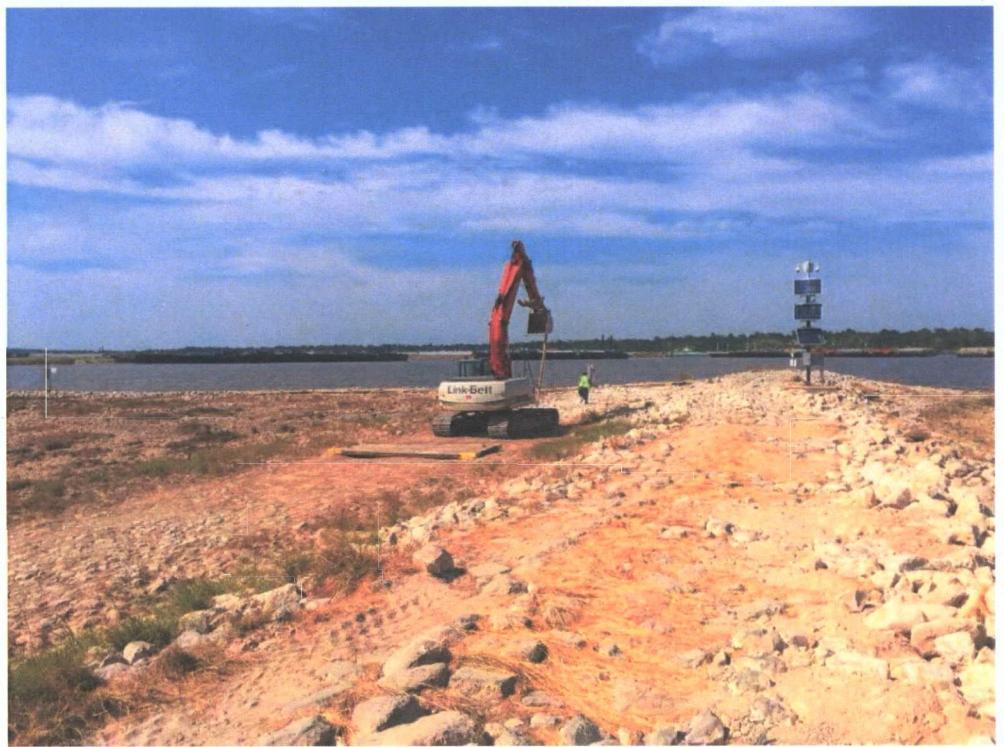
Photo 1 - moving heavy equipment pads from northwest shoreline area in preparation for demobilization

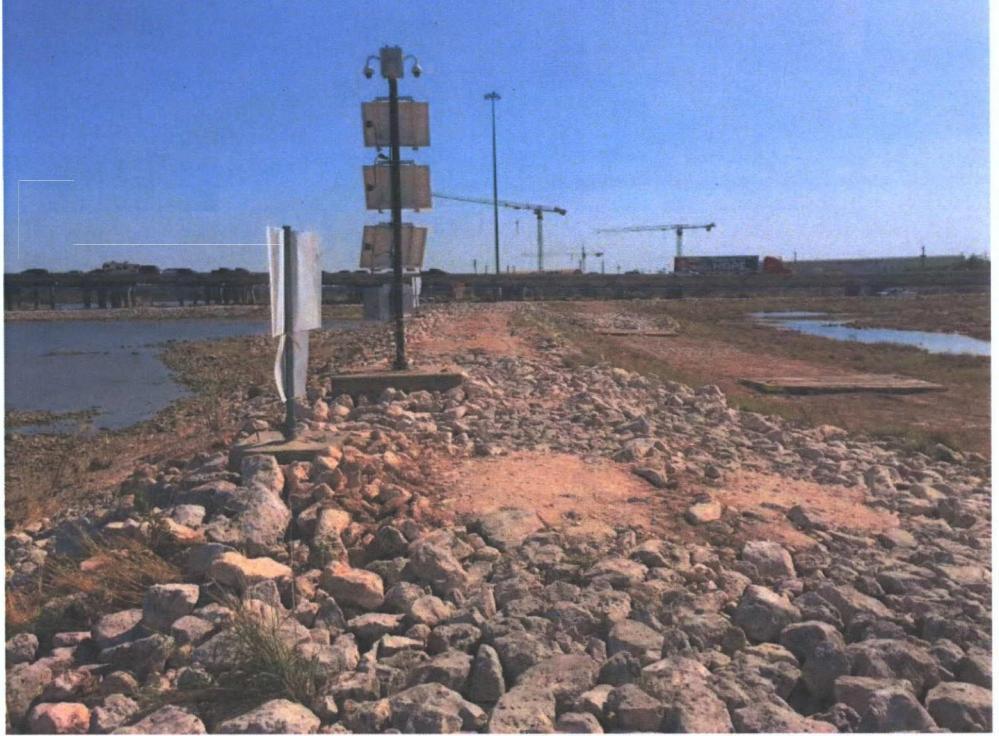
Photo 2 - area around camera system on central berm following maintenance

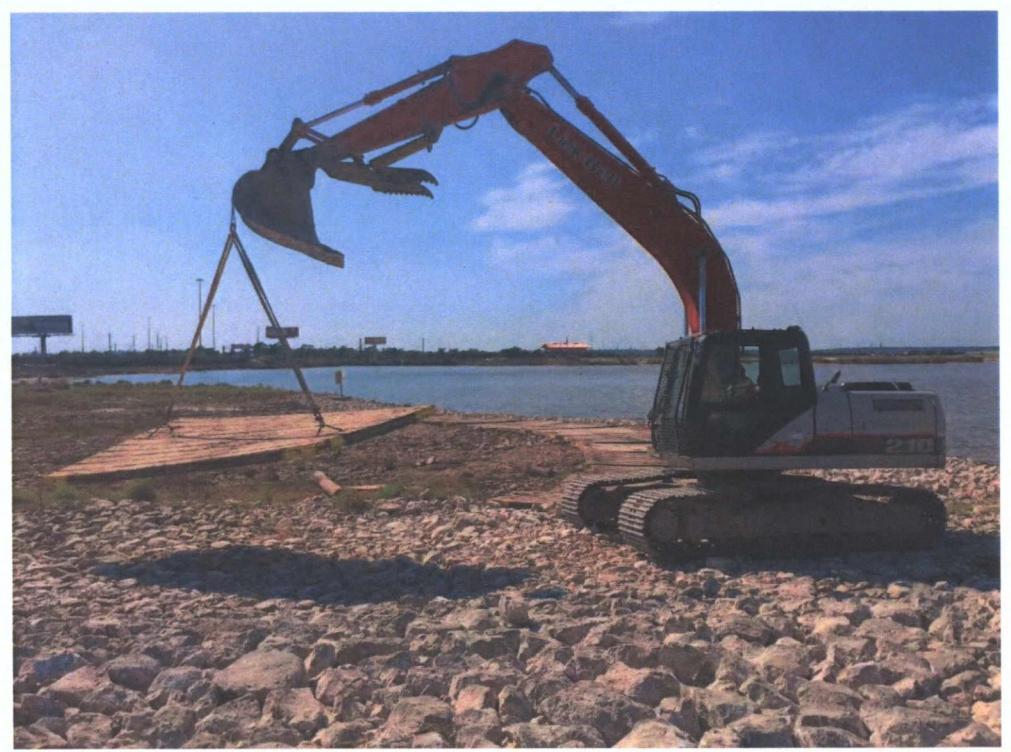
Photo 3 - moving heavy equipment pads from northwest shoreline area in preparation for demobilization

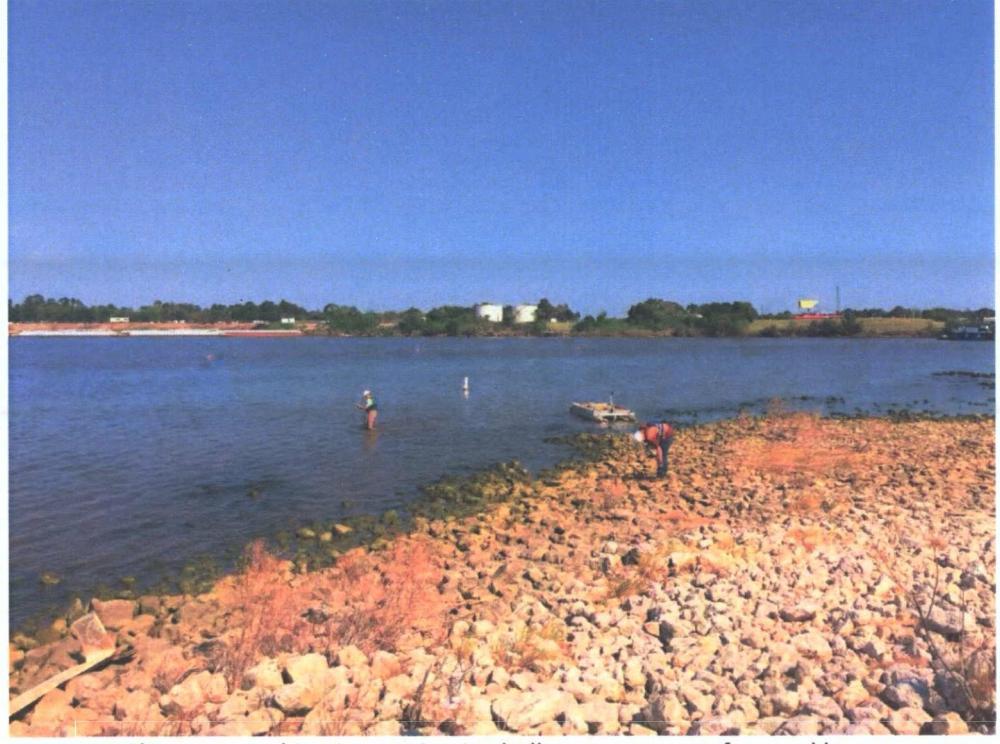
Photo 4 - probing inspection in shallow areas east of central berm
