Memorandum

October 6, 2017

0	
Re:	Post-Harvey TCRA Inspection and Maintenance Report – October 2017		ج د	Ö
		25	PM	\leq
	David Moreira, McGinnes Industrial Maintenance Corporation	ST.	\sim	
сс	Phil Slowiak, International Paper Company			$\overline{\mathbf{O}}$
From	John Laplante, John Verduin, Wendell Mears, and David Kelth		00	m
[rom	John Lanlanta, John Vardum, Wandell Maars, and David Kaith	AF C	7	$\boldsymbol{\Sigma}$
To:	Gary Miller and Anne Foster, U.S. Environmental Protection Agency		_

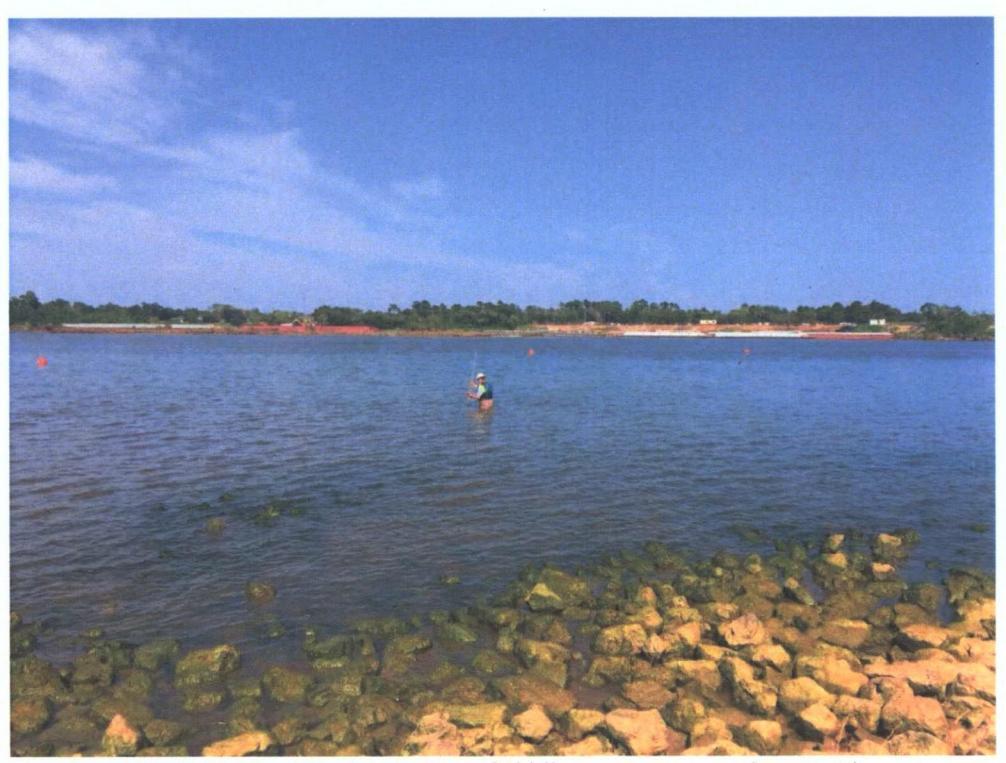
Photo 5 - probing inspection of shallow areas on northwest side

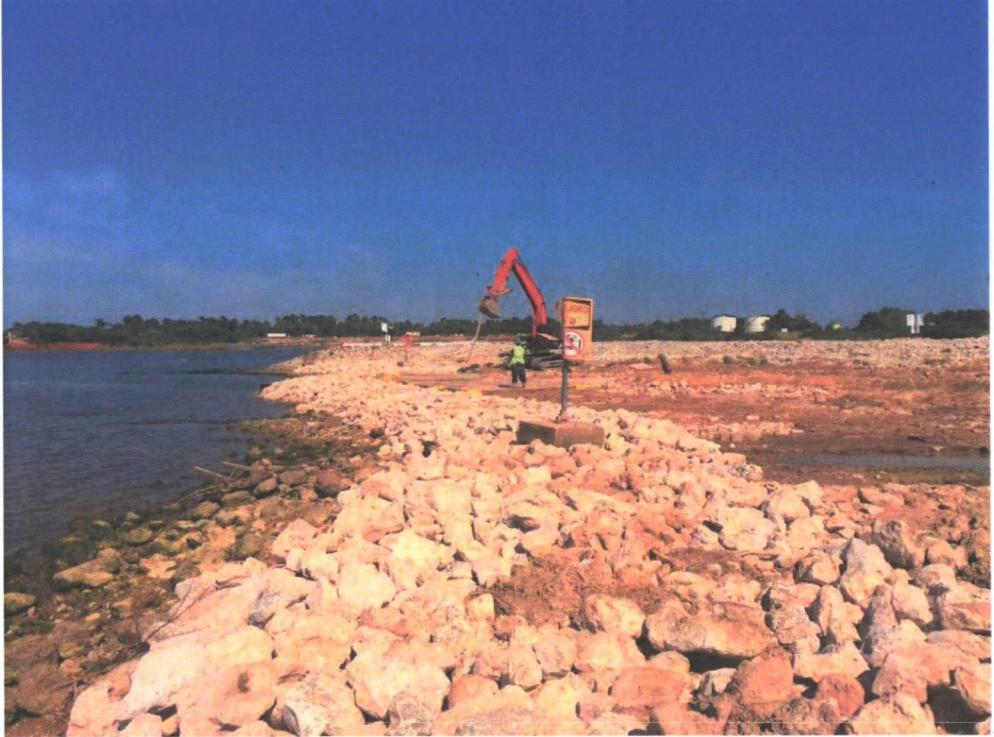
Photo 6 - northwest shoreline following maintenance

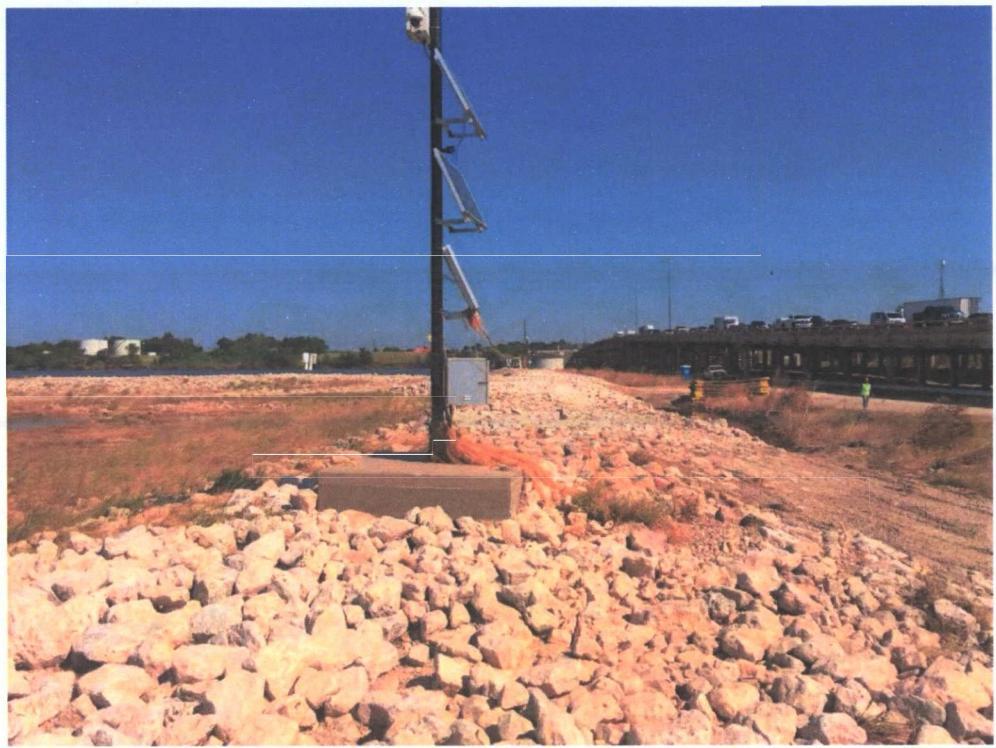
Photo 8 - area around west camera system on southern berm following maintenance

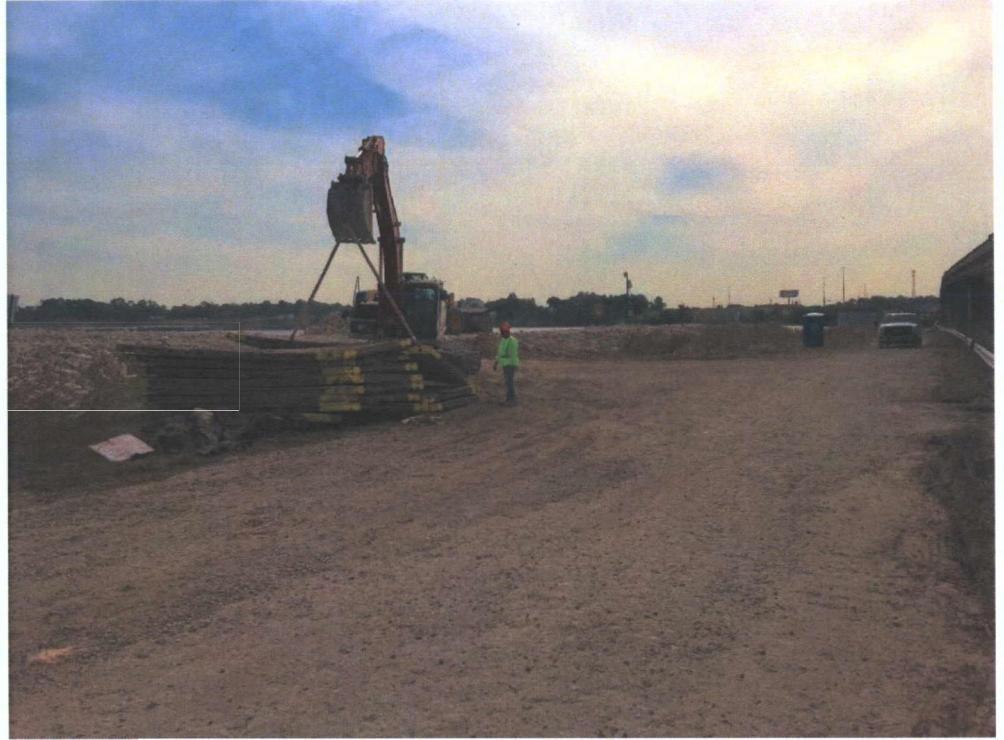
Photo 1 – preparing heavy equipment pads for demobilization

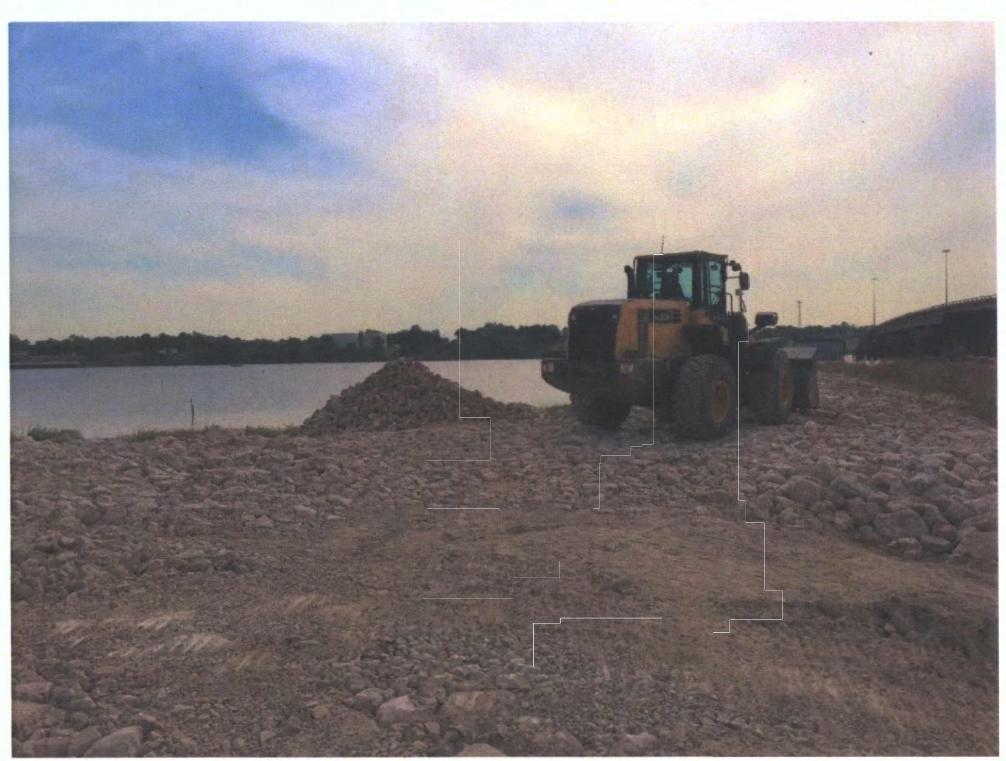
Photo 2 – performing stockpile management

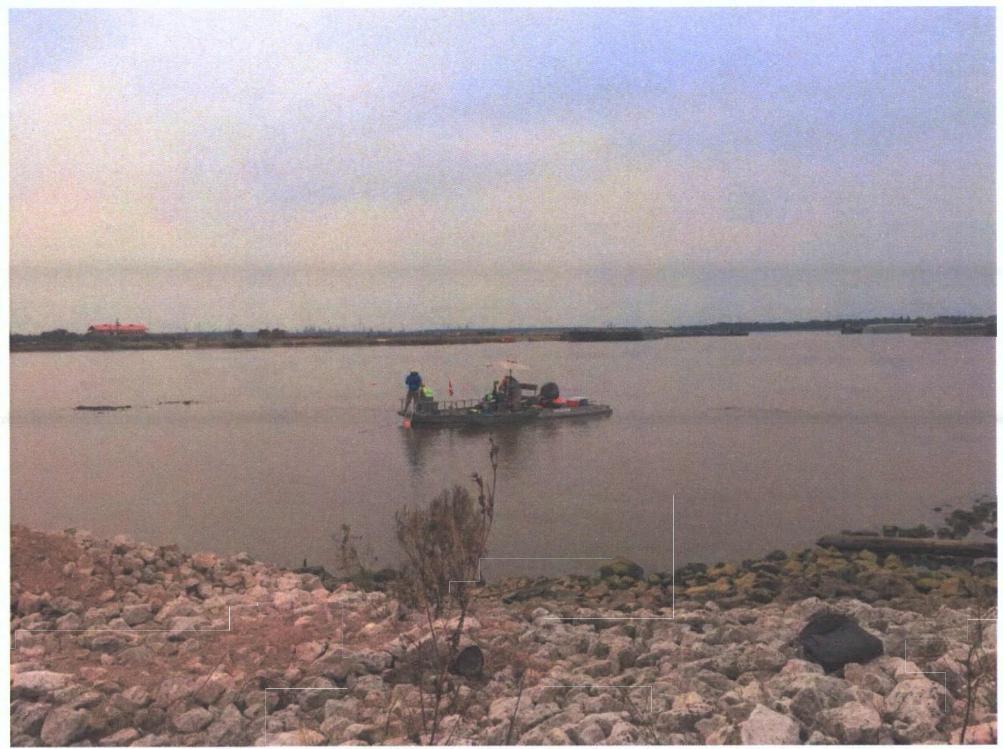
Photo 3 – probing inspection of northwest area

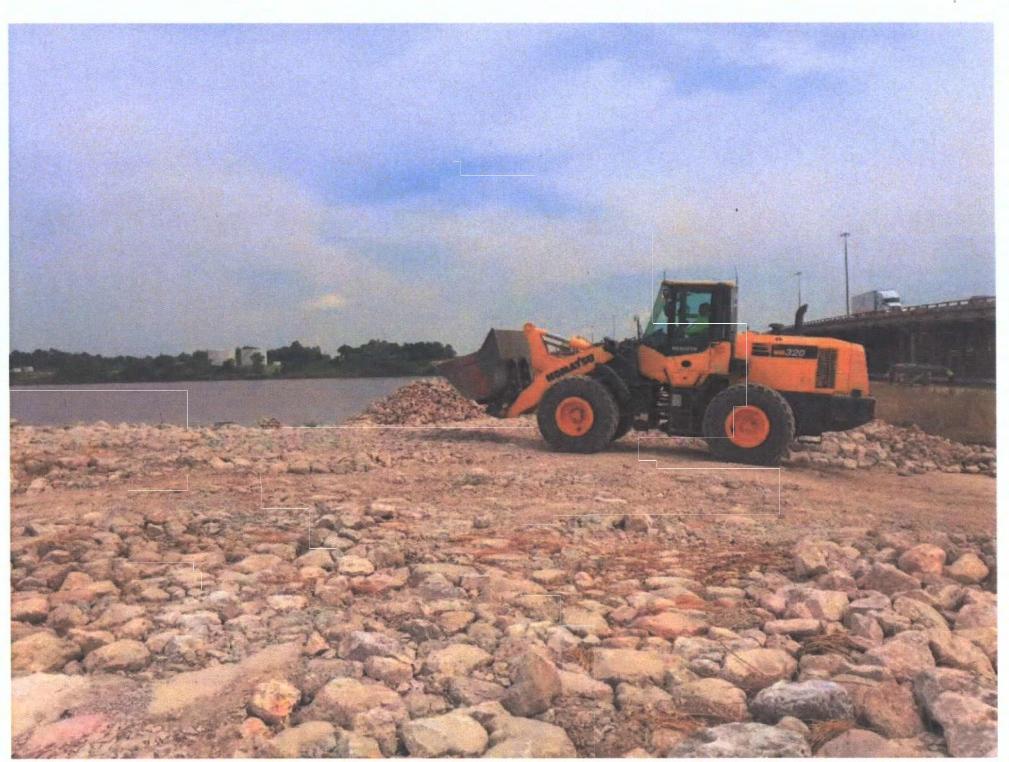
Photo 6 – performing stockpile management

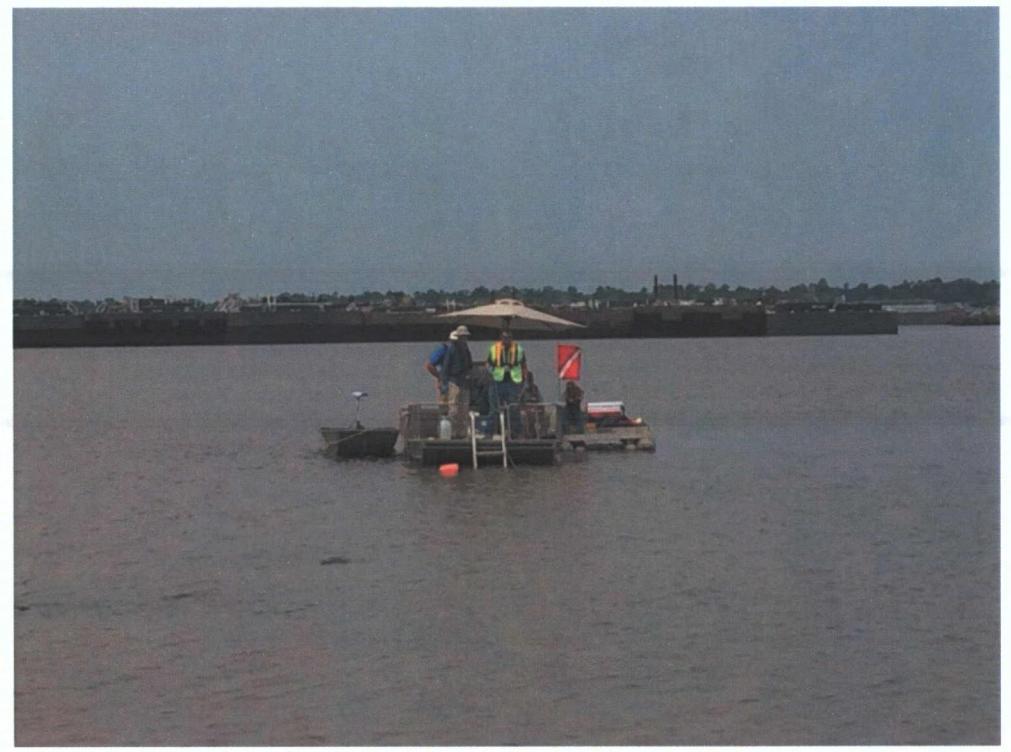
Photo 7 – probing inspection in west area

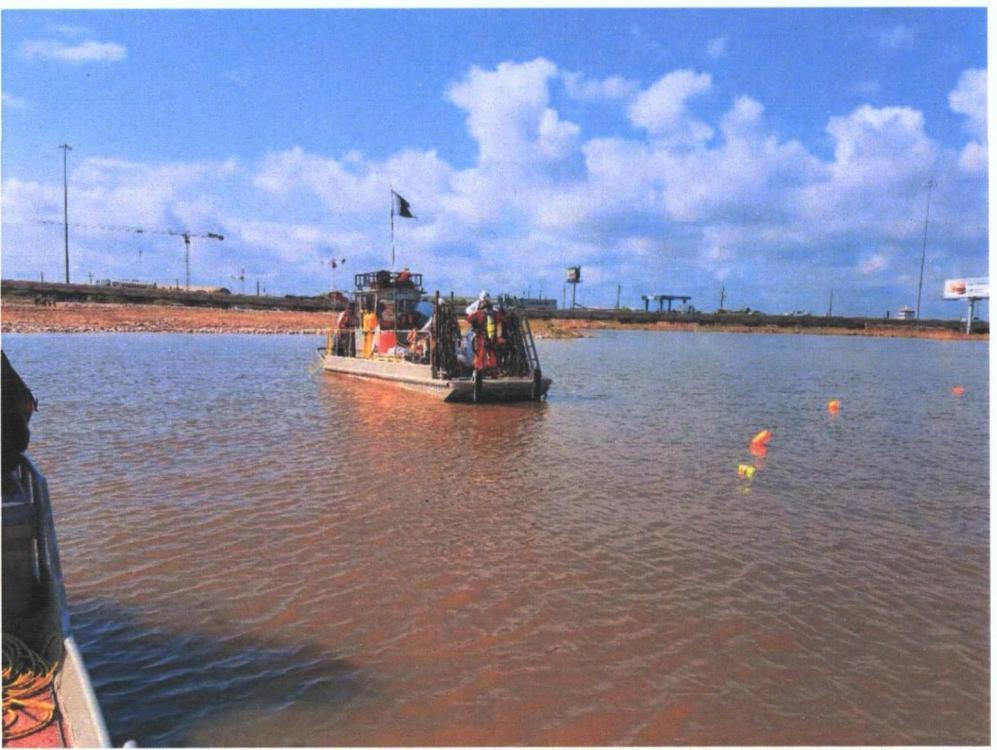
Photo 1 – Orion dive team preparing for dive sampling in the NW area

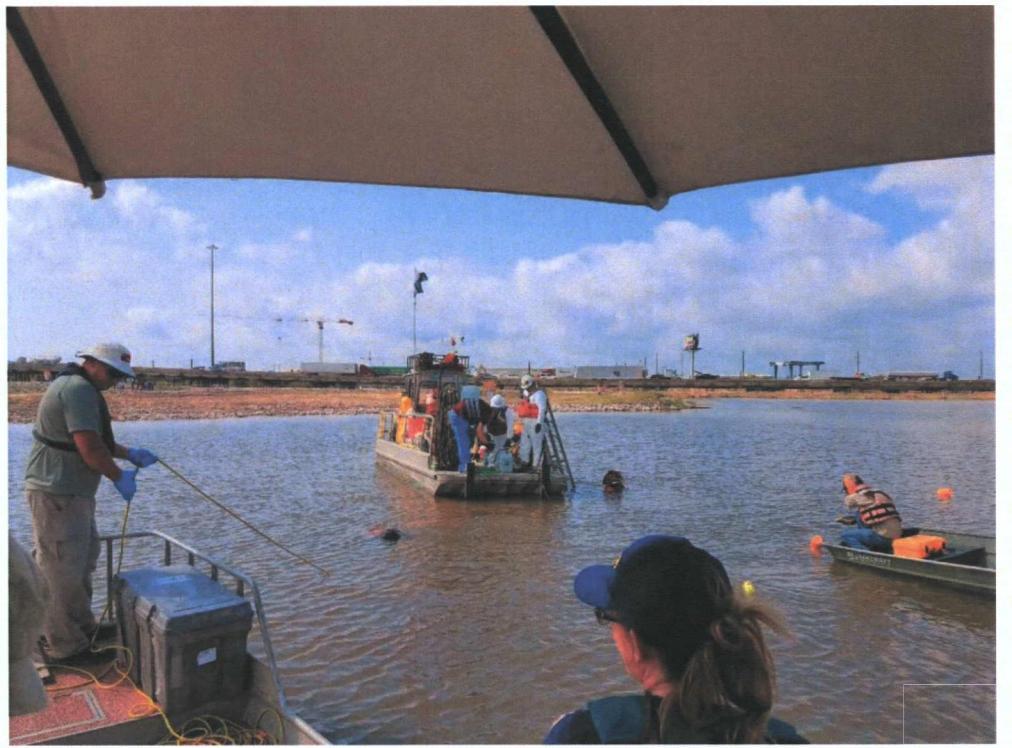
Photo 2 – USEPA dive team performing sampling in the NW area

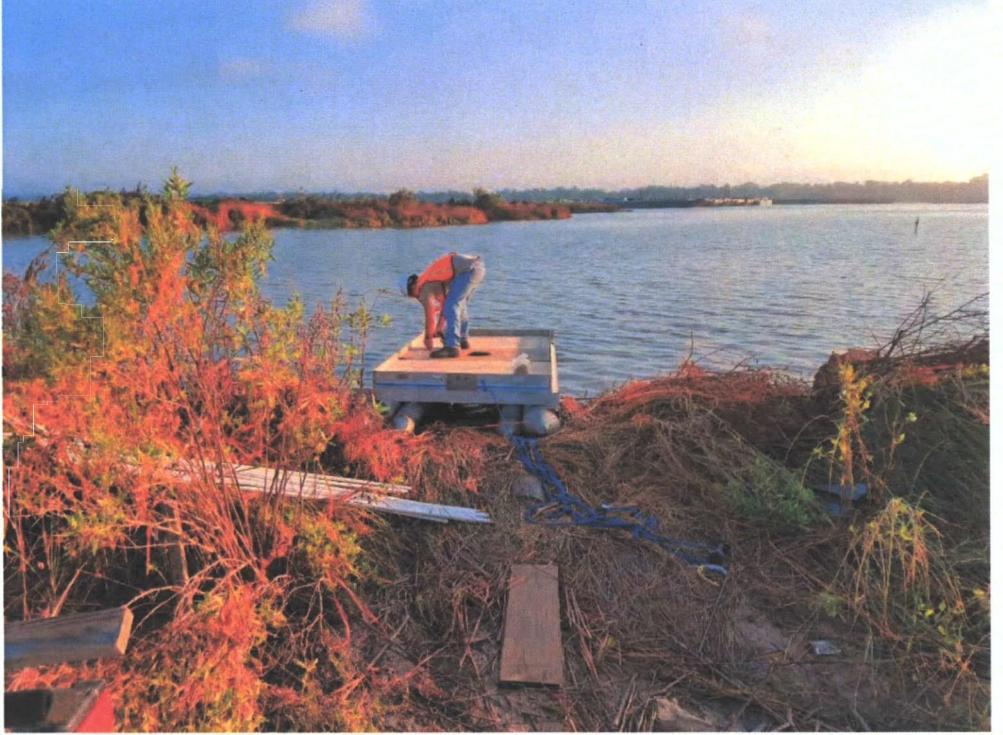
Photo 1 – BESI preparing pontoon barge for maintenance activities

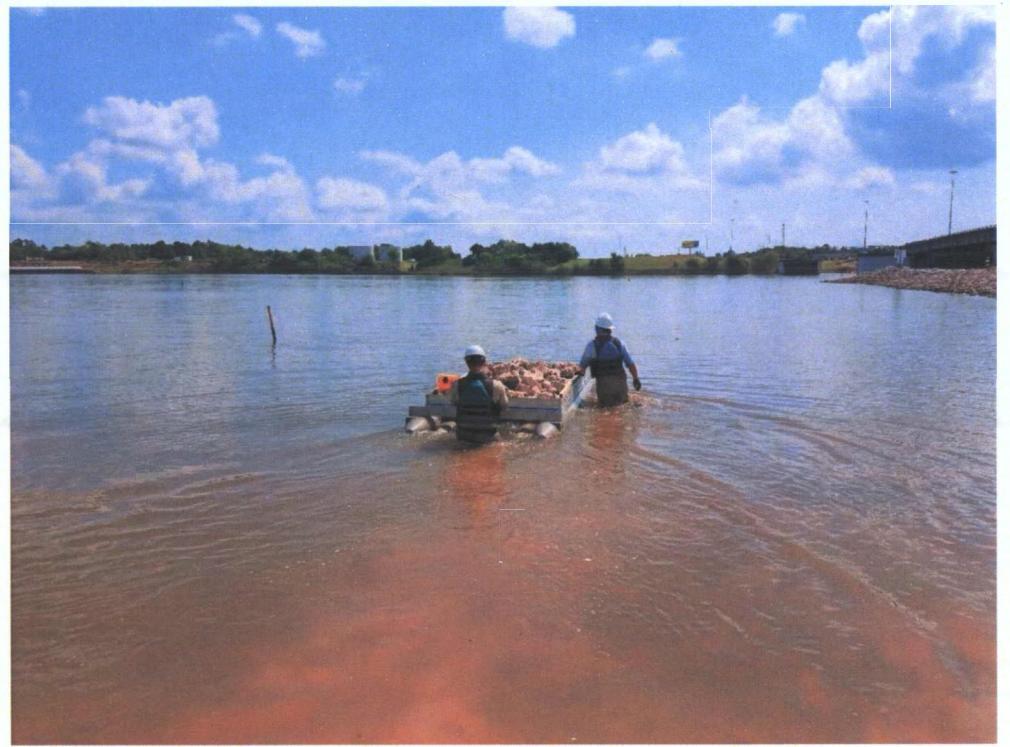
Photo 2 – BESI moving rock to a maintenance location in the Eastern Cell.

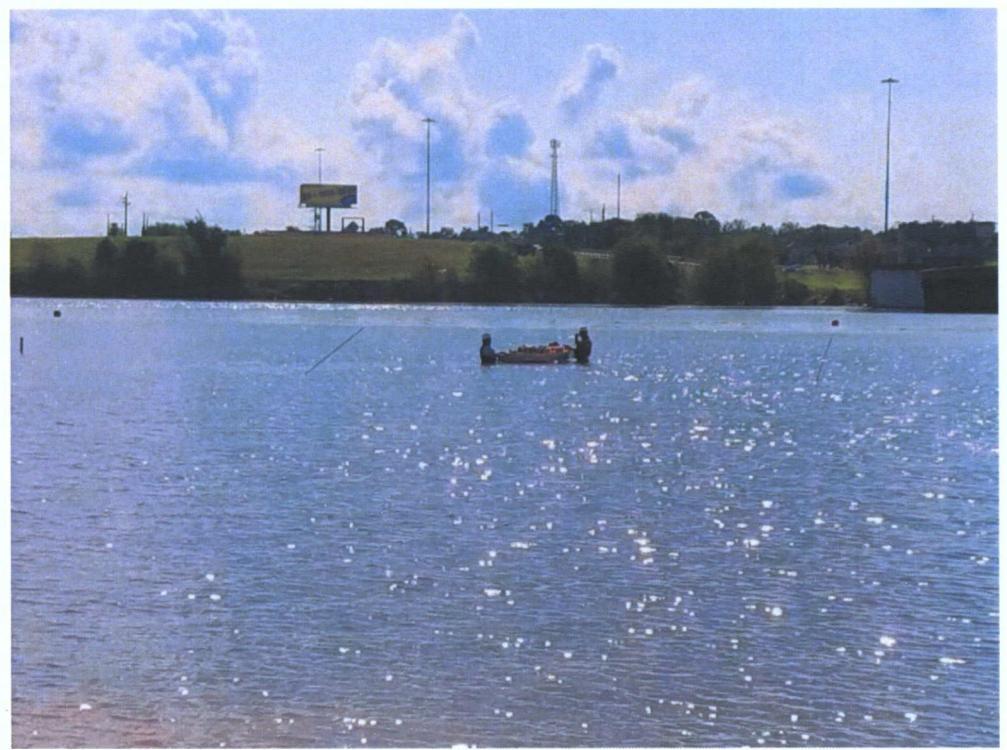
Photo 3 – BESI placing rock at maintenance location in the Eastern Cell.

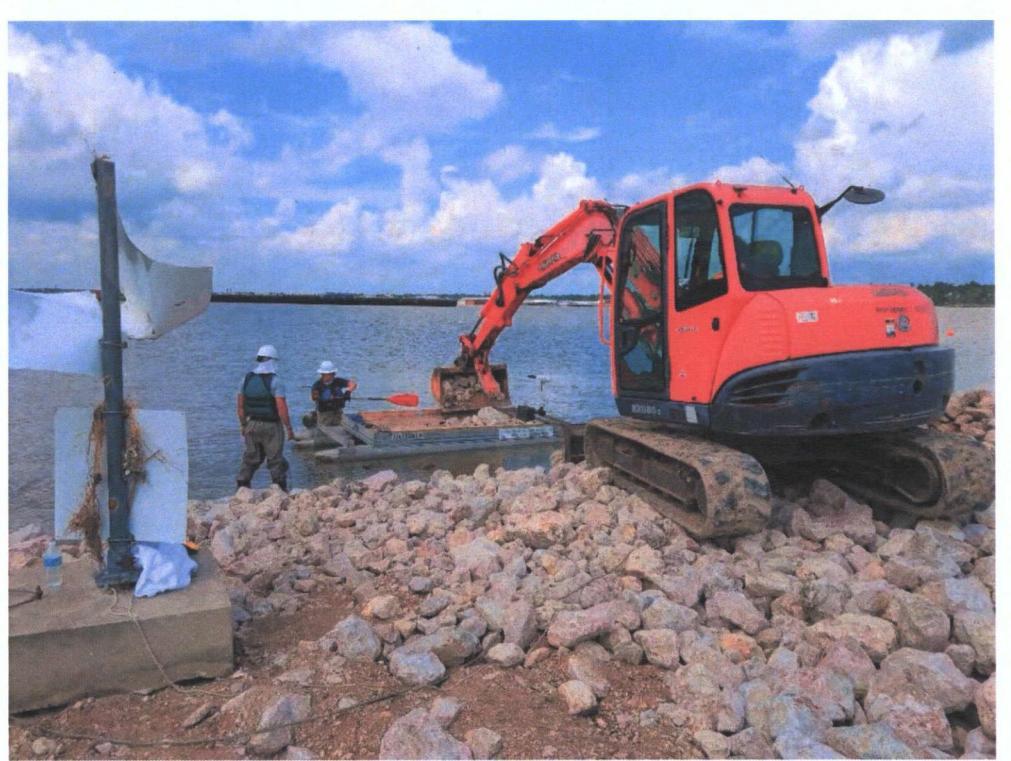
Photo 1 – USAE and BESI loading pontoon barge with rock during maintenance activities

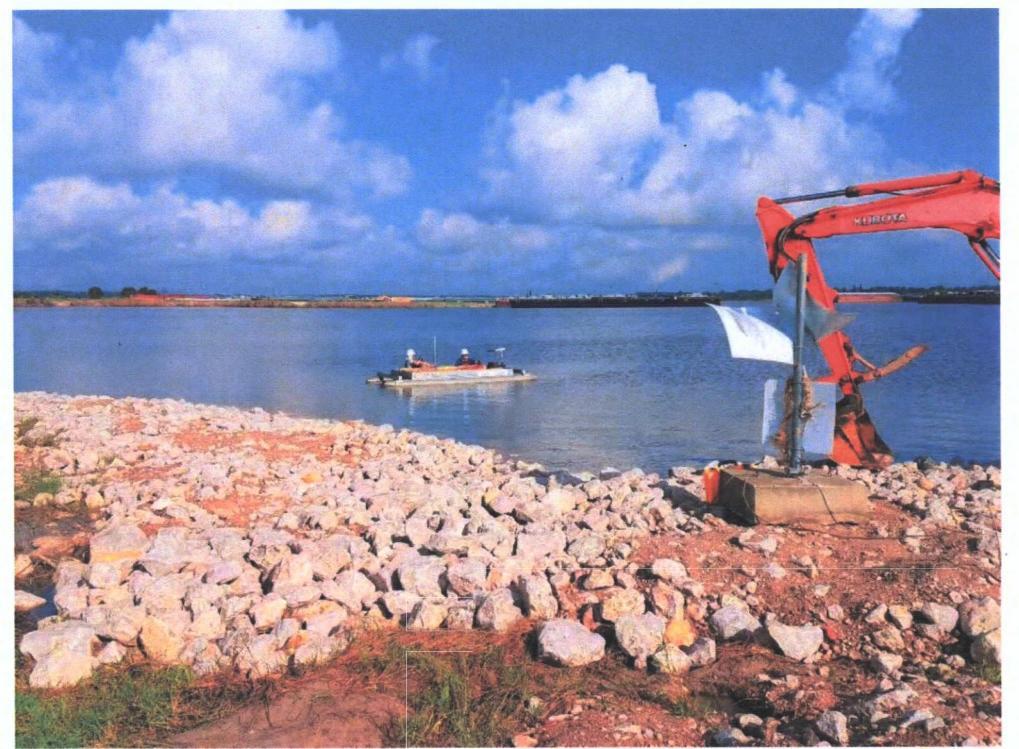
Photo 2 – BESI placing rock on a maintenance location in the NW area.

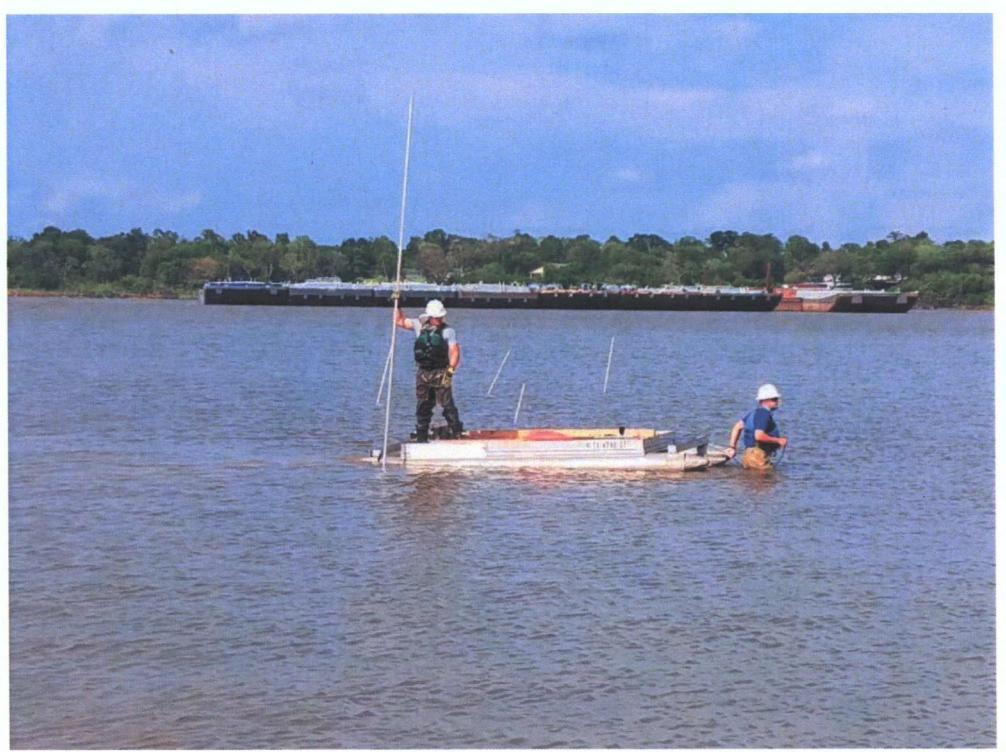
Photo 3 – Confirmatory probing of a maintenance location in the NW area.

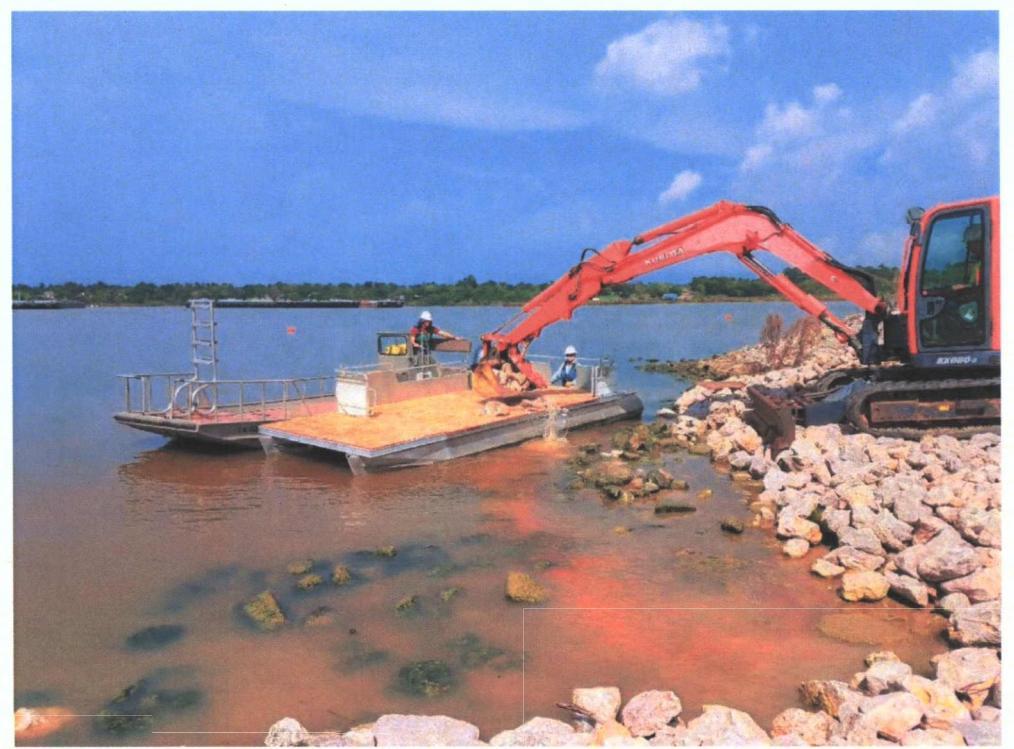
Photo 1 – USAE and BESI loading pontoon barge with rock during maintenance activities

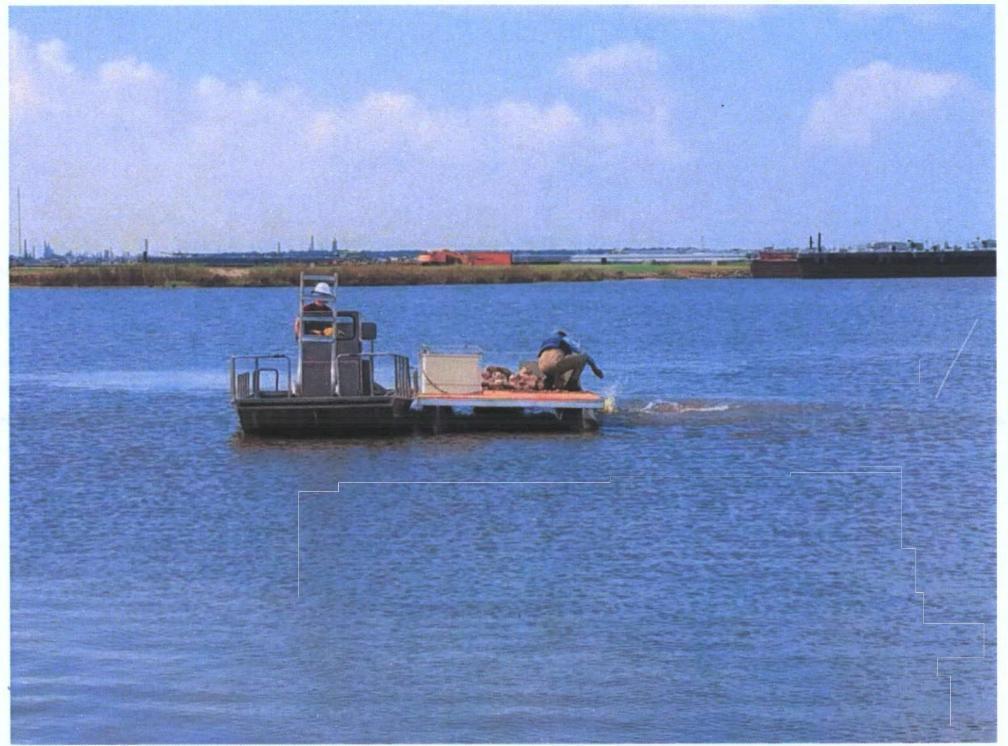
Photo 2 – BESI placing rock on a maintenance location in the NW area

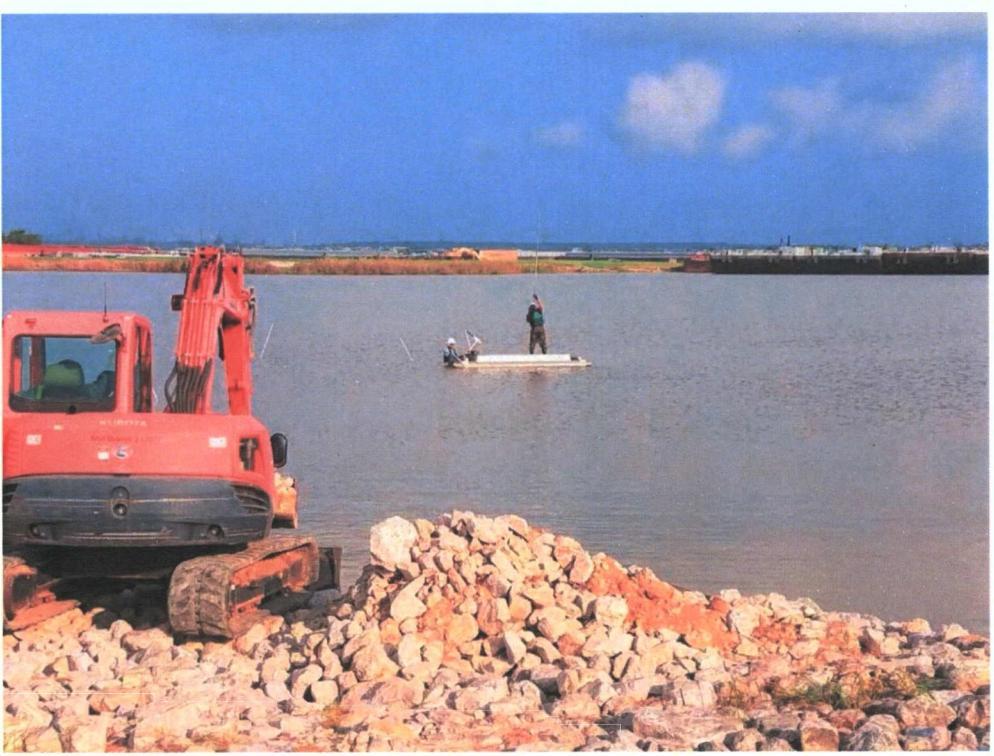
Photo 3 – Confirmatory probing of a maintenance location in the NW area

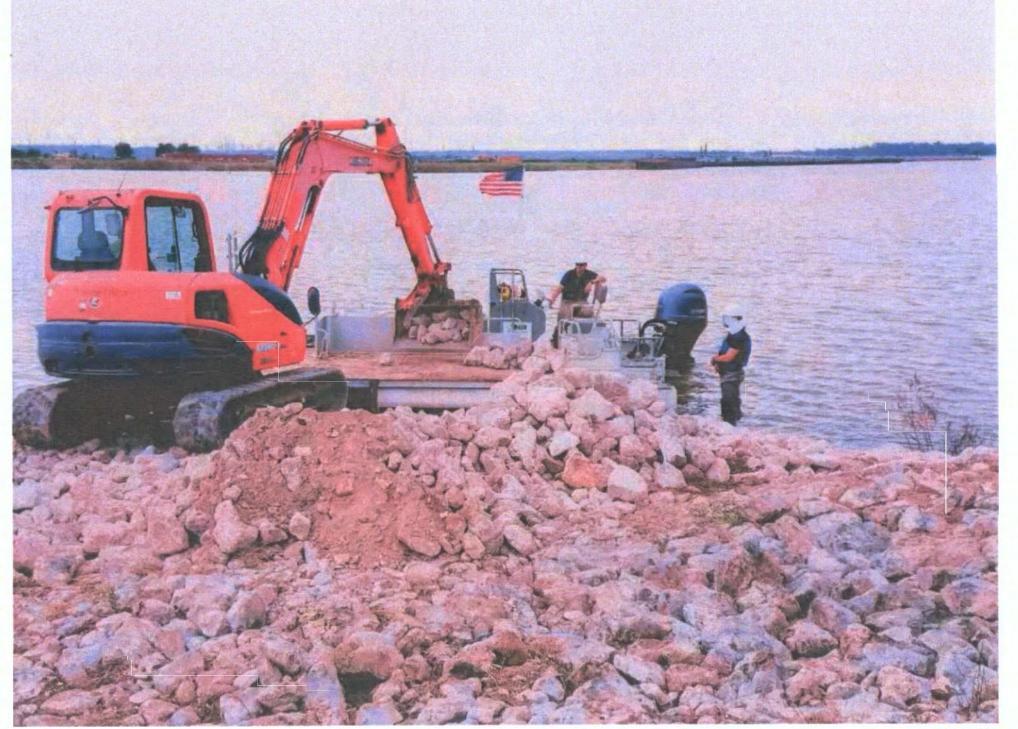
Photo 1 – USAE and BESI loading pontoon barge with rock during maintenance activities

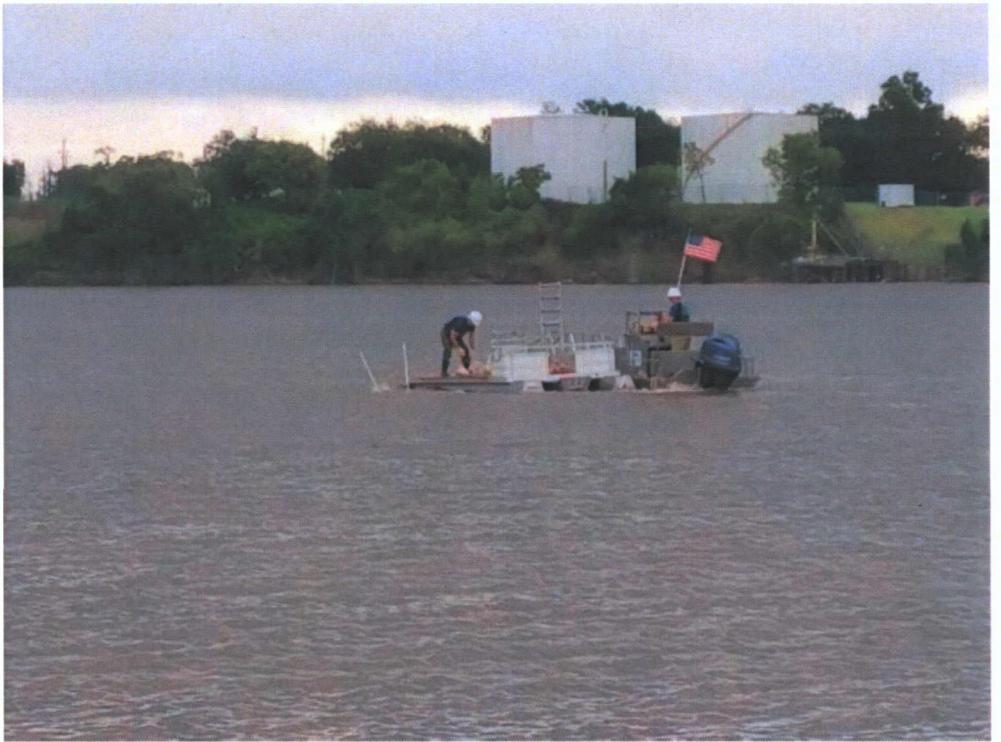
Photo 2 – BESI placing rock on a maintenance location in the Eastern Cell

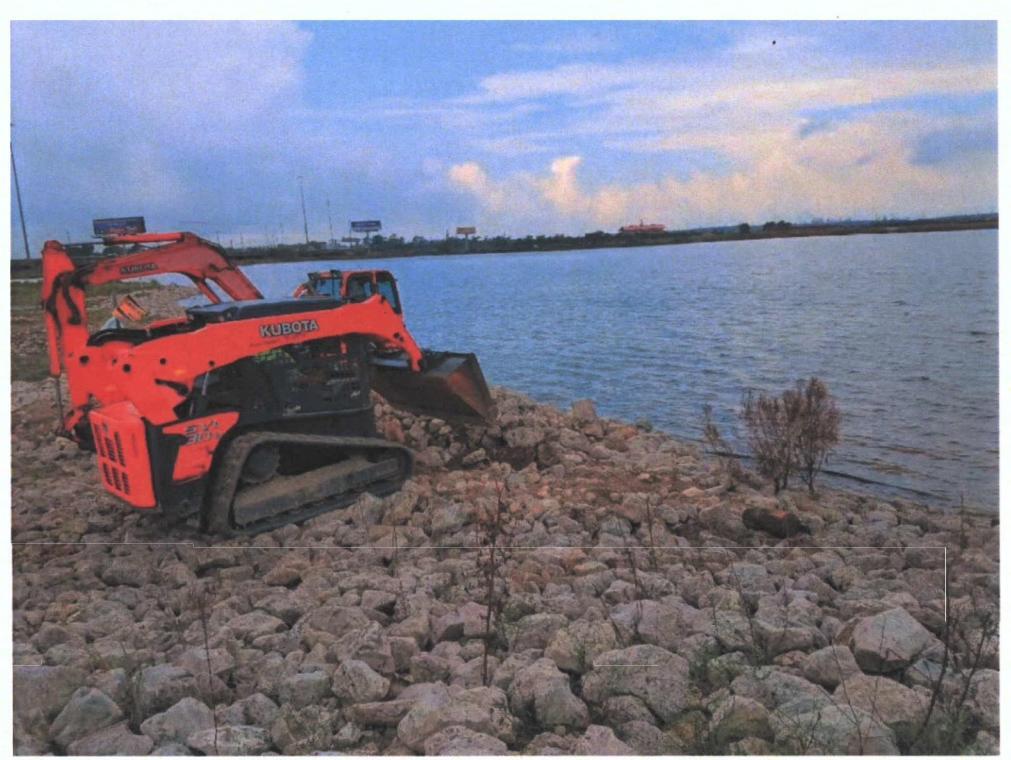
Photo 3 – USAE performing stockpile management

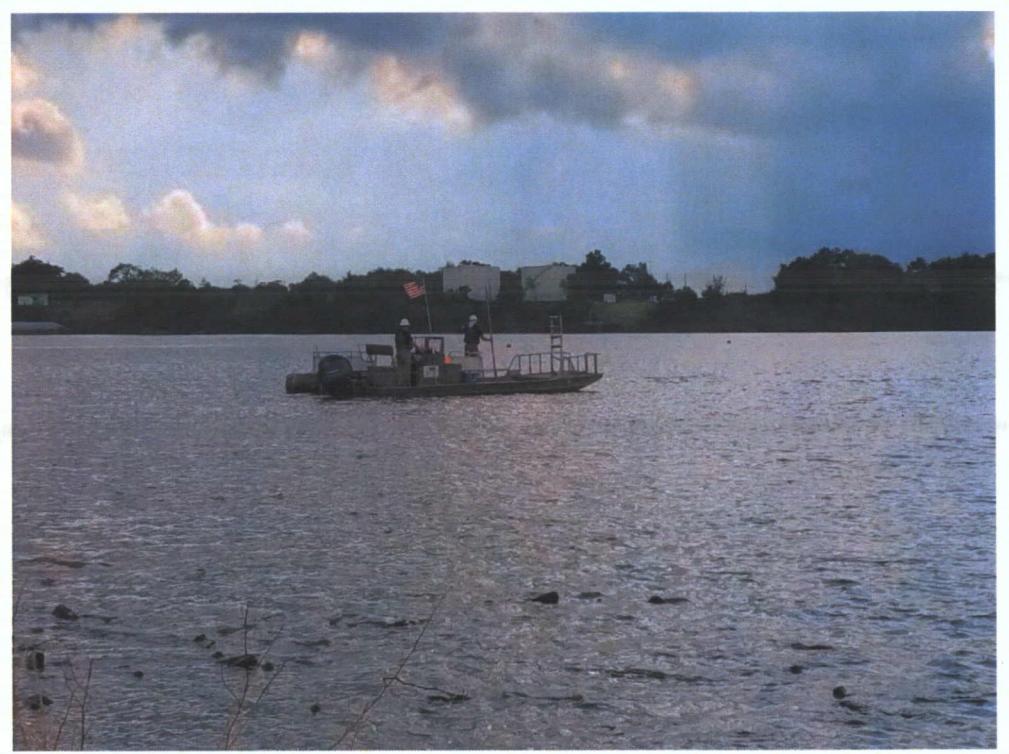
Photo 4 – BESI locating an AOI in the Eastern Cell
