## FIRST FIVE YEAR REVIEW REPORT

### KENNECOTT SOUTH ZONE

OU 1 Bingham Creek  
OU 4 Large Bingham Reservoir  
OU 5 Copperton Tailings  
OU 10 Copperton Soils  
OU 11 Bingham Canyon  
OU17 Bastian Sink

June, 2004

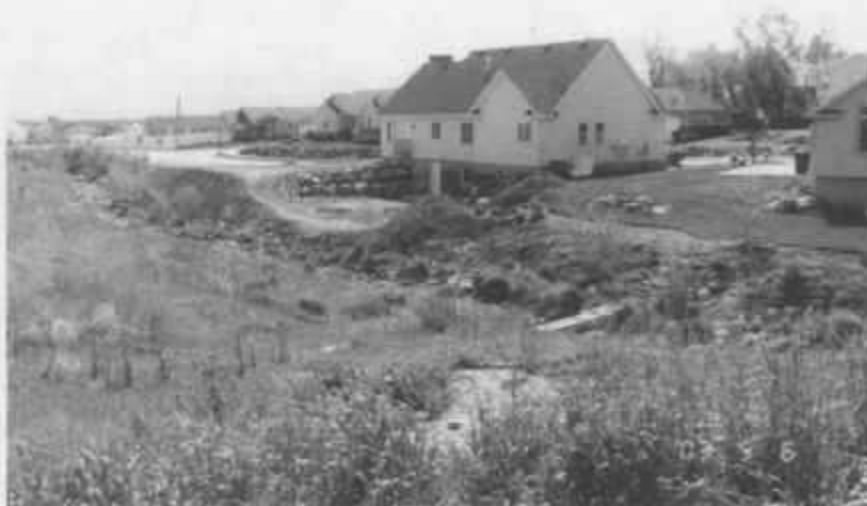
**Figure 1:** The Woods at Creekview. New construction and landscaping comes right up to the creek channel

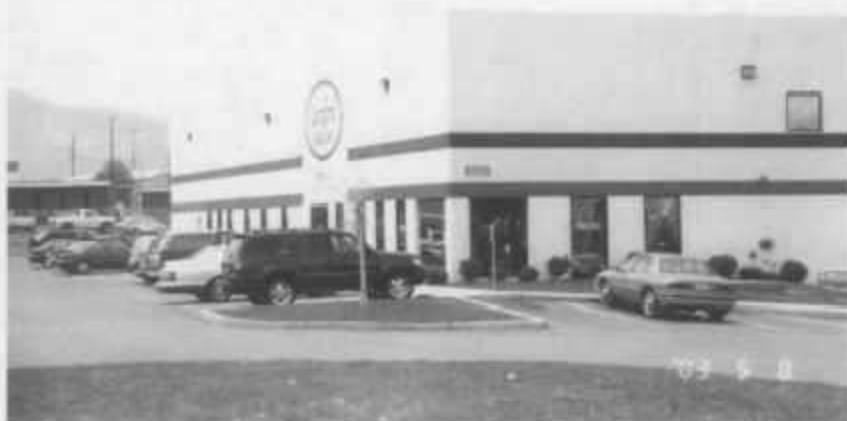
**Figure 2:** Mountain View Business Park, pad construction on top of the remedy

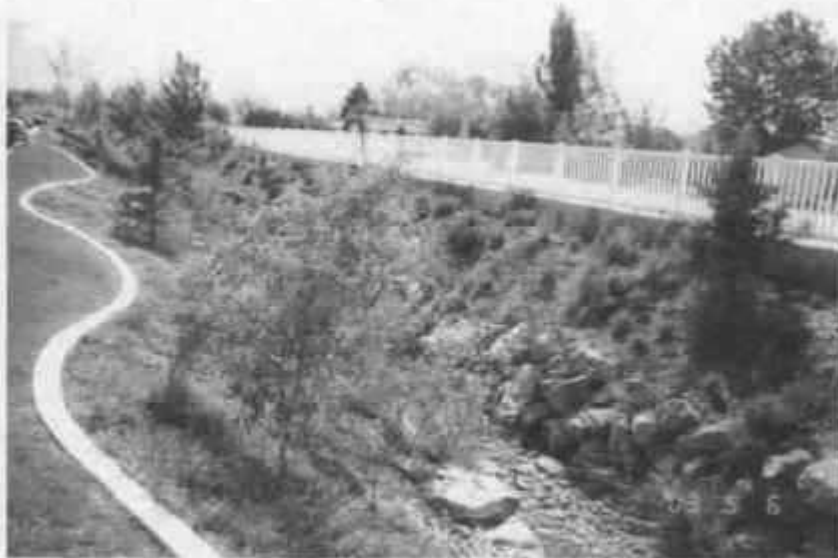
**Figure 3:** Newly reconstructed Bingham Creek Channel in front of the Cascade Springs Apartments

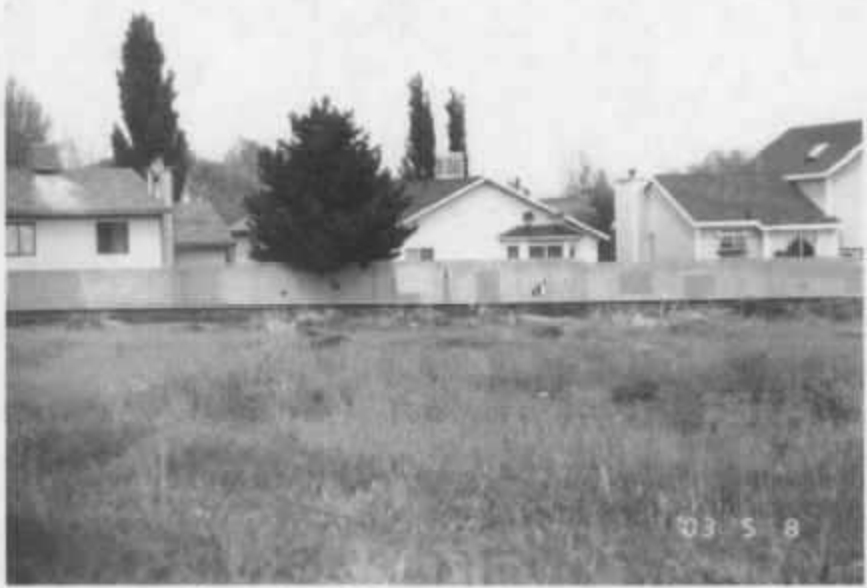
**Figure 4:** The fence line of the next Sugar Creek Condos abuts on the creek channel

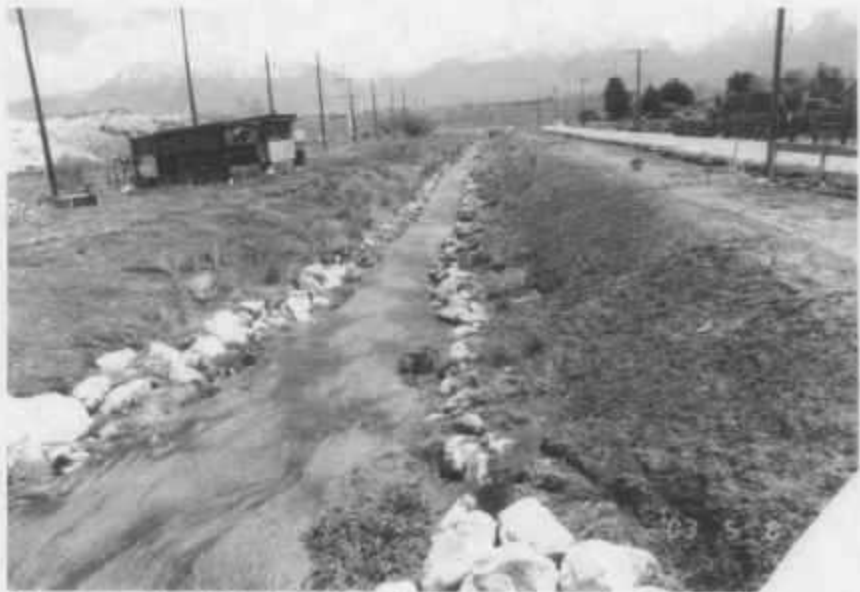
**Figure 5:** New Bingham Creek Channel near the Jordan River

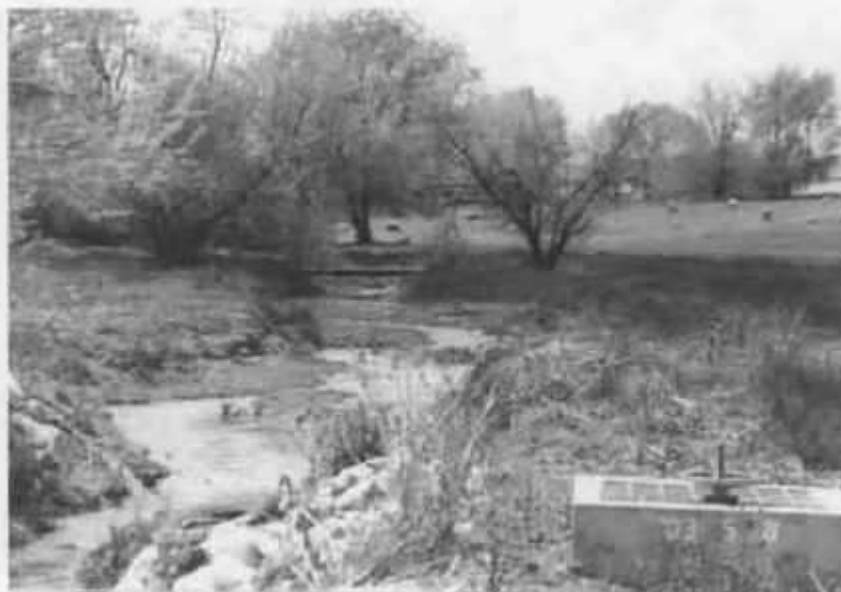
**Figure 6:** Diversion structure between old and new channels

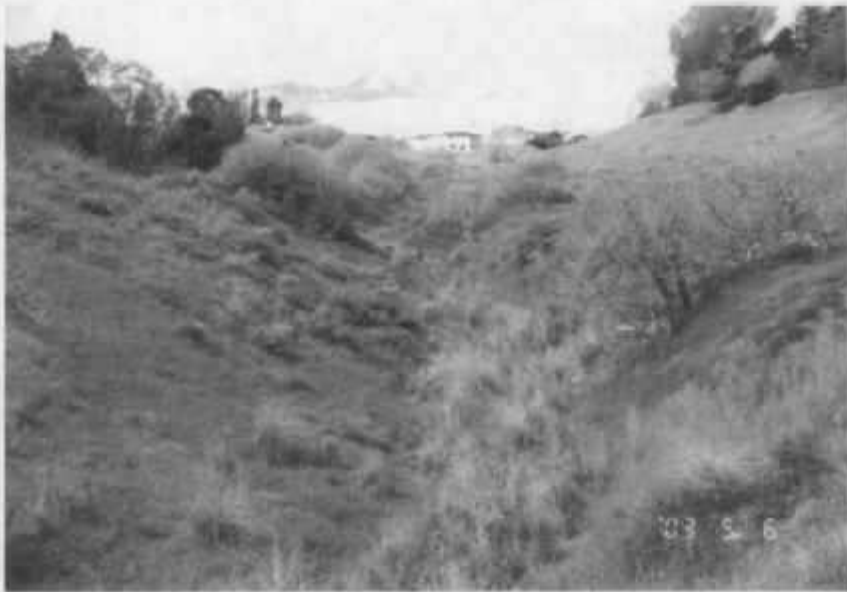
**Figure 8:** Revegetation of Bingham Creek Channel

4. With very few exceptions, the revegetation efforts along the creek channel, in the residential neighborhoods, and in the new developments are in excellent shape. It is difficult to see that the area had ever been disturbed by the cleanups. In many cases, the vegetation is healthier than was there before the cleanups.

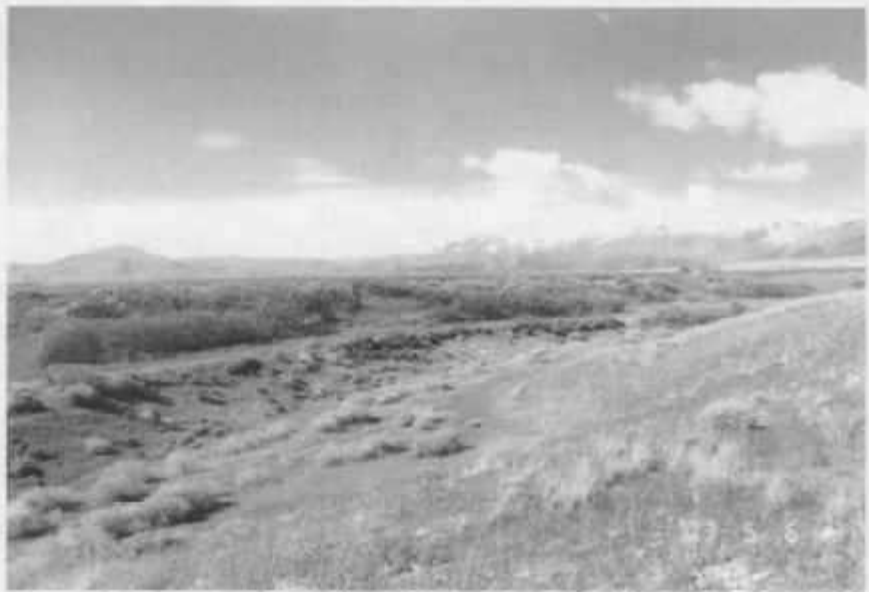
**Figure 9:** Revegetation of Creek Channel

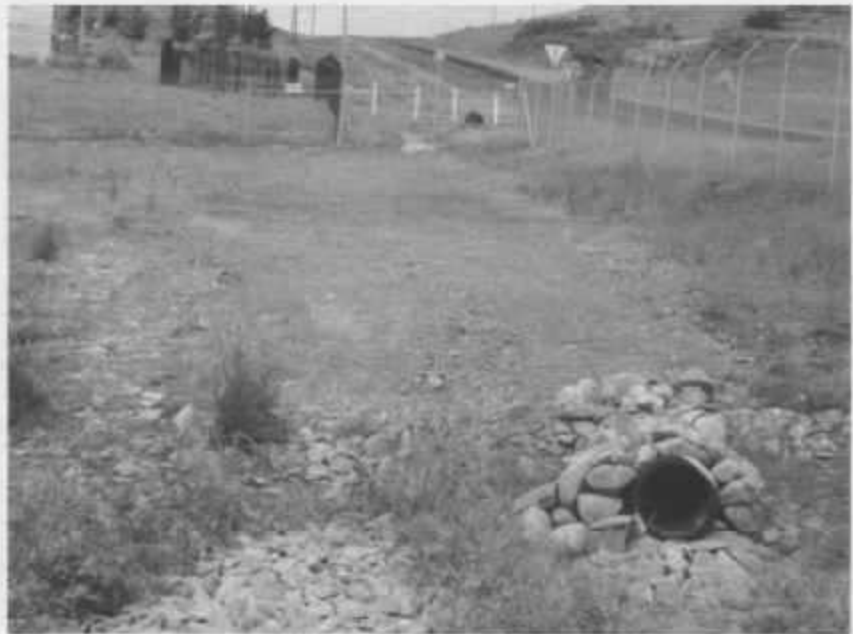
**Figure 11:** Outfall of new pipe directing road runoff to creek

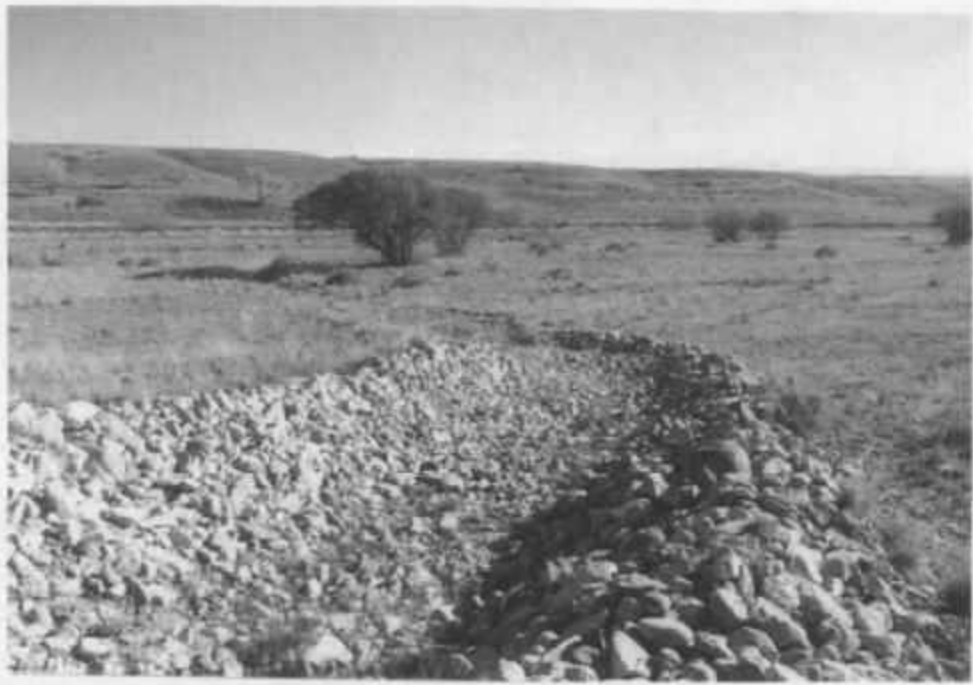
**Figure 15:** Drainage ditch with larger rip-rap lining

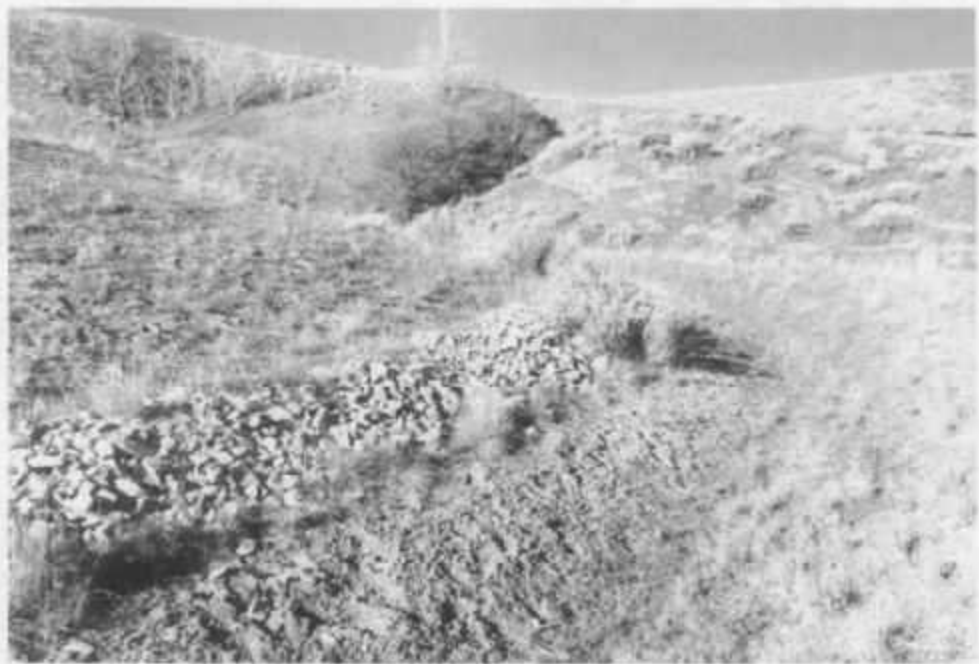
The Five Year Review Team and participants visited the Copperton Tailings site to determine if changes were visible in the facility since it was constructed. Present were prime contractor for ARCO and the original EPA On-scene Coordinator for the work. The slopes on the repository cap showed no evidence of erosion or settlement and the vegetation was doing well. The drainage controls, both run-on and run-off controls, were still in good shape and had collected only a very small amount in sediments. The smaller rip-rap initially used in the drainage ditch from the repository to the retention basin had been replaced with larger rip-rap when the smaller size was washed away during a storm. This event had occurred during construction of the facility. The new larger size rip-rap was still in place and was preventing erosion in the ditch. The retention basin dikes were in good shape also and seemed unaffected by any stormwaters. The facility's O + M manager confirmed that water had not risen high enough in the retention basin to overflow into the creek. The maximum depth of water in the retention basin was 3 feet. The overflow chute looked new. The plastic liner in the chute showed hoof prints of deer which had apparently walked on the liner, lost their footing and skidded down to the bottom of the chute. The vegetation on the retention basin dike and in the retention basin itself was doing well. The inspection team were pleased that the trees which had been saved during the cleanup were thriving. Two of the trees near the retention

**Figure 14:** Upgradient side of the Copperton Tails cap

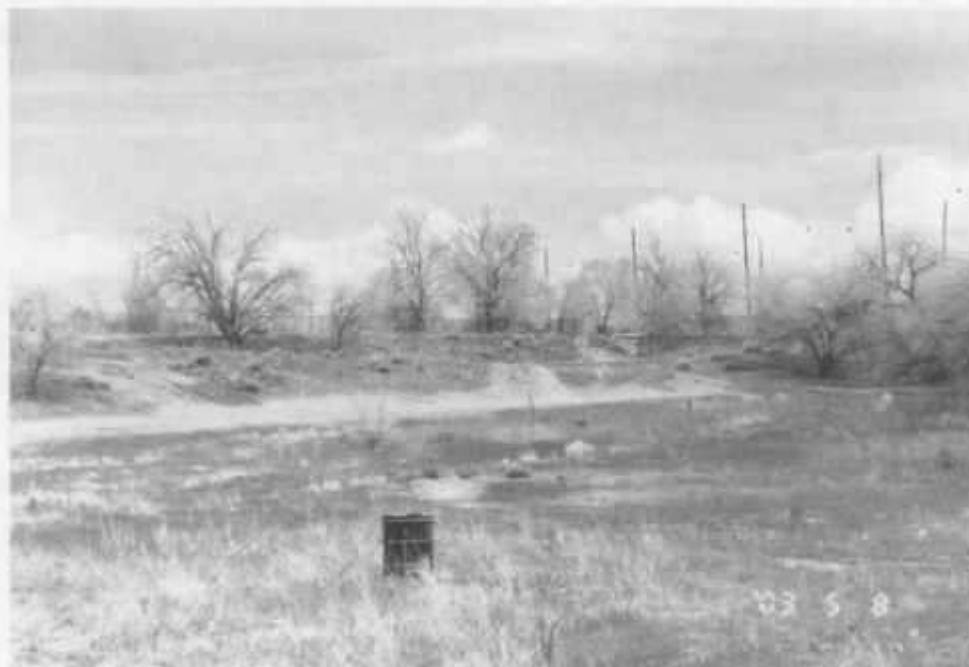
**Figure 17:** Remnants of mining wastes still visible in industrial area. (The barrel has been removed.)

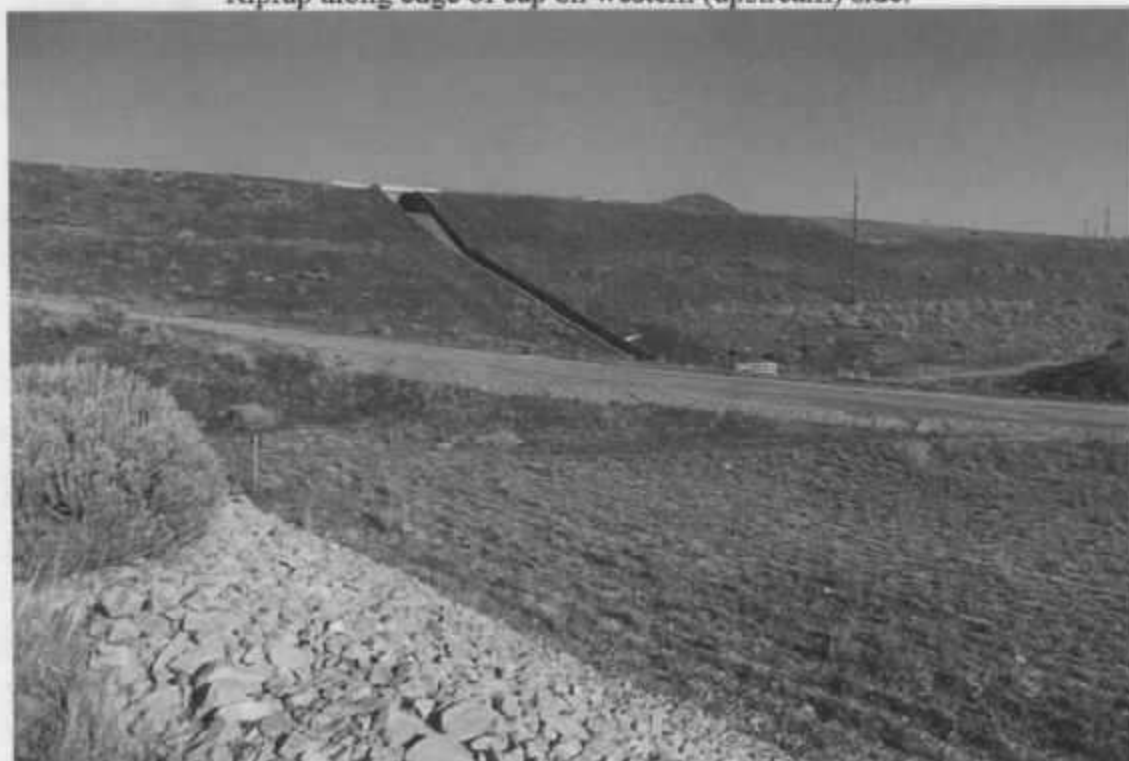
Large Bingham Reservoir Dam from tailings pond showing riprap on the upstream side

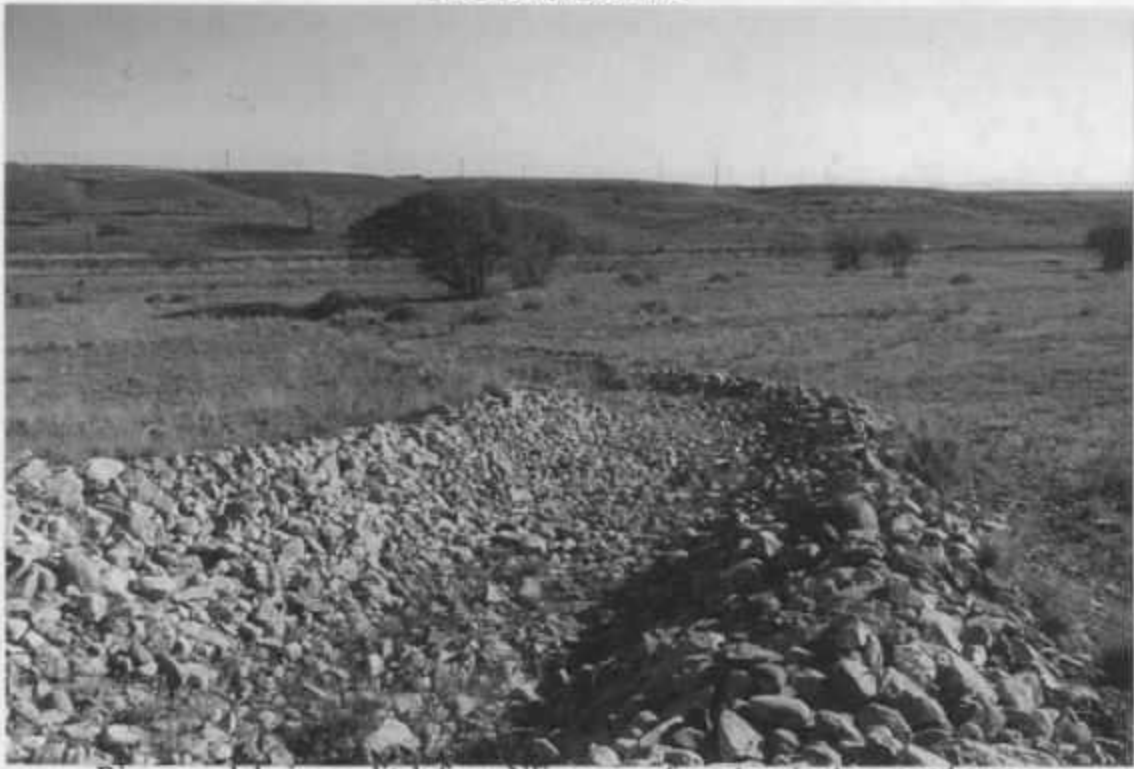
Riprap and drainage ditch from NE corner of cap to retention pond area

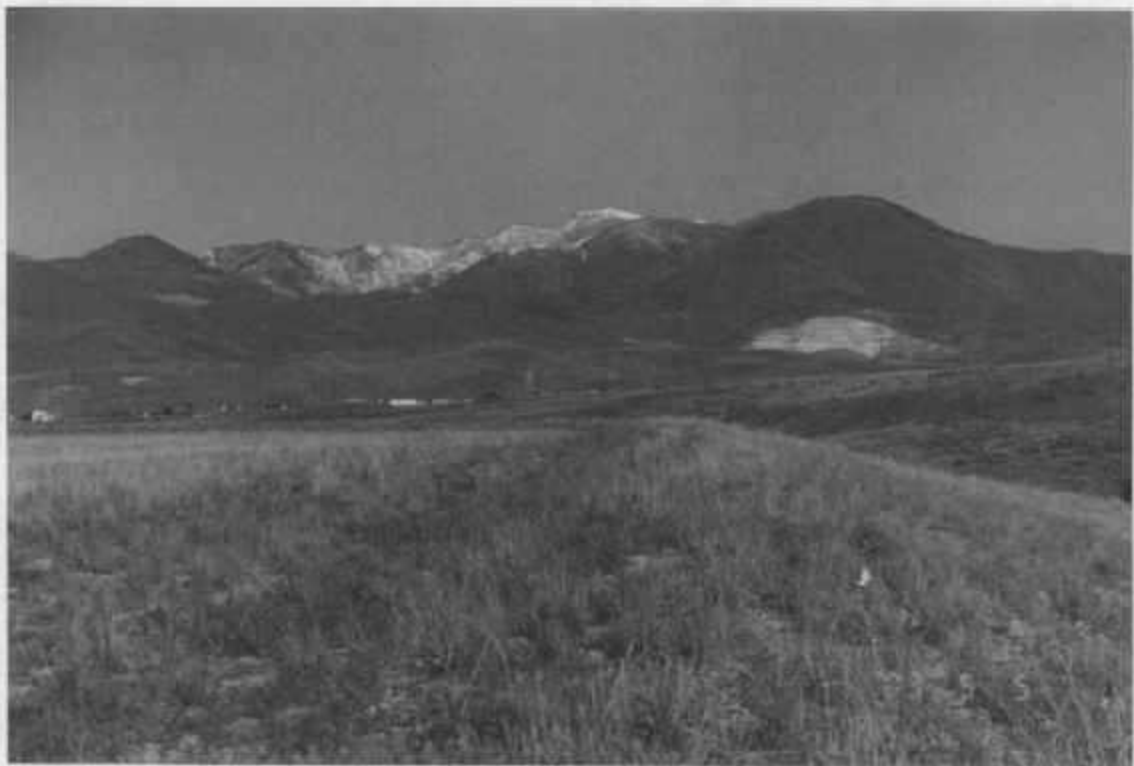
Berm around retention pond area NE of tailings area cap

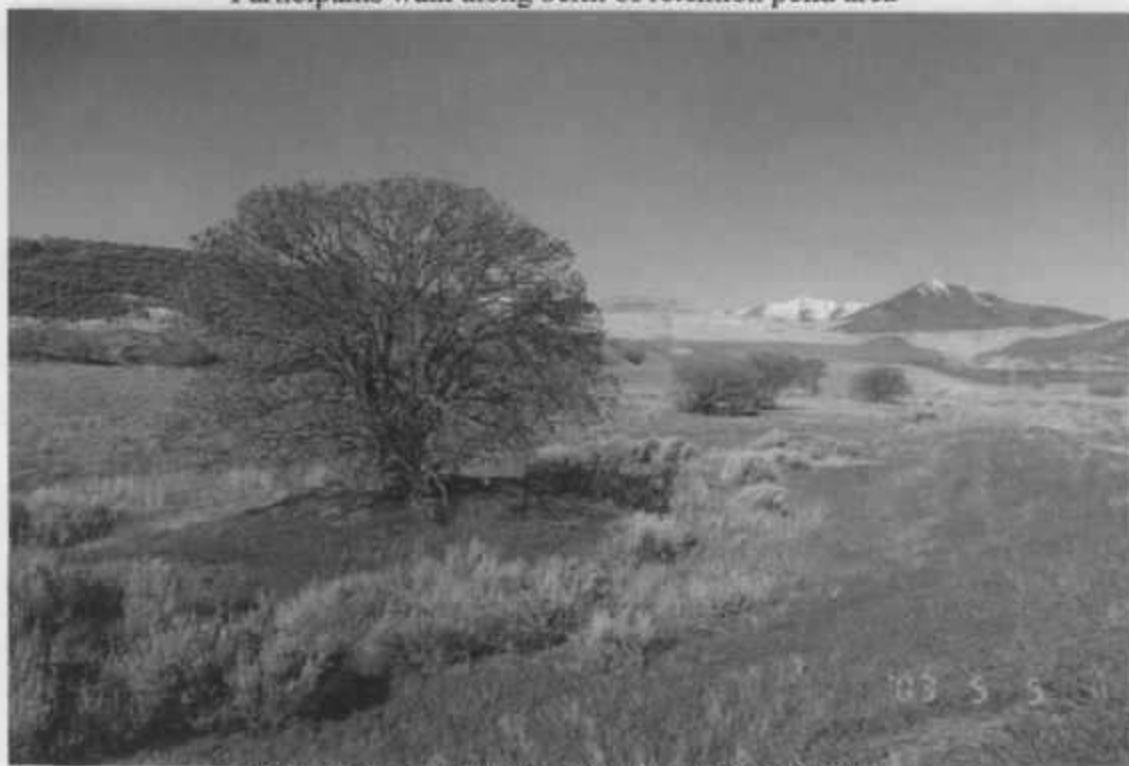
Tree in retention pond area with an owl nest in it

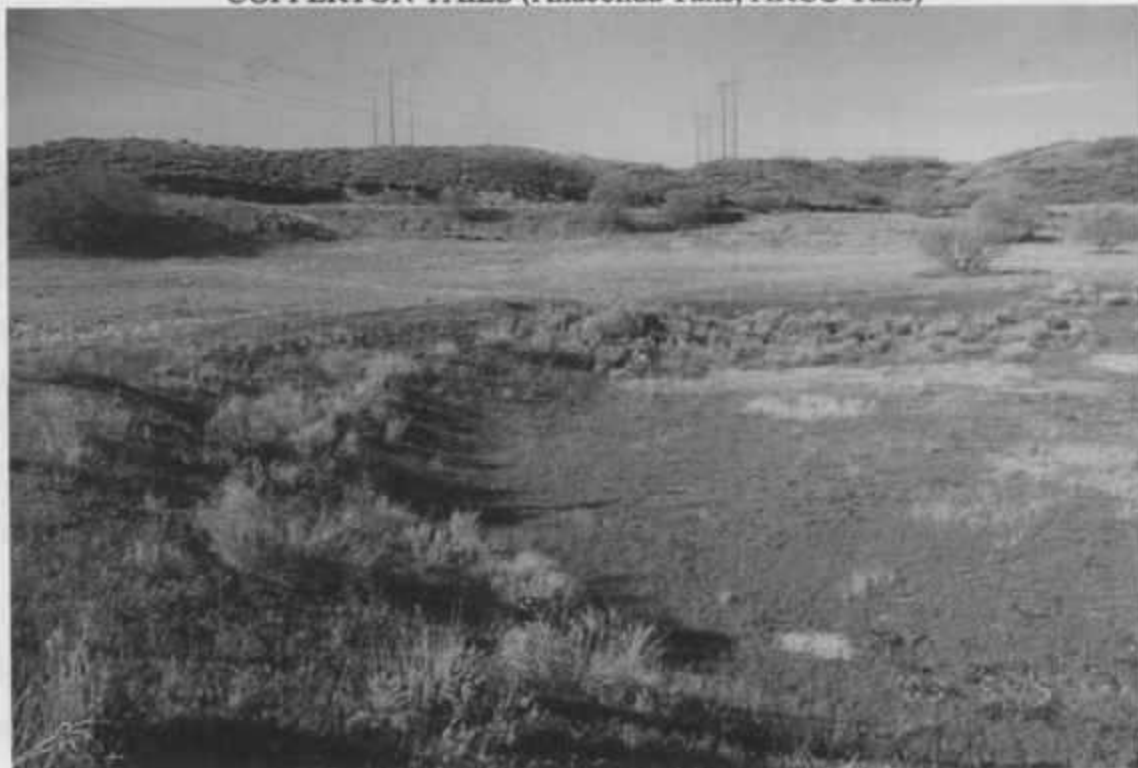
Retention Basin, revegetation with grass, trees

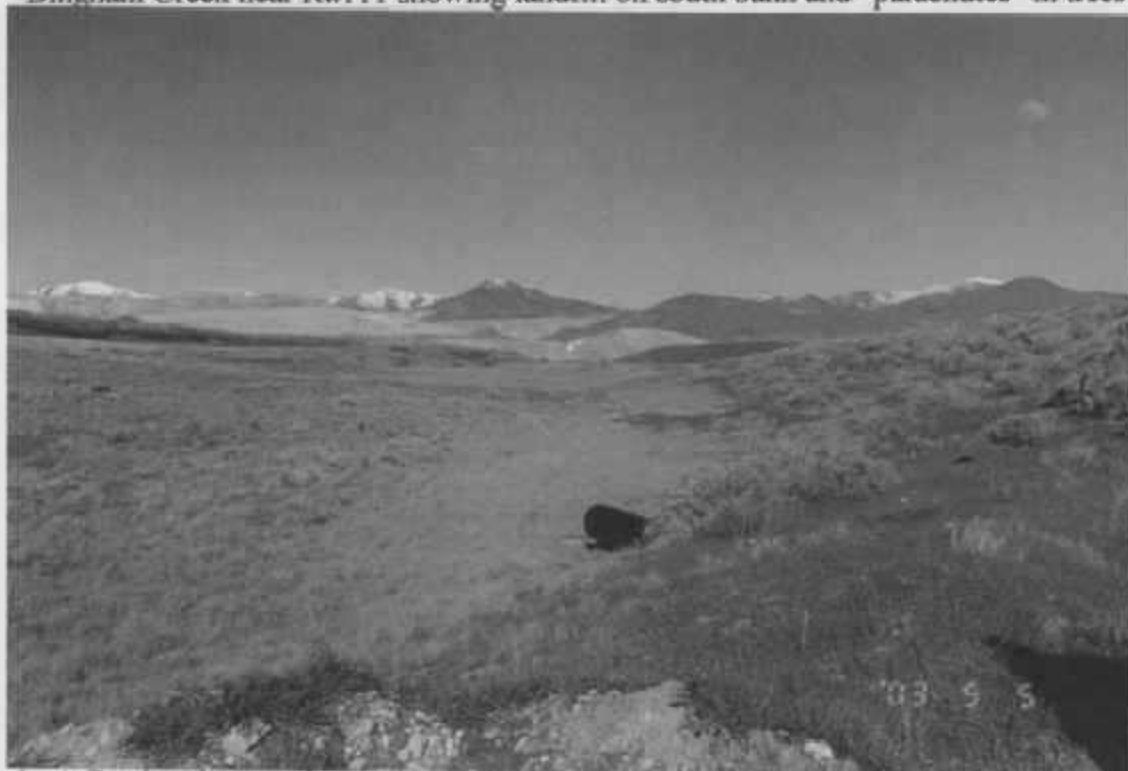
Bingham Creek culvert under access road near power substation at eastern boundary of Zone 19, revegetation

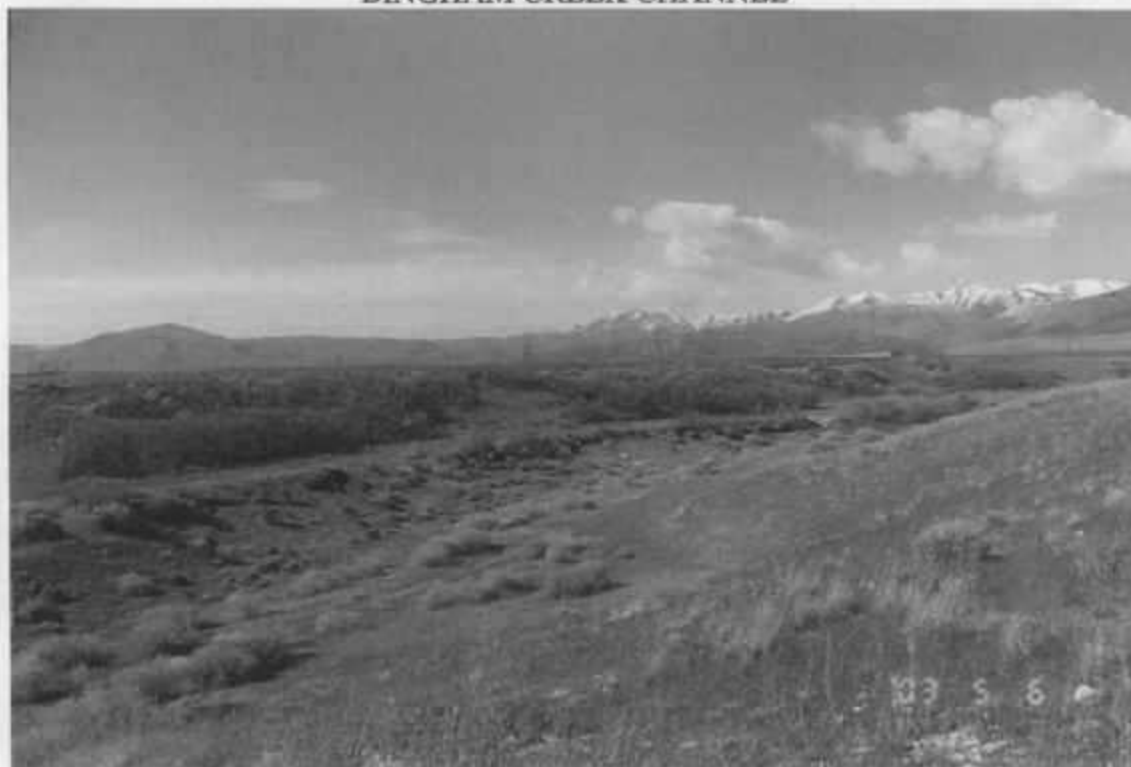
Bingham Creek Channel adjacent to Bingham Flats

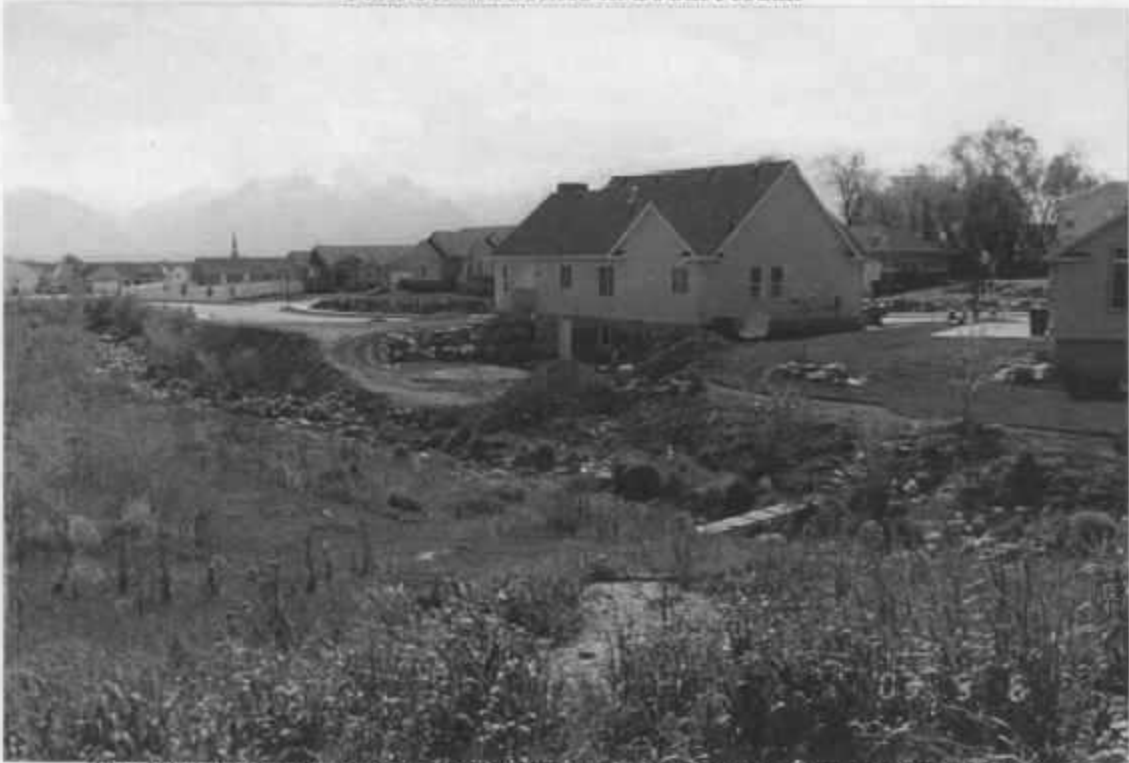
The Woods Subdivision new houses back up to creek channel near hospital

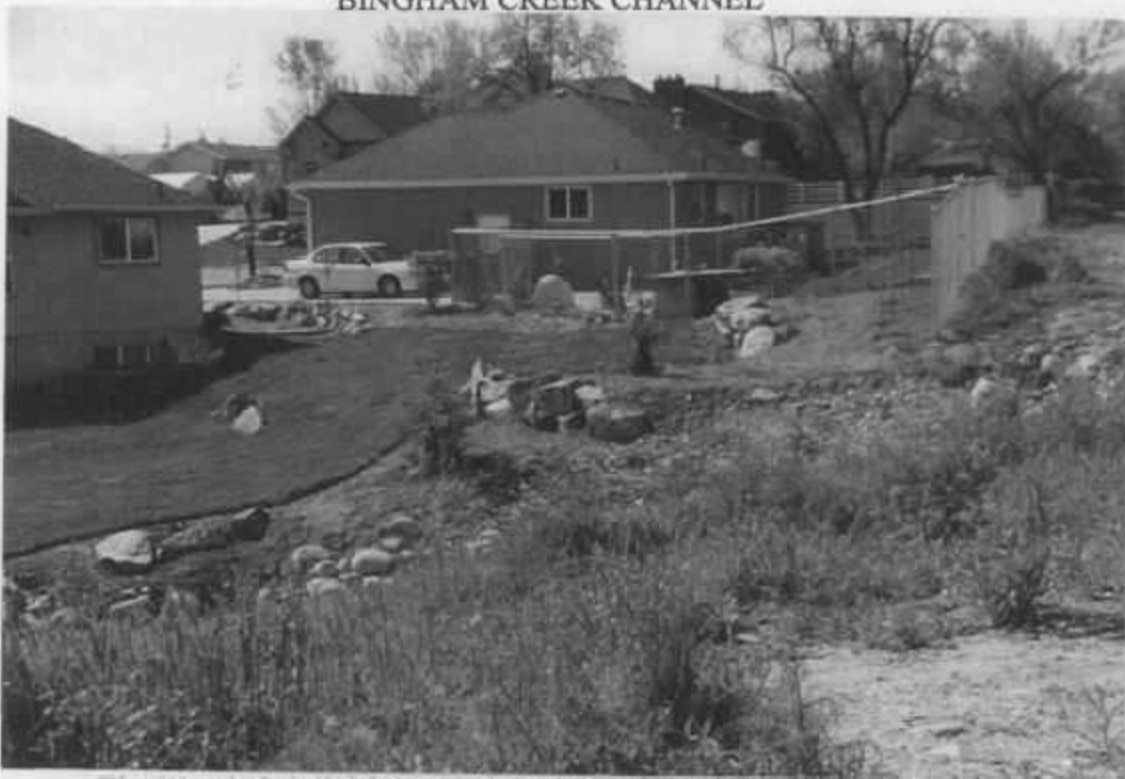
The Woods Subdivision, new homes landscaped up to banks of creek.

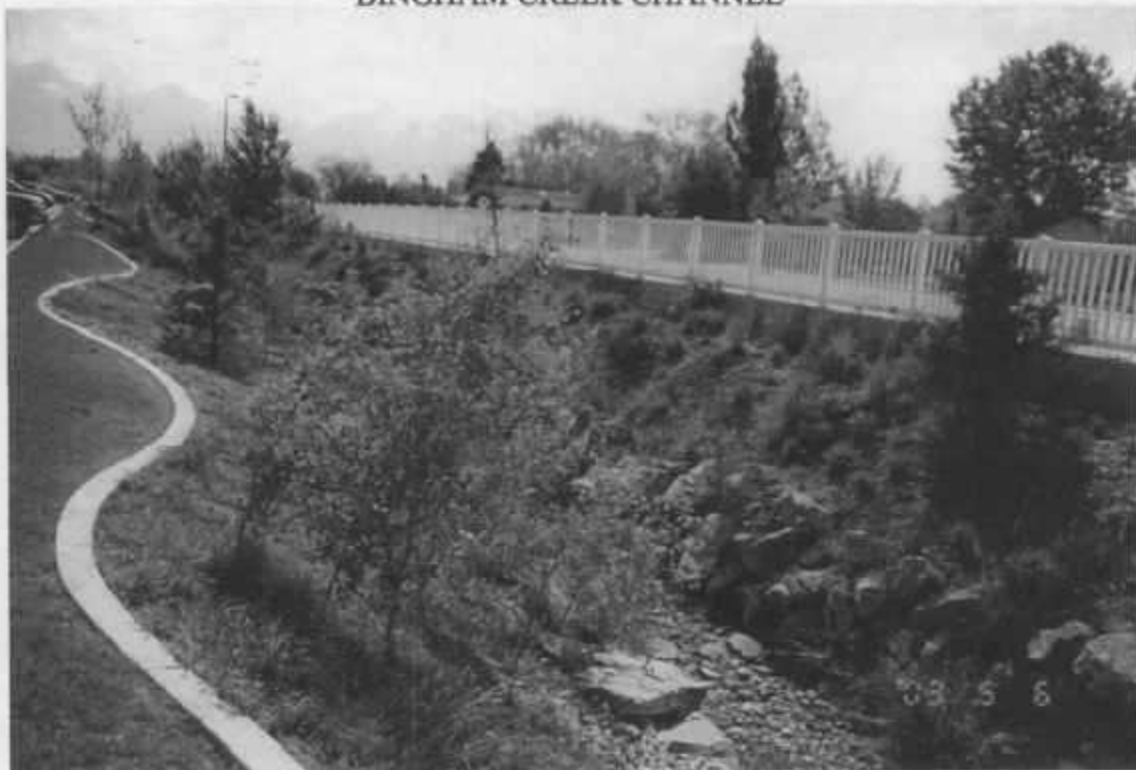
Bingham Creek Channel in front of Cascade Springs Apartments

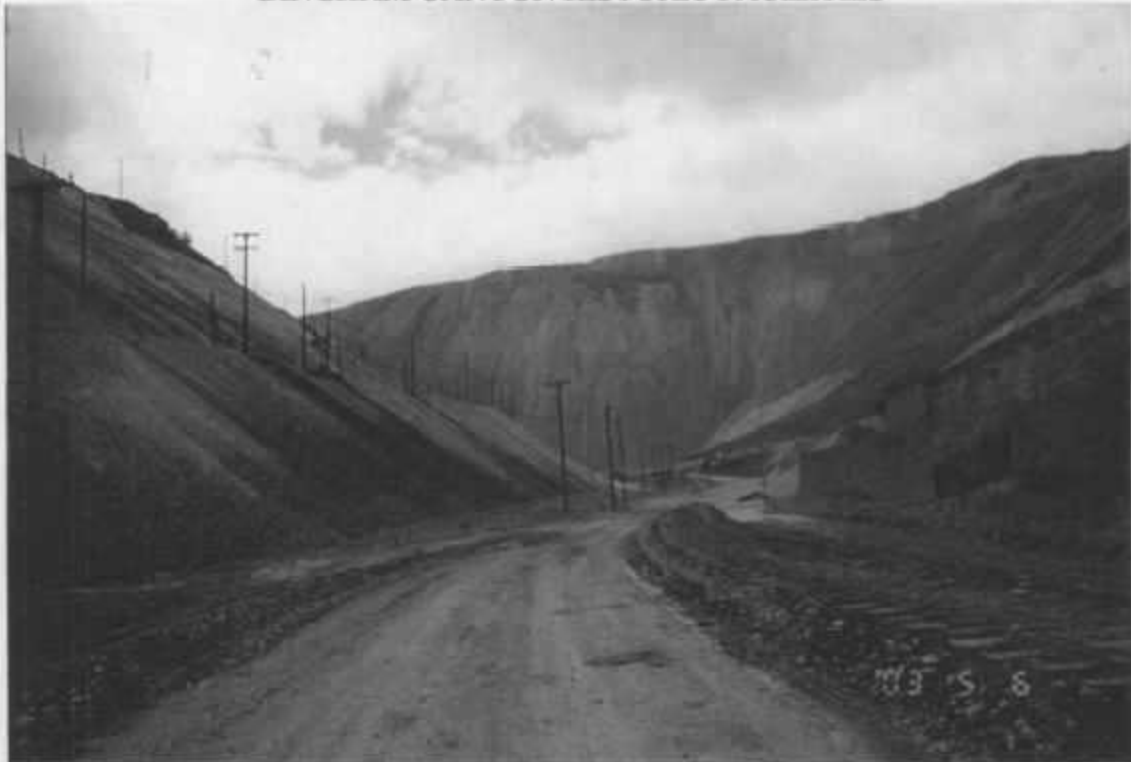
Current toe of the dumps in Bingham Canyon, Utah Copper Mill foundations in foreground

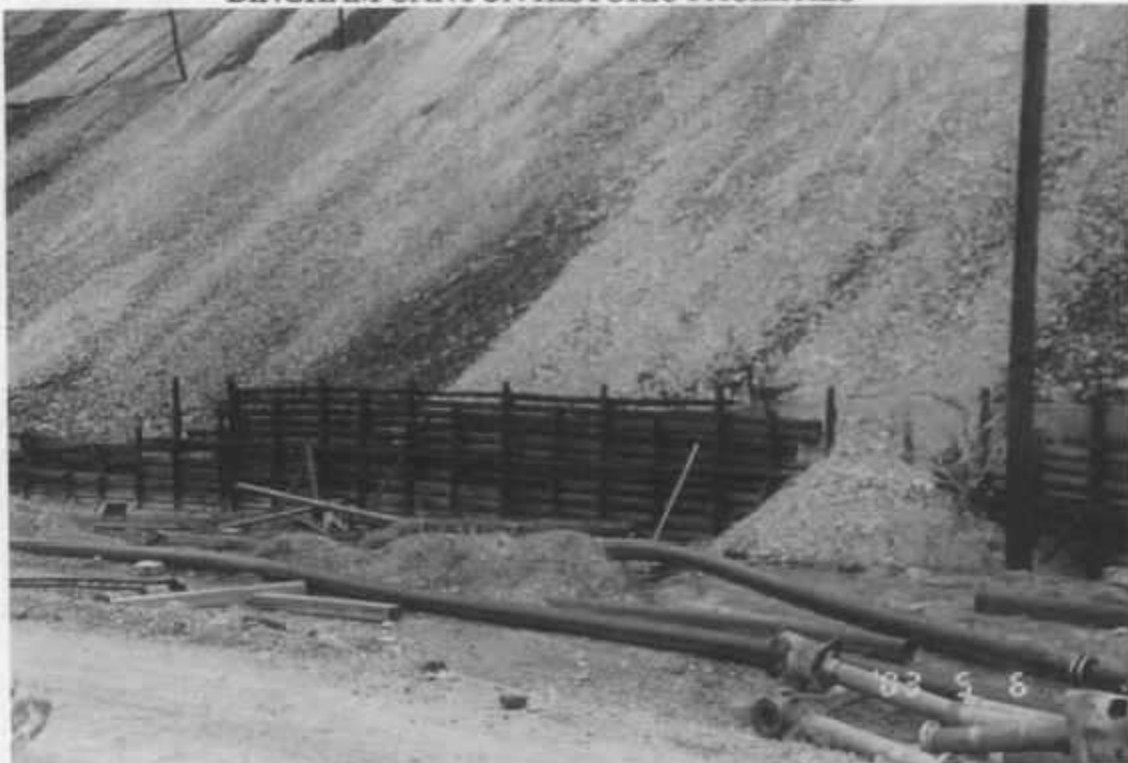
Cribbing along Bingham Creek in the Canyon

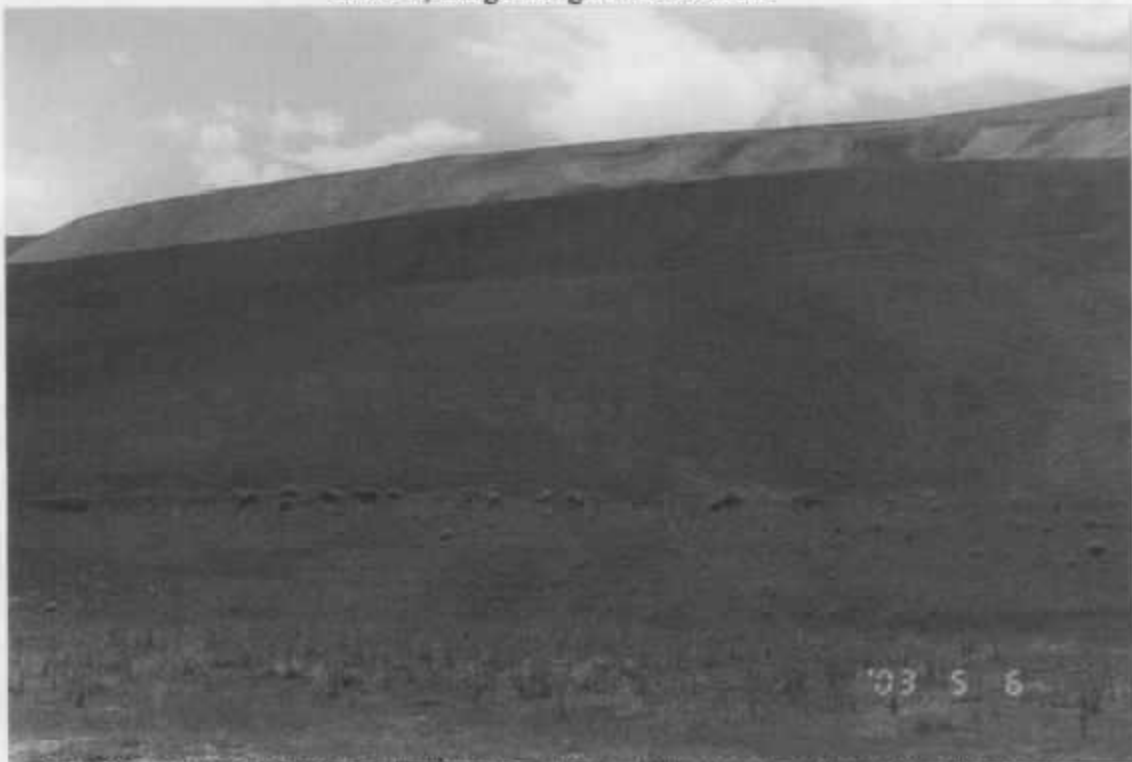
Relaxed Slope of Dumps where sludge, lime, soils mixed and used for the slope

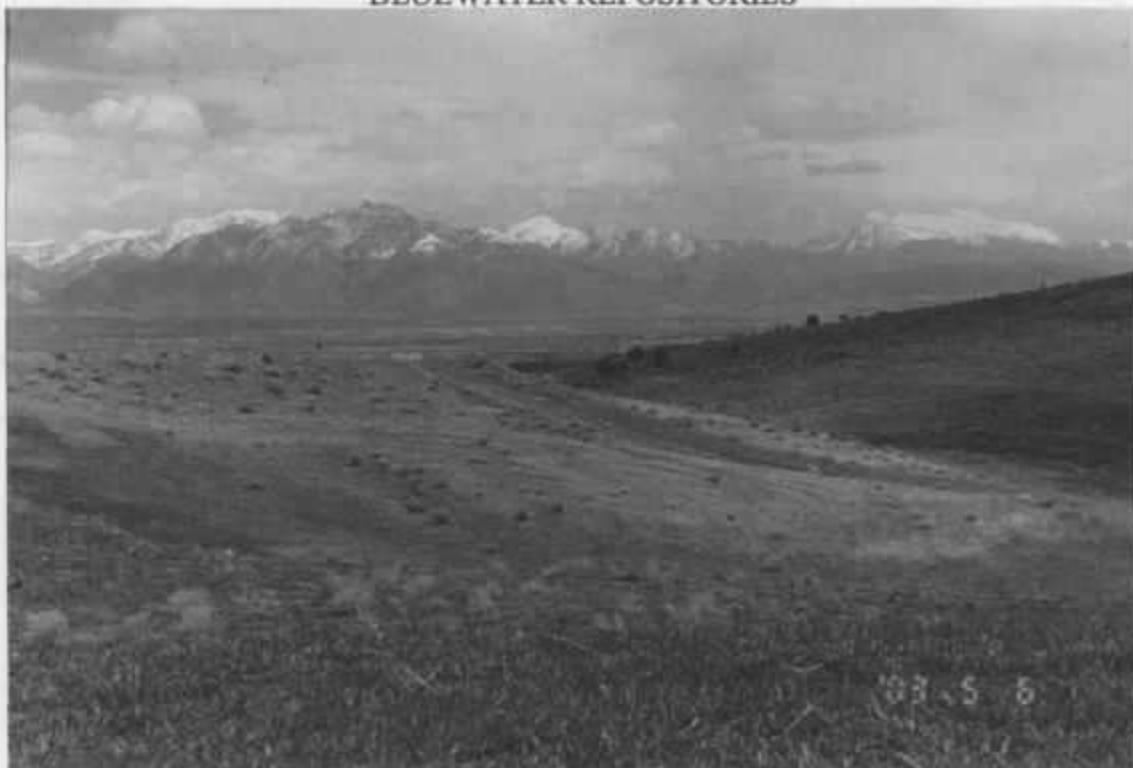
Open Bluewater Repository with closed portion in foreground.

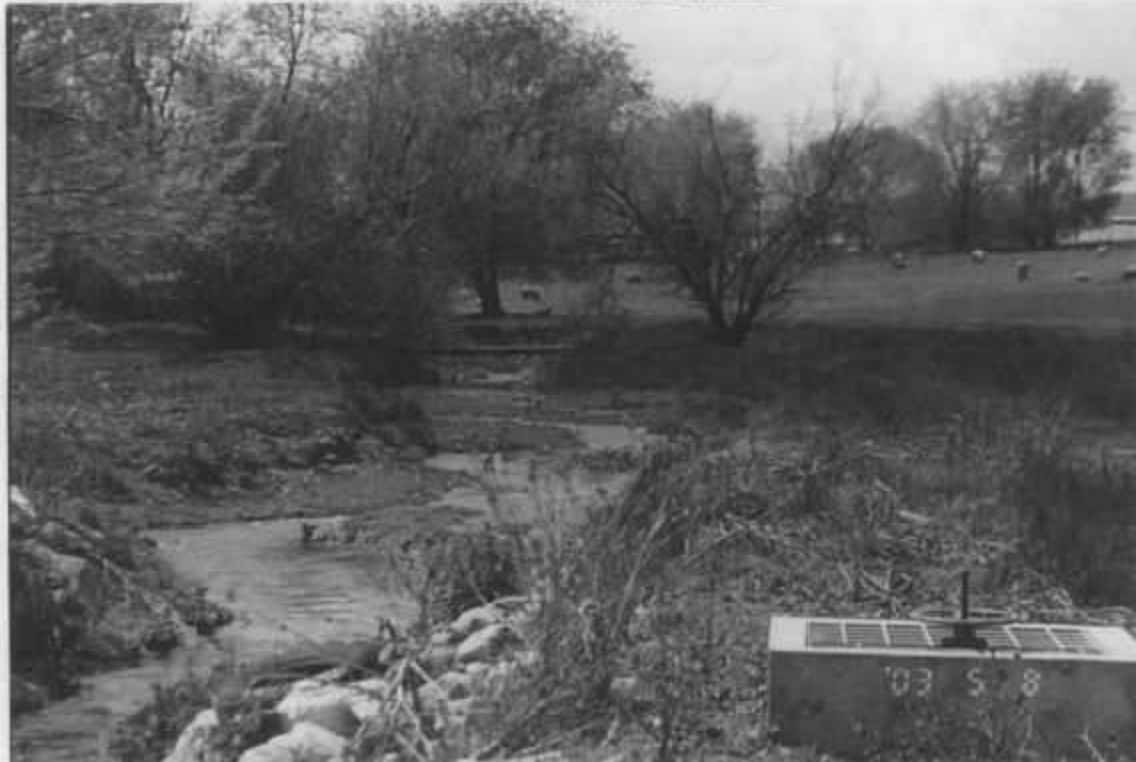
Lower Bingham Creek just upstream of new channel, diversion control shown at right.

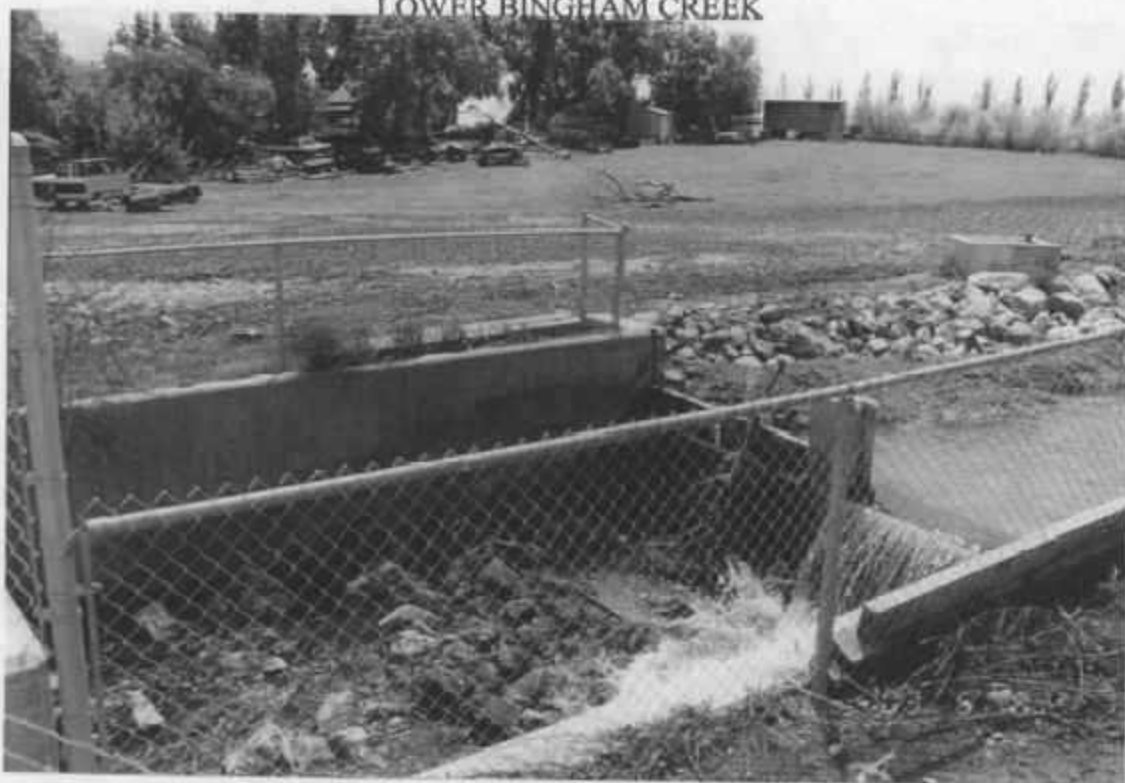
Diversion Control to new Bingham Creek Channel

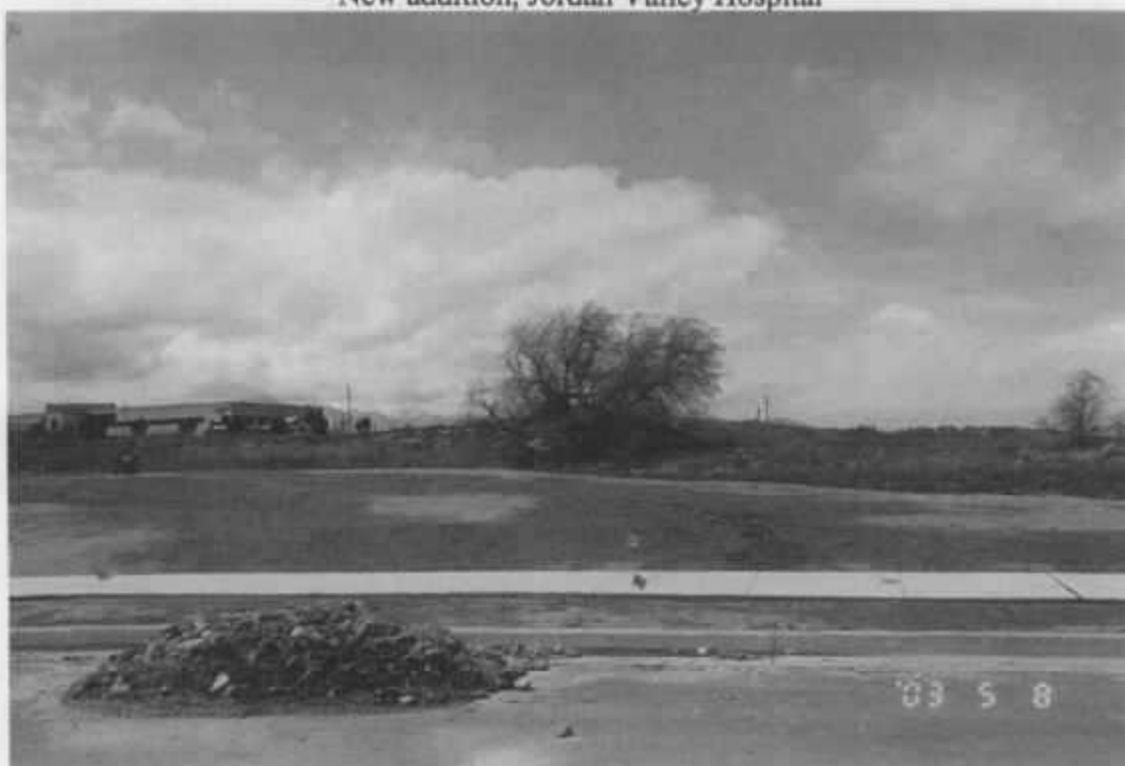
New landscaping area in the Woods subdivision, creek is at edge of dirt.

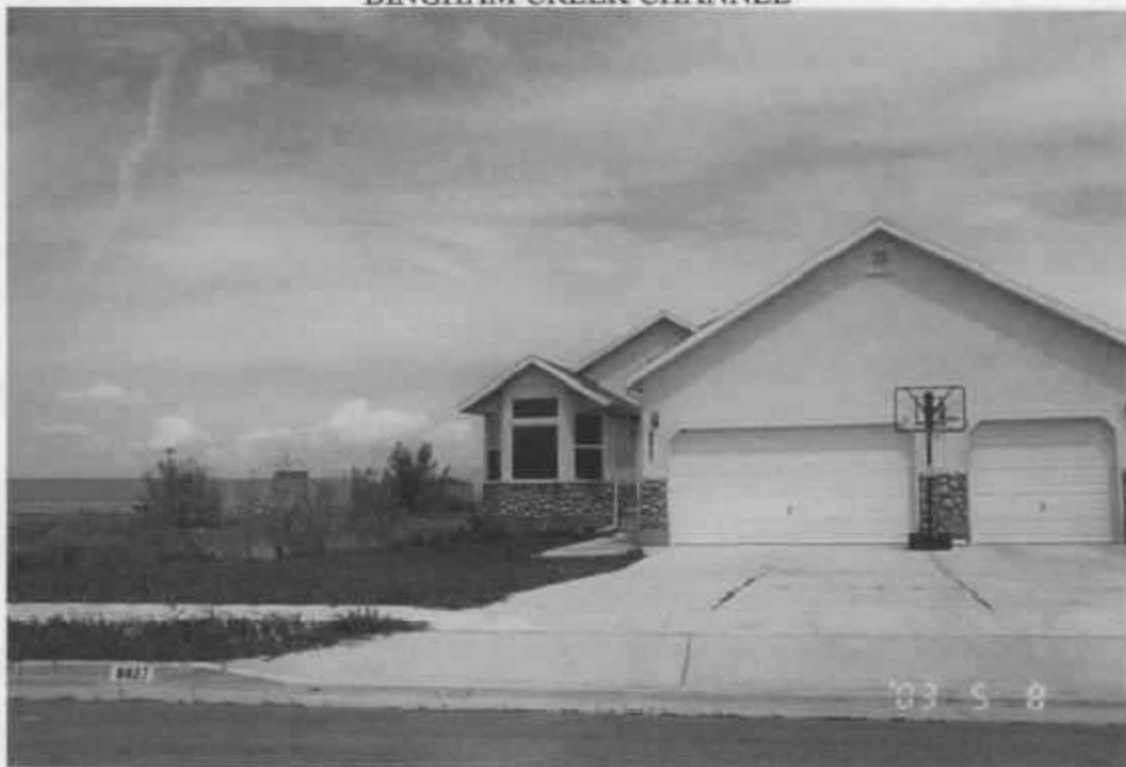
New Home in The Woods Subdivision, channel on the extreme left.
