## FIRST FIVE YEAR REVIEW REPORT

### KENNECOTT SOUTH ZONE

OU 1 Bingham Creek  
OU 4 Large Bingham Reservoir  
OU 5 Copperton Tailings  
OU 10 Copperton Soils  
OU 11 Bingham Canyon  
OU17 Bastian Sink

June, 2004

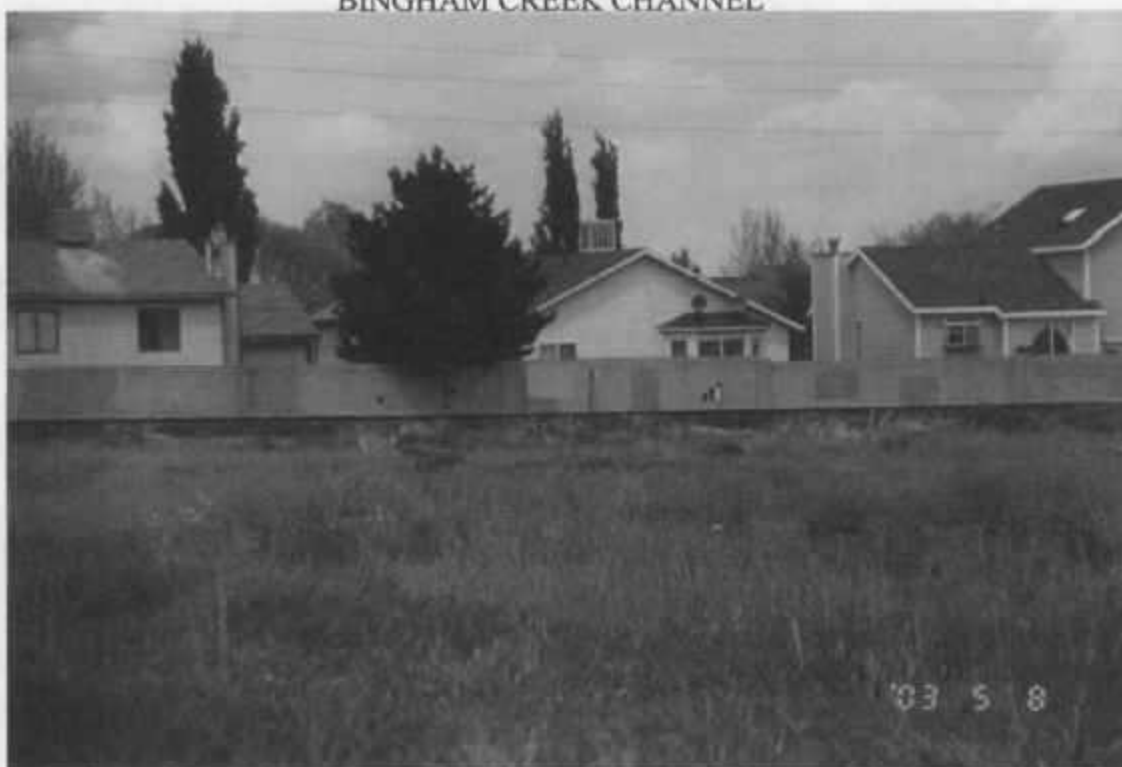
Creek channel is just this side of fence line, Sugar Creek Condos.

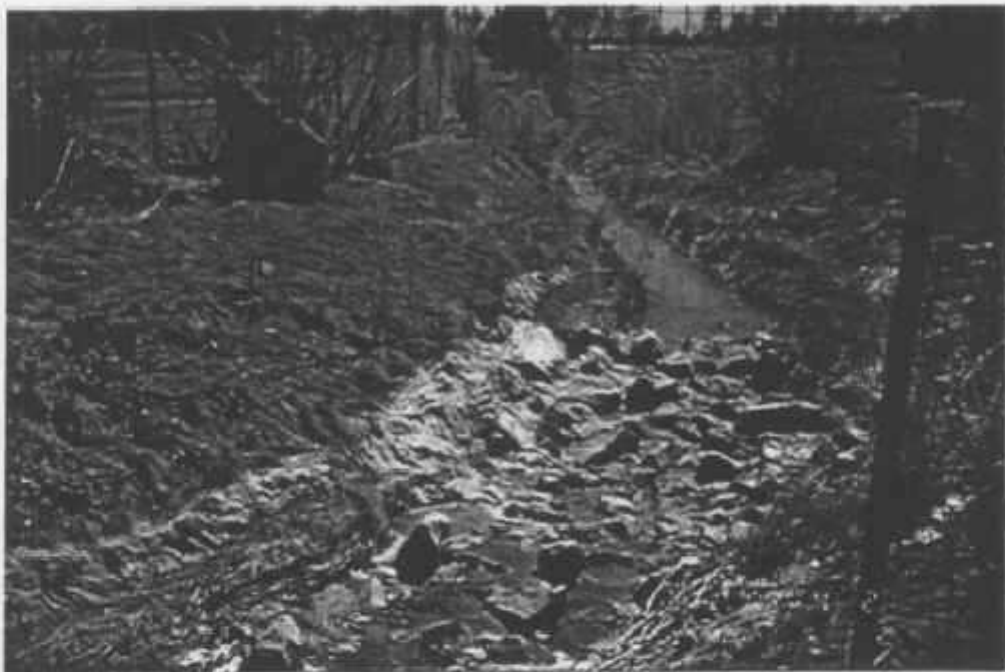
Photo 1, Structure No. 3

Photo 1 is representative of structures between 2700 West and the 4 ft X 10 ft underground conduit.

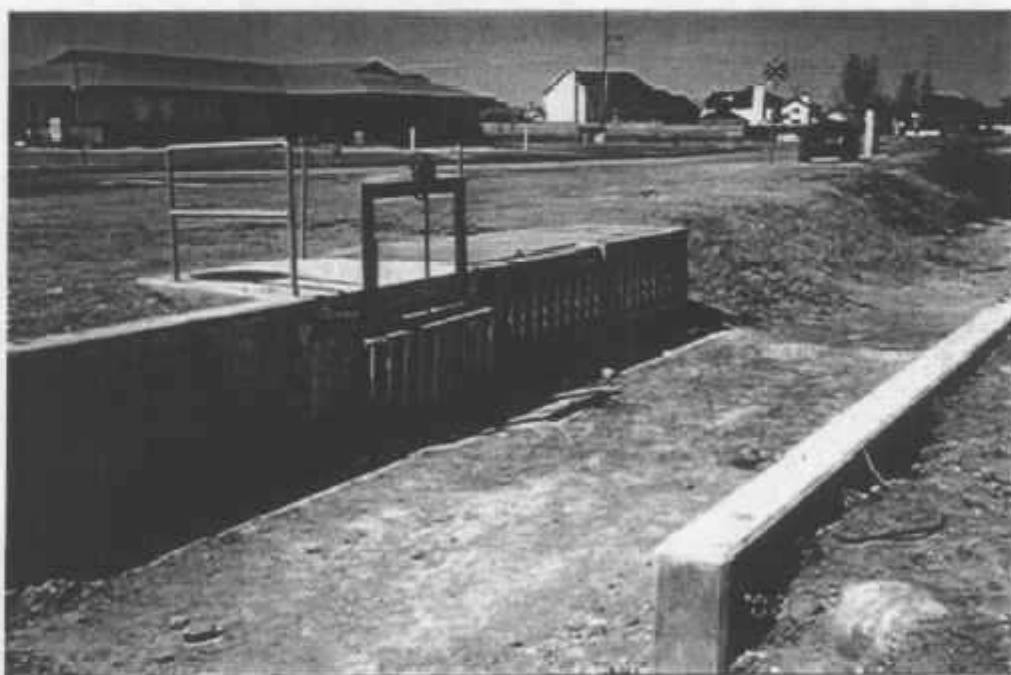
Photo 2, Canal Overflow Structure

Photo 2 shows the newly constructed overflow structure on the irrigation canal that allows excess flow to spill over weirs into the underground conduit at 2200 West Street near the end of the conduit which is shown in Photo 3.

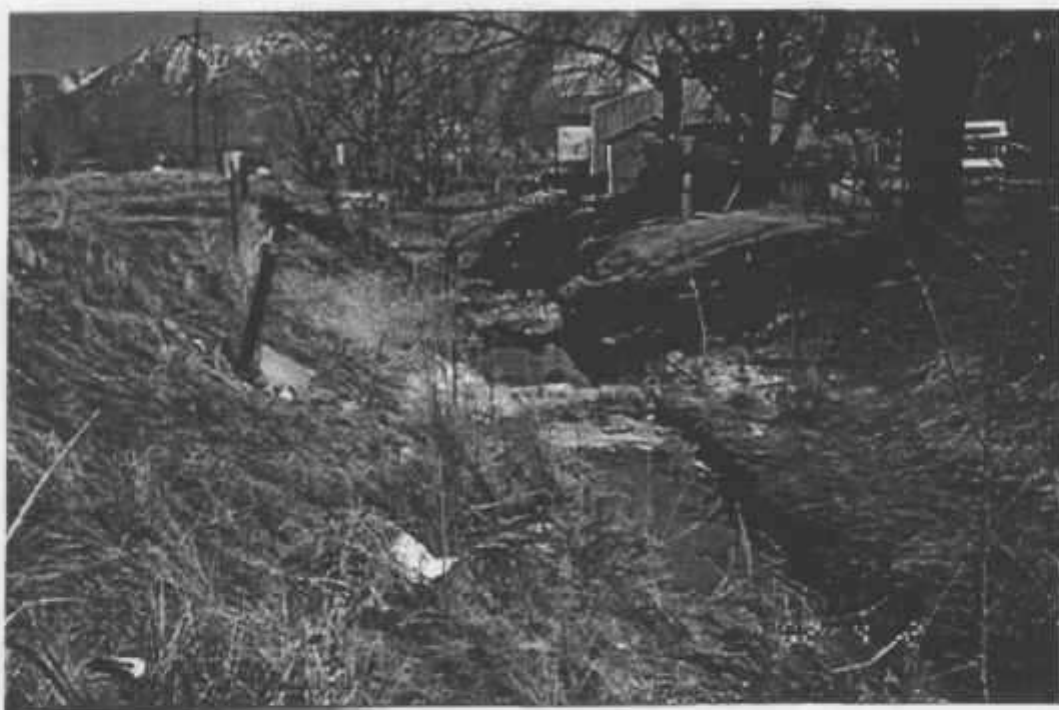
Photo 7, Structure No. 16

Vegetation continues to flourish in the channel along most of Bingham Creek that was observed, as shown in the accompanying photographs in this section. Estimates of high water flow during spring runoff indicate a flow depth of about 3 feet. The flow structures have functioned as designed to help control flow velocity between structures and allow vegetation to develop a root matrix that will control channel erosion during normal flows. One exception is the area between Sugar Factory Road and Redwood Road where land owners have made duck/geese ponds at the flow structures and these fowl have completely denuded the channel and banks of any vegetation (see Photo 7).

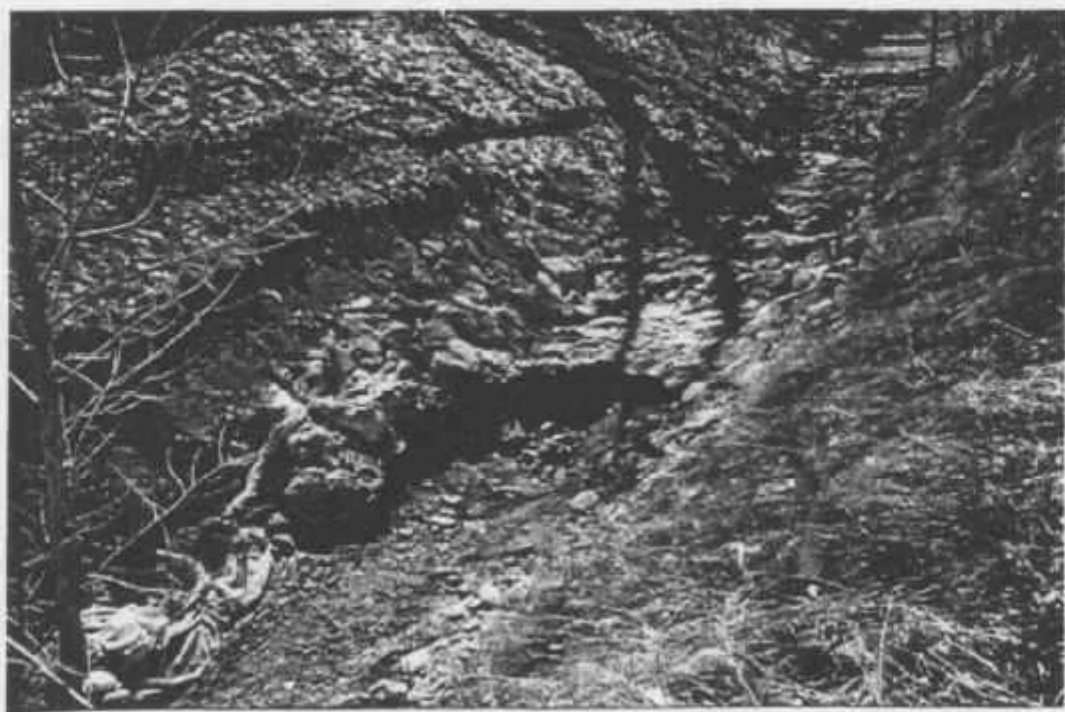
Photo 8, Structure No. 17

The general structural condition of the flow control structures was excellent. The only qualification is Structure No. 17, which has a still pond undercut of the exit apron (see Photo 8). As can be seen in the photo, this is a very steep reach of the channel that is exacerbated by the private citizen constructed dam placed on the entrance apron of Structure No. 17, clearly seen in upper right of Photo 8. This dam was placed by the land owner to provide more water storage for his ducks and geese. The effect of this dam is to raise the water surface elevation over its crest about 18 inches adding a large amount of potential energy into the water, increasing flow velocity through Structure No. 17. At this time the undercut is only under the exit apron and is about 6 ft. from the end of the flow structure.

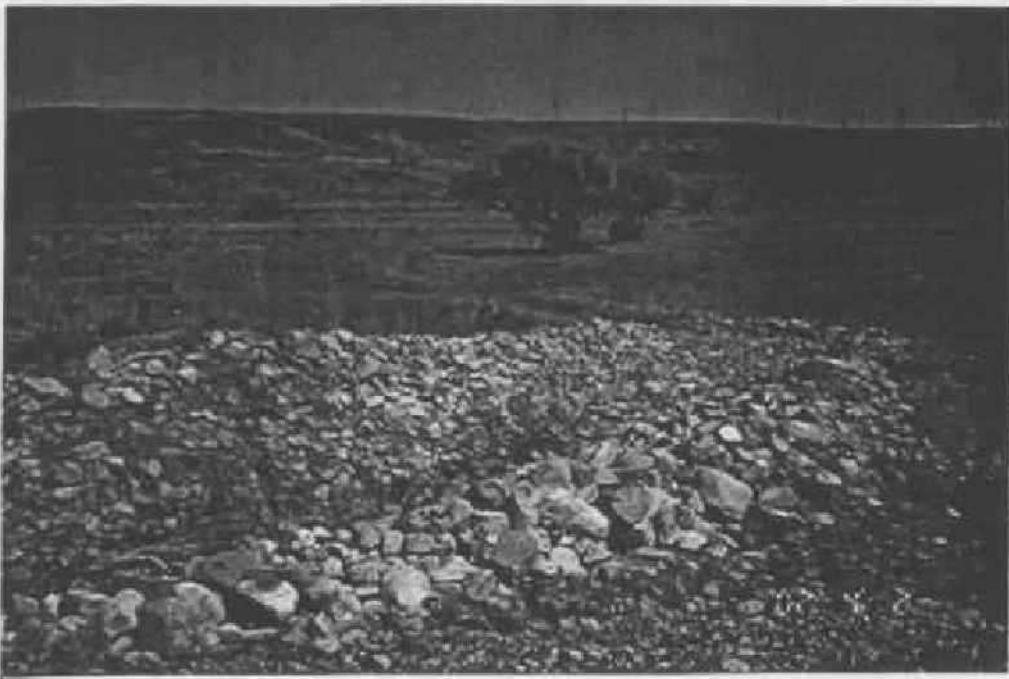
Photo 6, SD No. 2E, Drainage Ditches Leaving Impound Area

Drainage ditches carrying surface runoff water to the sedimentation pond were walked and found to be in excellent condition with considerable vegetation growth within the channel (see Photo 6).

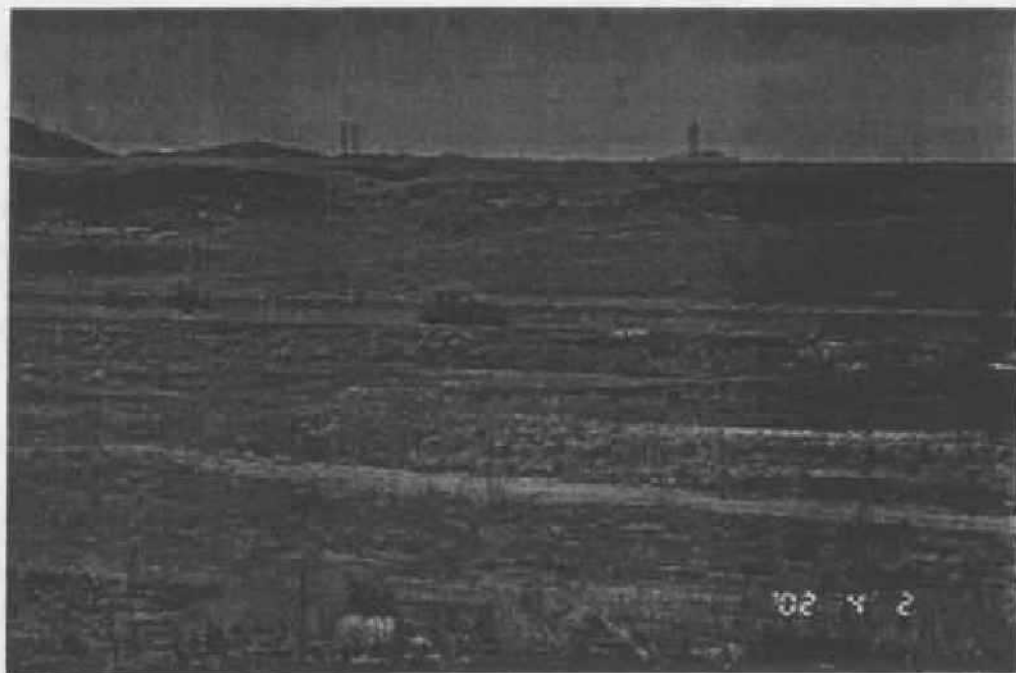
Photo 7, Sedimentation Pond and Structures

High water mark in the sedimentation pond for the year appears to be about 3 feet depth. Pond is clean and skimmer outlet and over-flow spillway are in good shape, with no evidence that the flow has ever left the pond (see Photo 7).

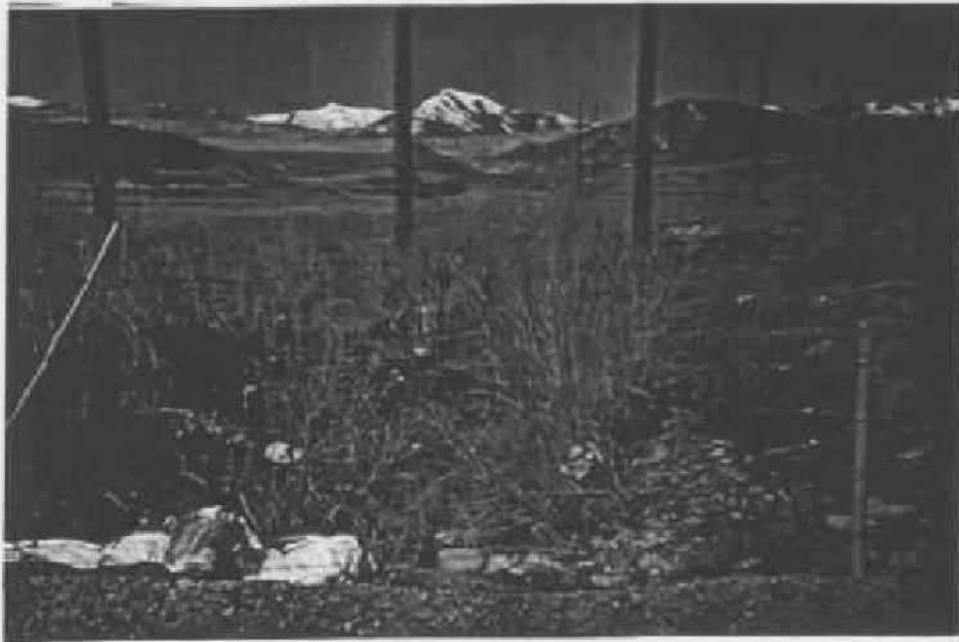
Photo 8, Sedimentation Basin at Property Line Before Cleaning

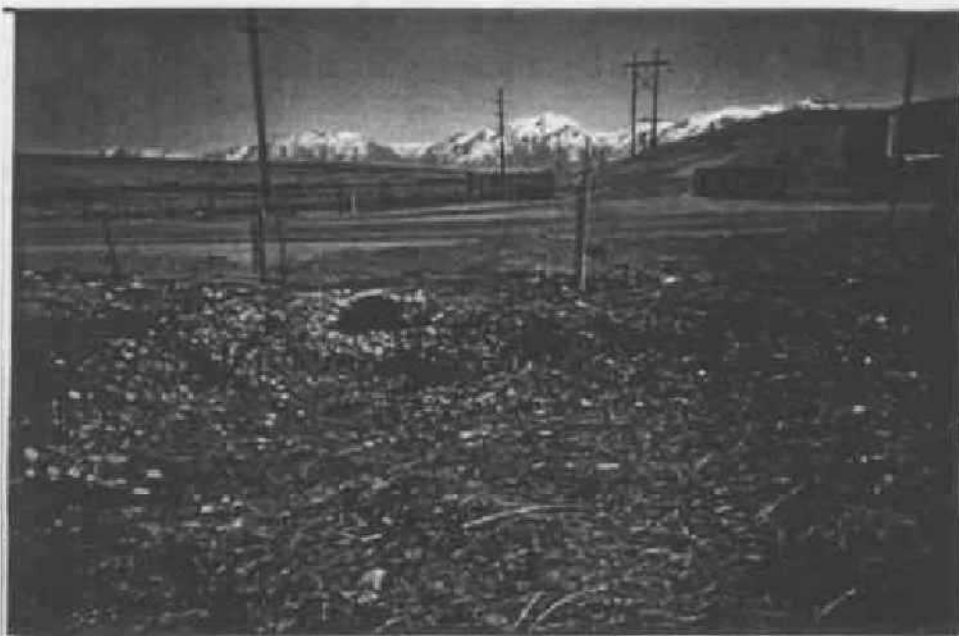
Photo 9, Sedimentation Basin at Property Line after Cleaning
