Third Five-Year Review Report  
for  
Raymark Industries, Inc. Site  
Stratford, Connecticut

September 2010

The United States Environmental Protection Agency  
Region 1, New England  
Boston, Massachusetts

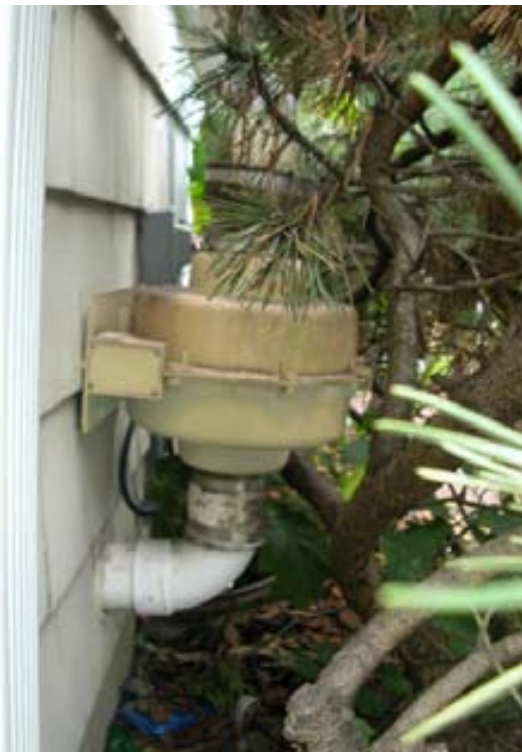
Photograph 25) House #101 – 120 Willow Avenue: Large Bush Preventing Access to Electric Box

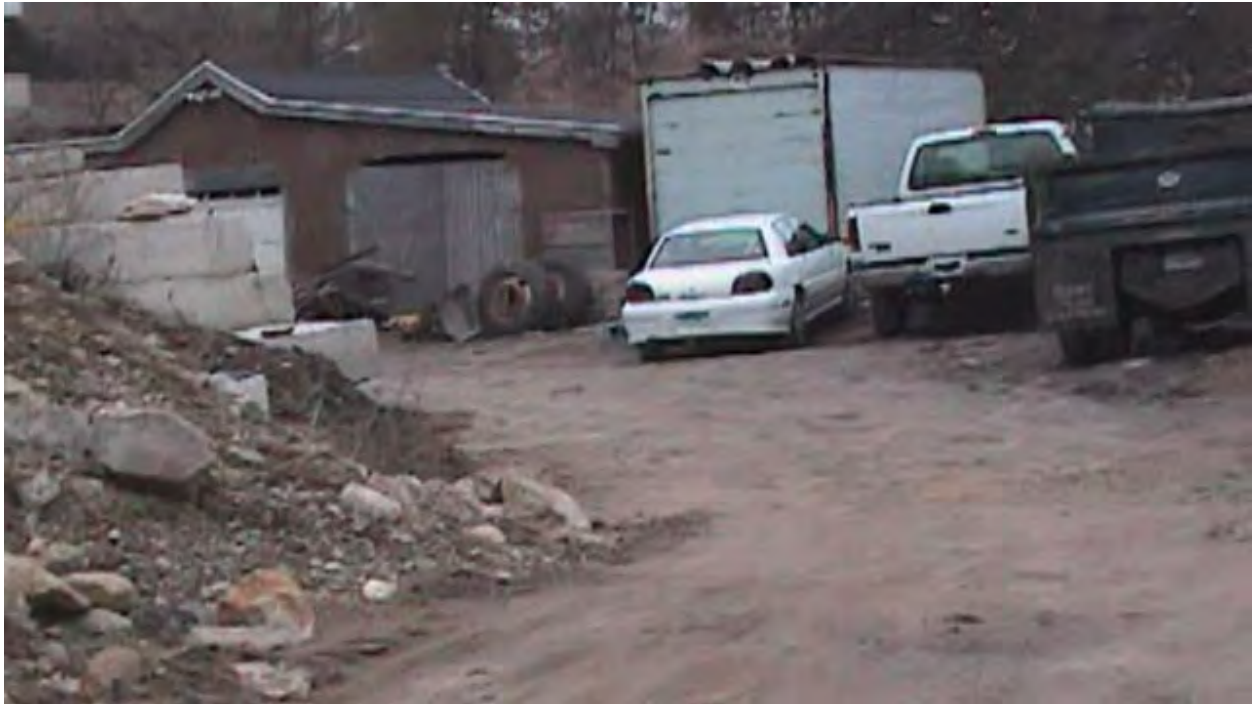
**340 East Main Street:**

In 2009, 340 East Main Street required emergency response due to the unauthorized excavation of Raymark waste. The property owner excavated Raymark waste that was buried on the property and spread the Raymark waste on the surface of the property. CTDEP responded to the site on May 18, 2009 to evaluate the conditions at the property and on May 19, covered the excavated material with a membrane and clean fill. On May 20, 2009, EPA Emergency Response arrived on-site to secure additional areas where Raymark waste was placed and to decontaminate mechanical equipment used during the unauthorized excavation. The State of Connecticut filed suit for cost recovery of CTDEP's expenditure and a final injunction prohibits any future activity that could release Raymark waste.

Inside fence near front of property.

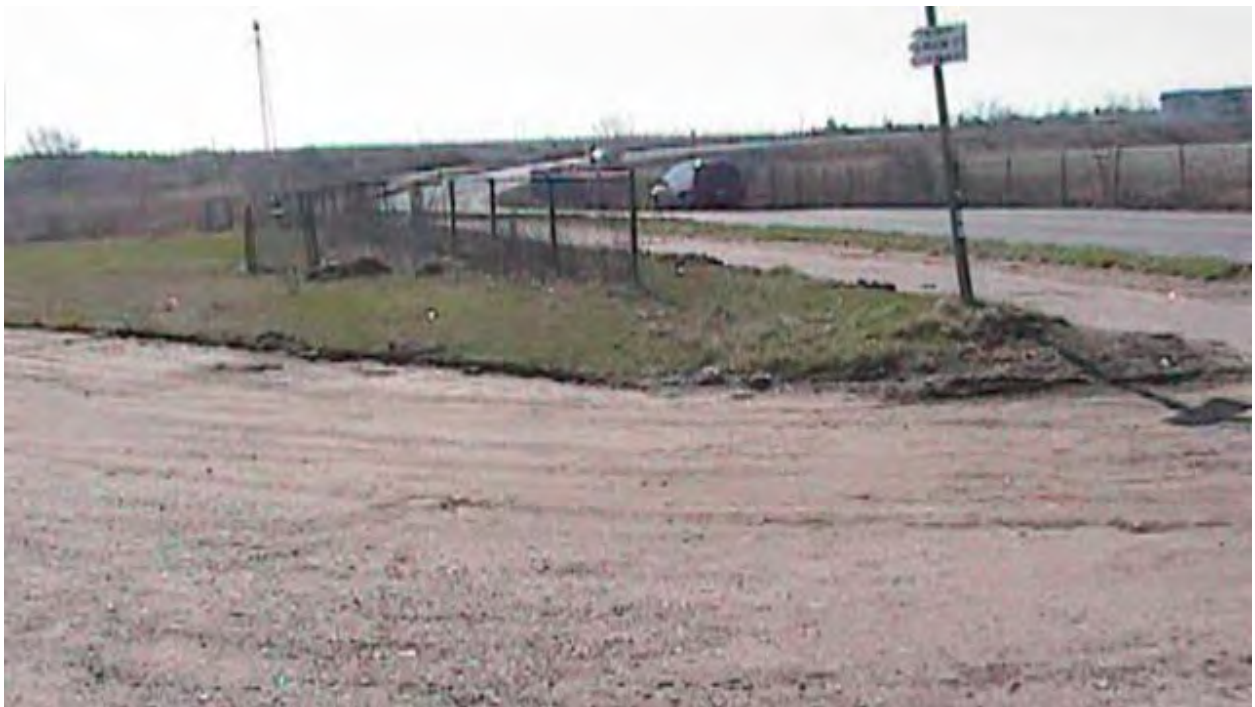
Entrance off Main Street

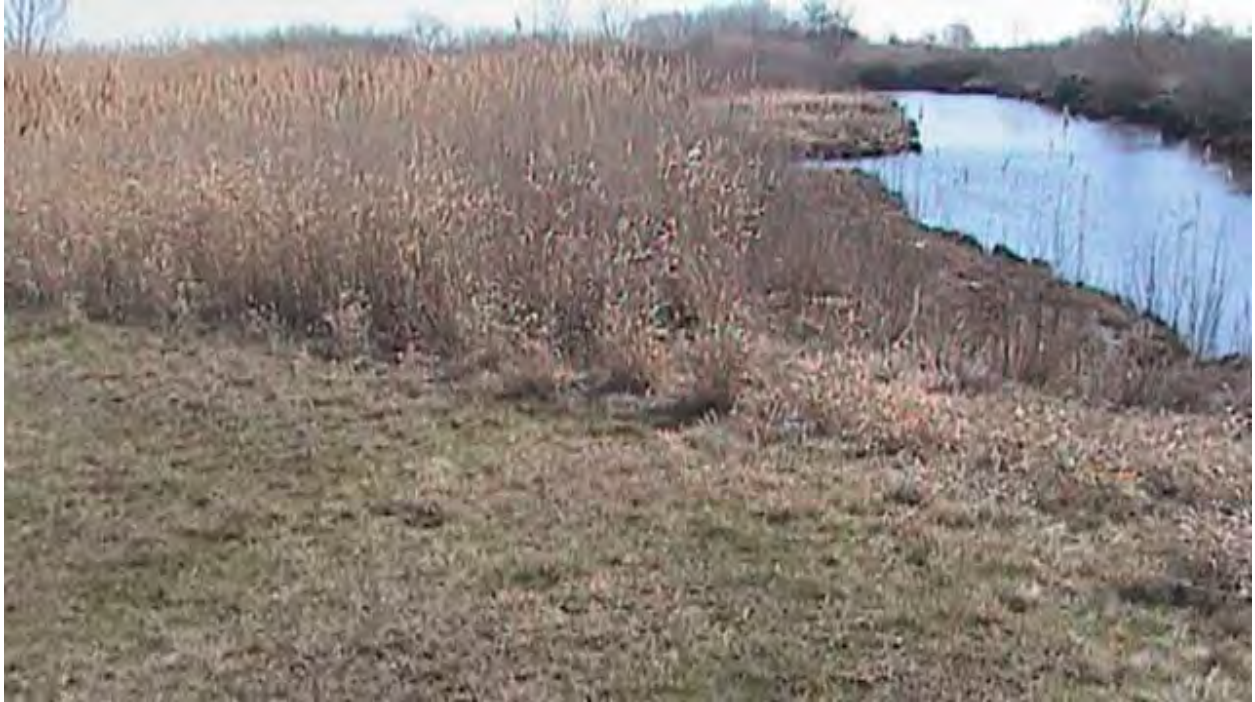
View of the drainage stream

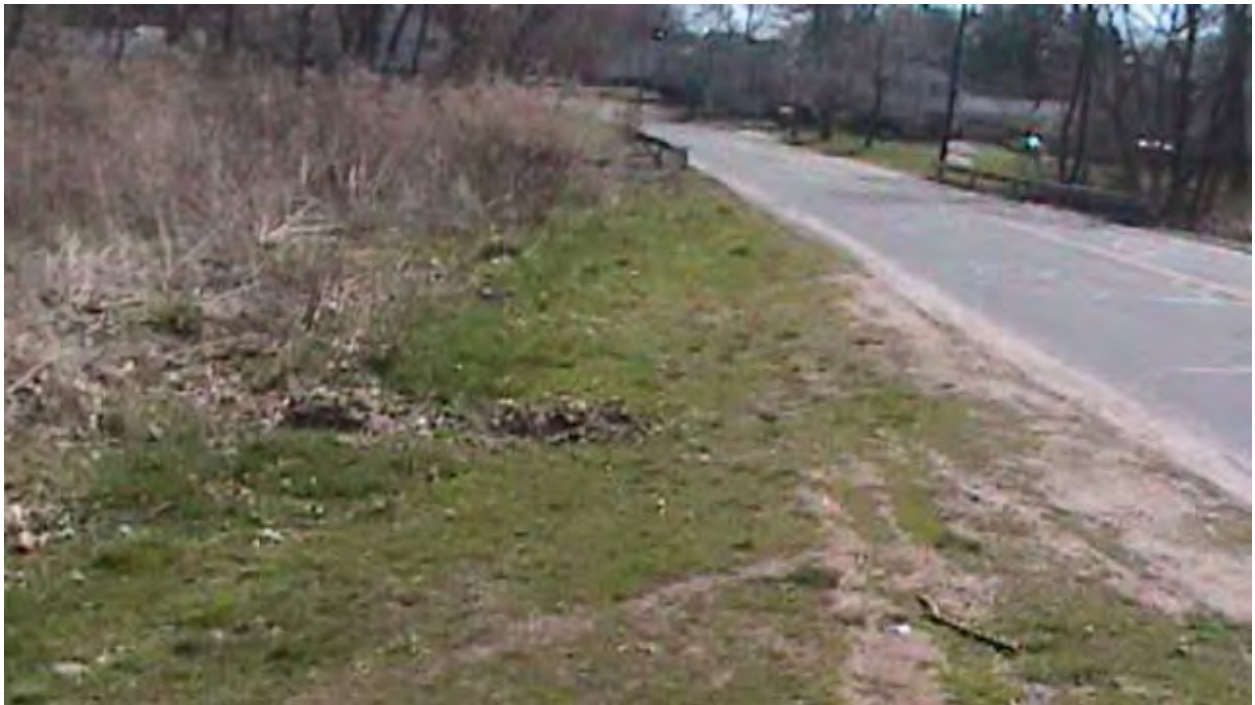
View of Wooster Park/Quail Avenue looking East.

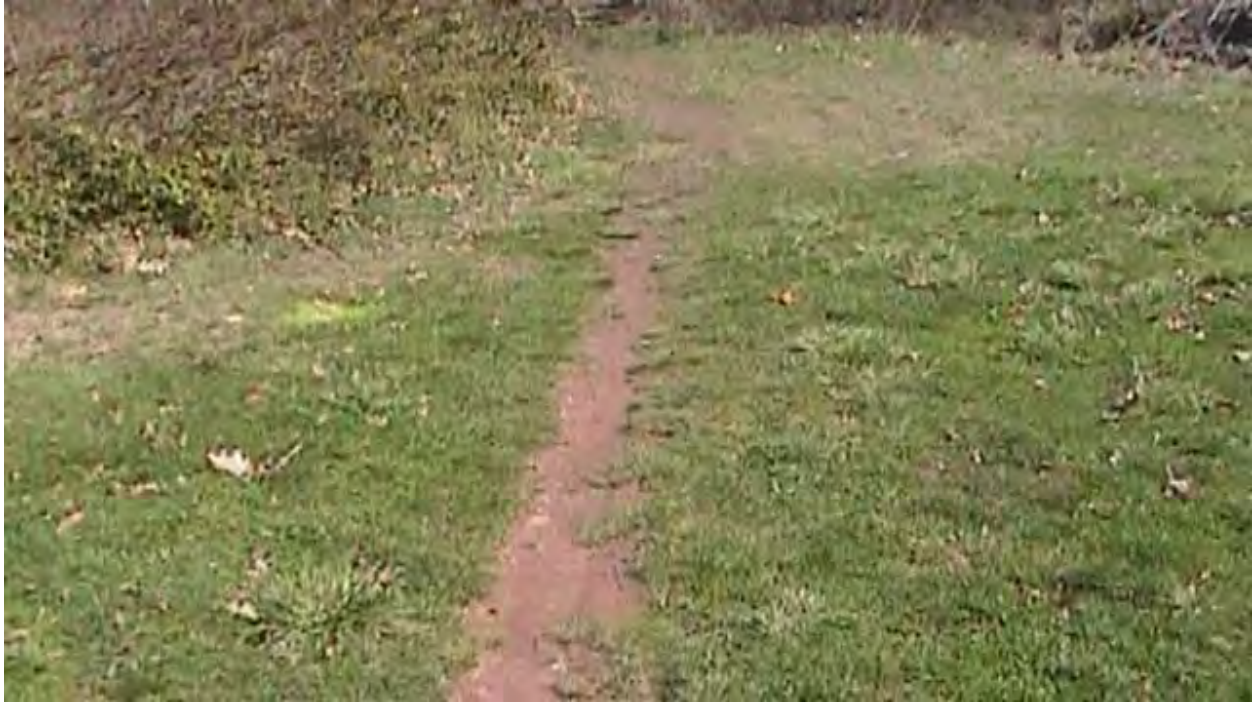
Image of bike path on property.

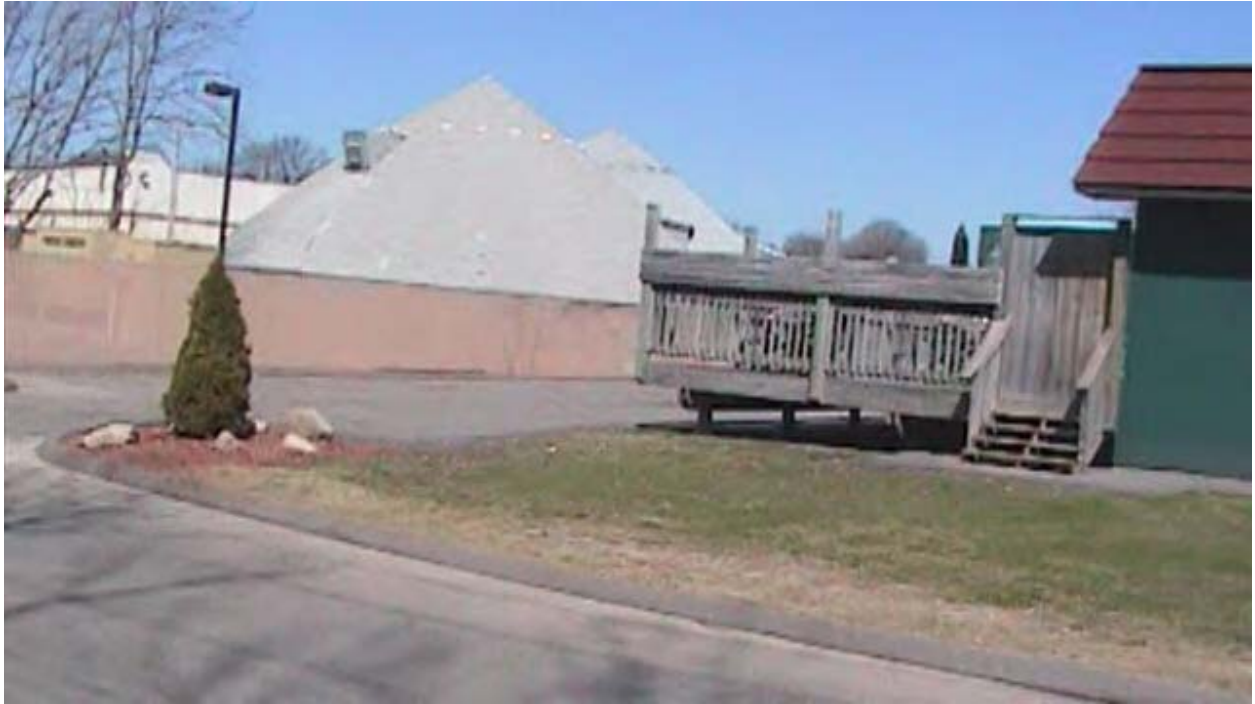
View of the back of Frog Pond Tavern.

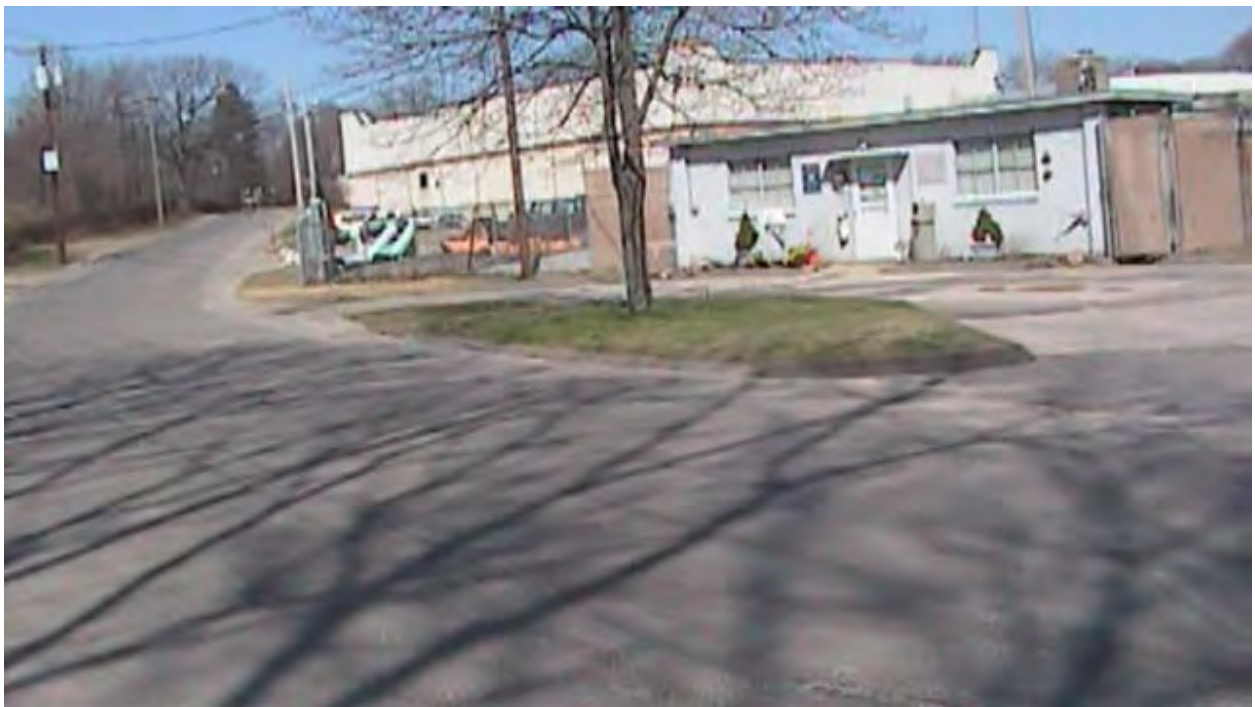
View of dog pound building.

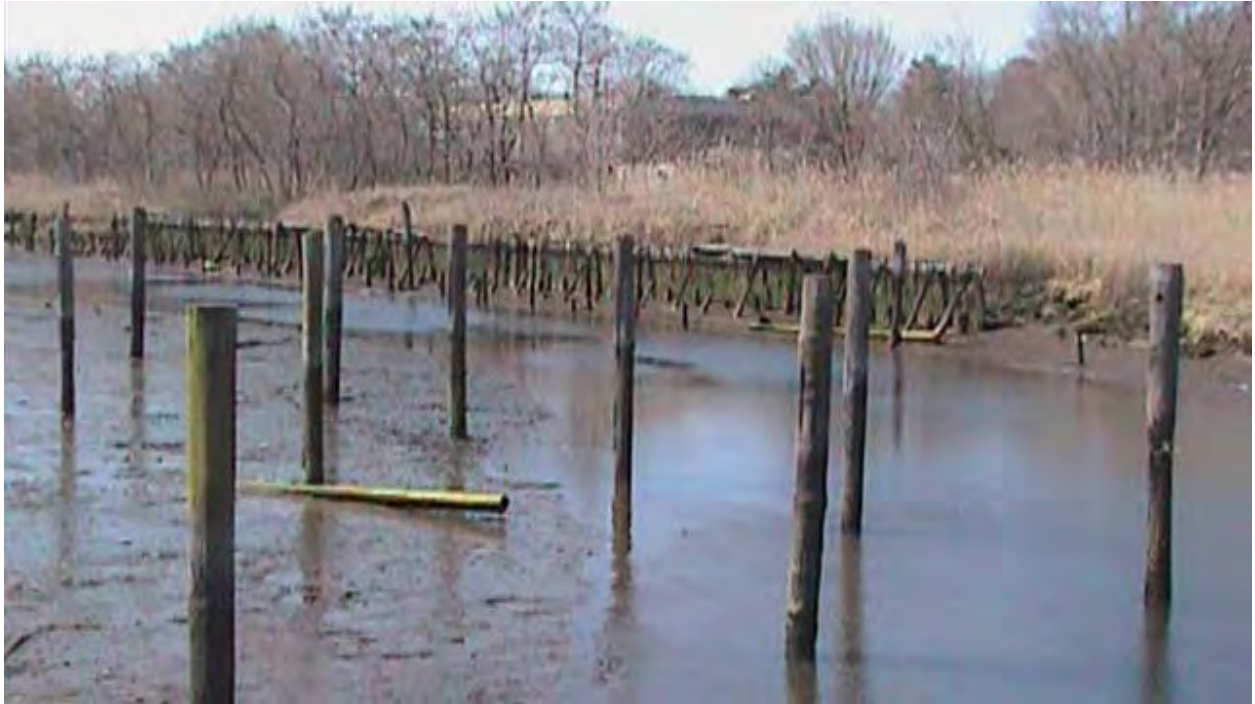
Lower Ferry Creek at low tide from Broad Street.

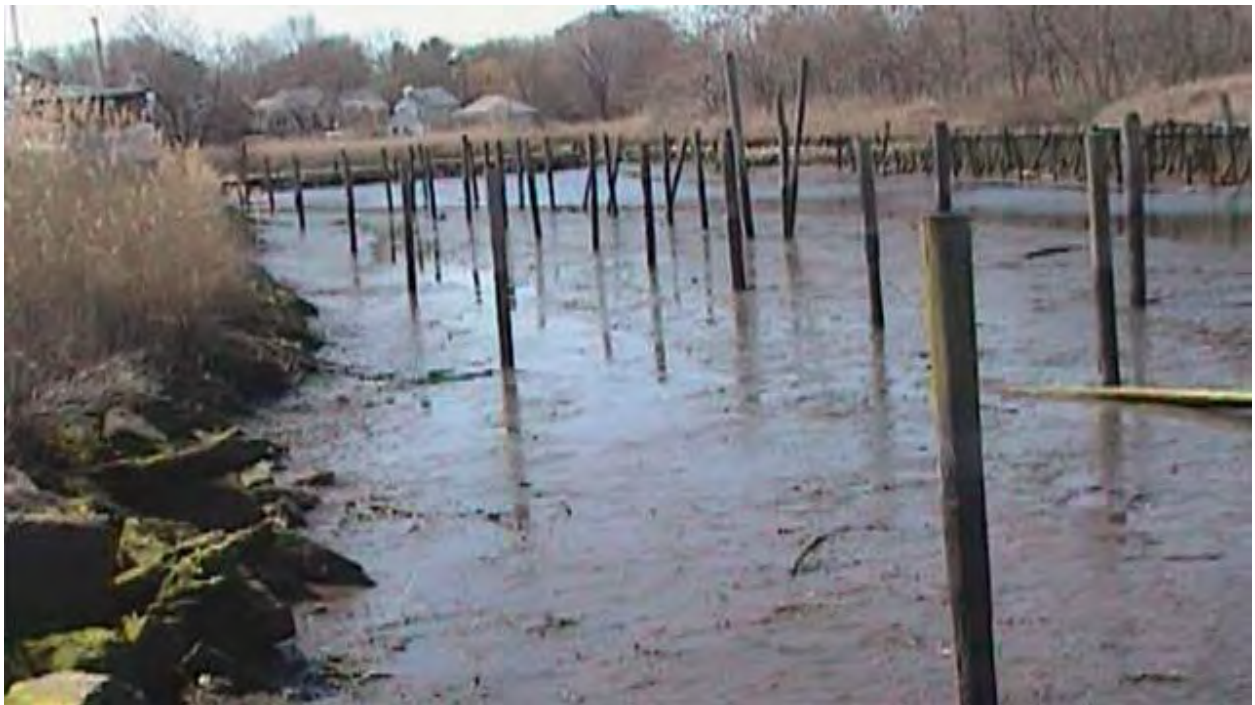
Lower Ferry Creek from Broad Street looking toward the Shakespeare Theater.

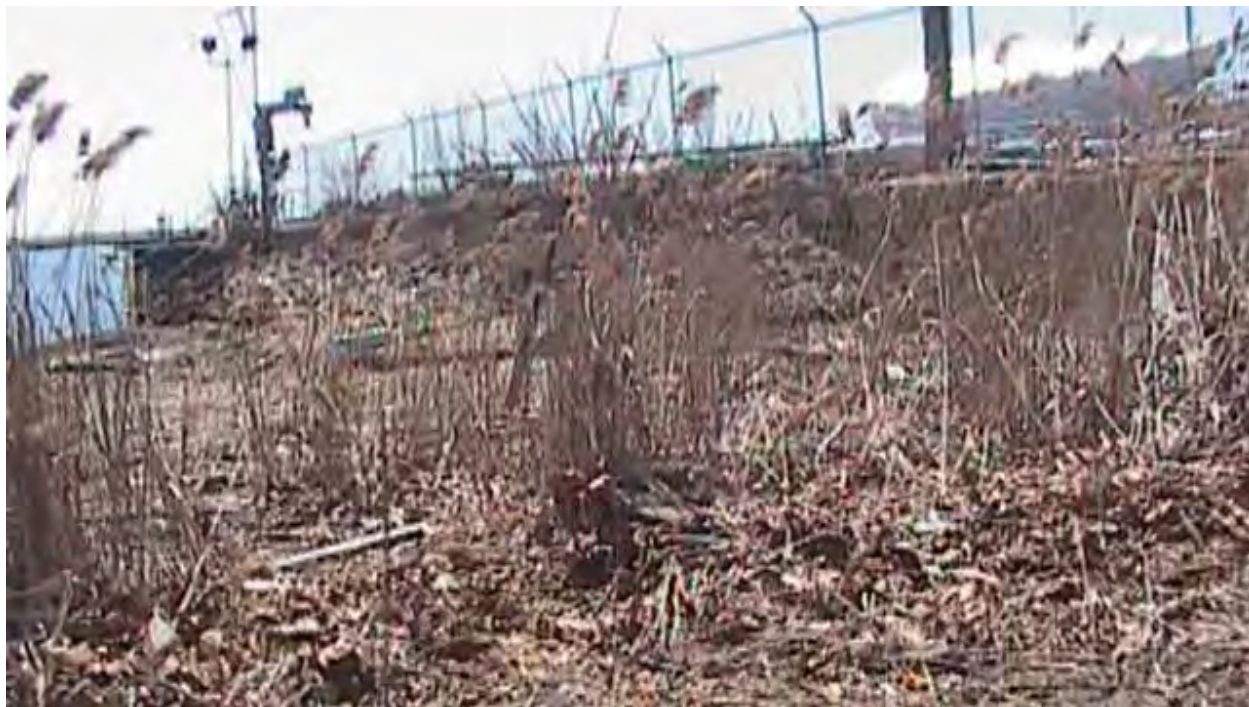
Wetland north of Housatonic Boat Club (HBC).

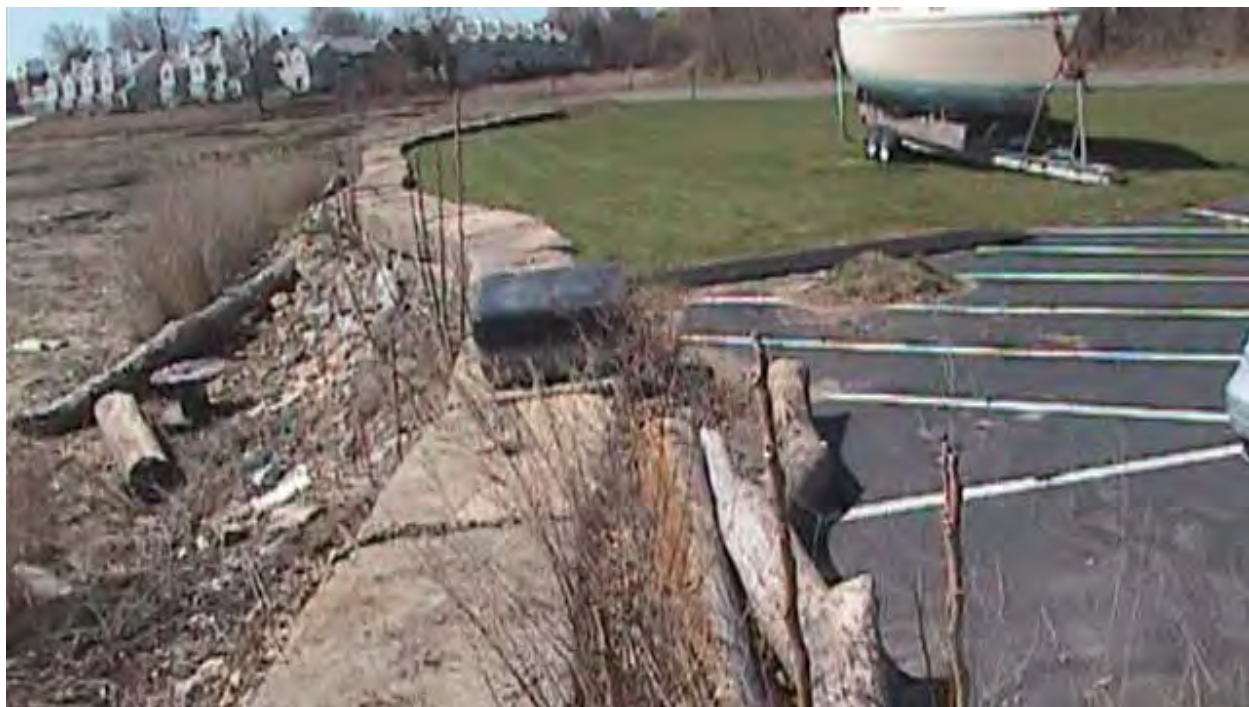
OU5 and Shore Road looking from Housatonic Boat Club entrance.

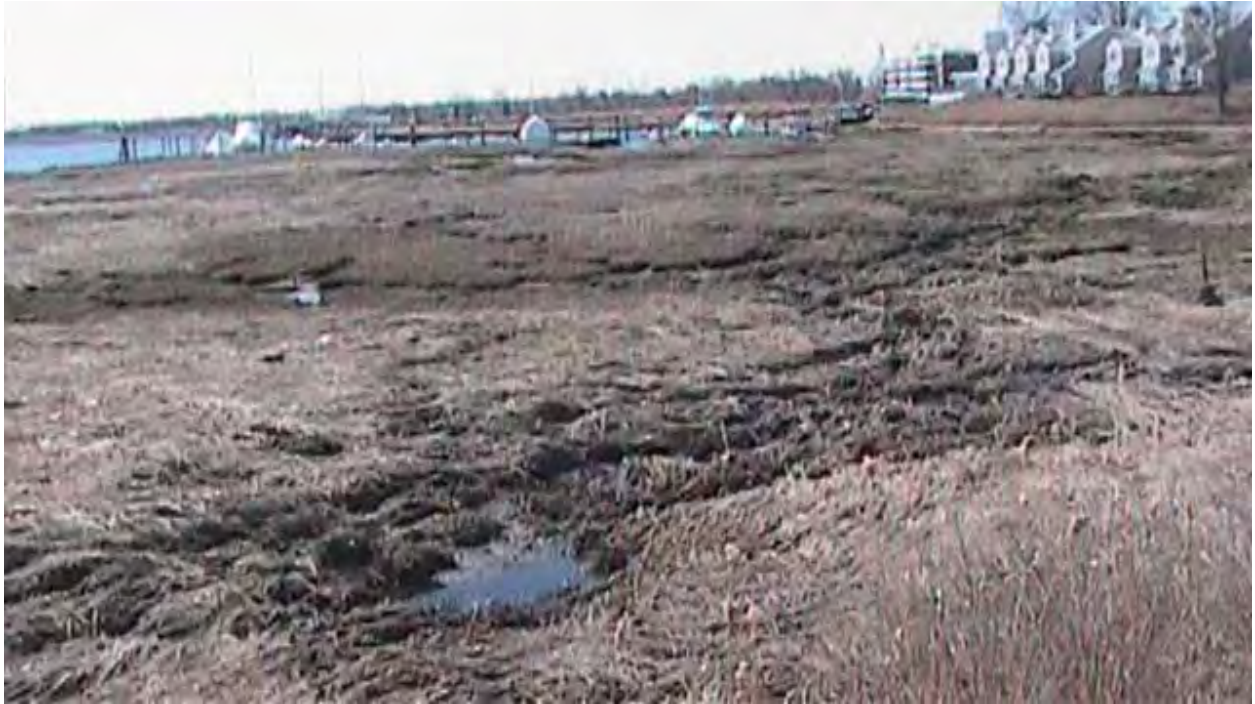
Mac's Harbor tidal drainage channels.

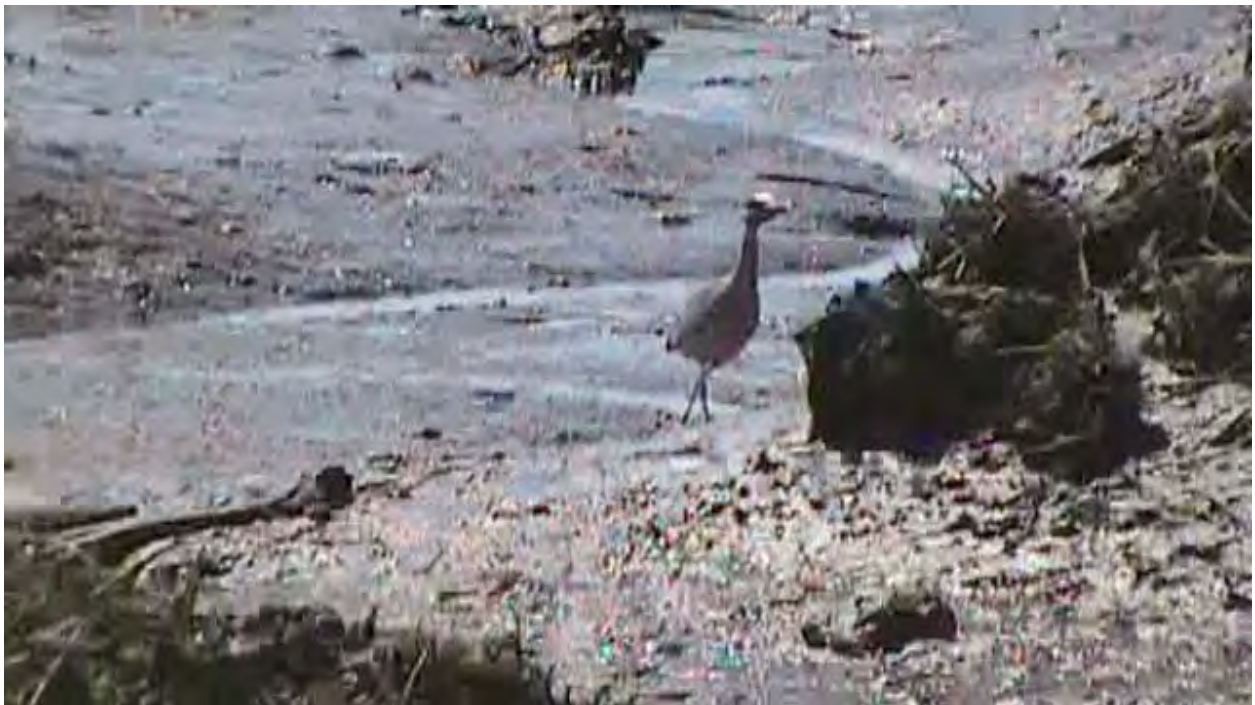
Birds feeding in the tidal drainage channels at Mac's Harbor.

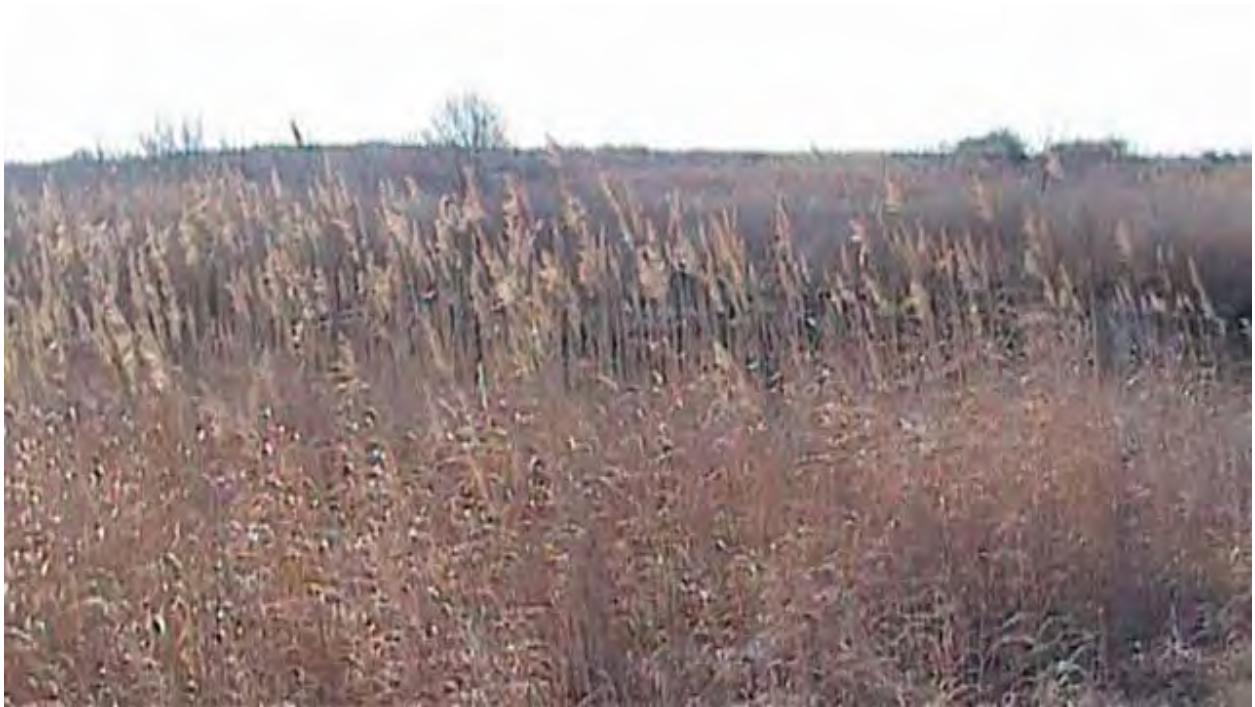
The HHRA identified actionable risks from receptor exposures to surface contamination at OU9. Surface contamination at OU9 remains exposed to potential receptors. The Town's park and playing fields receive heavy use by town residents and visitors.

Short Beach Park looking across soccer field to Dorne Drive/landfill.

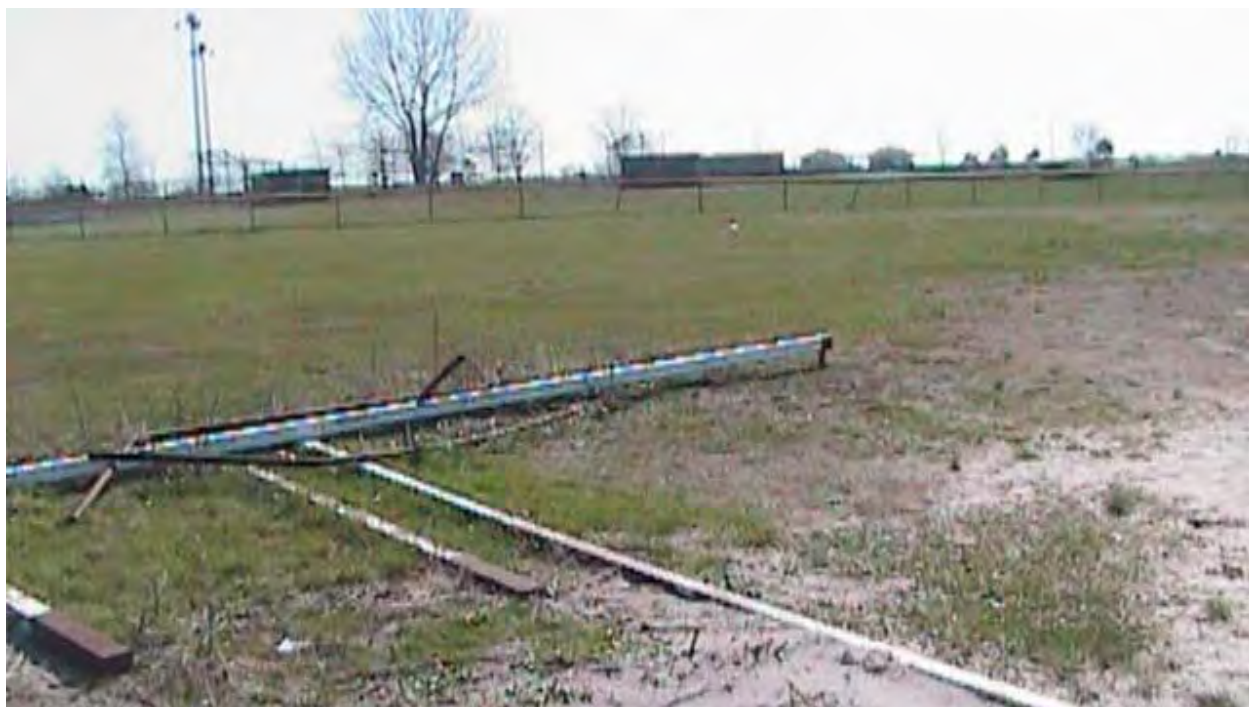
Landfill along Dorne Drive.

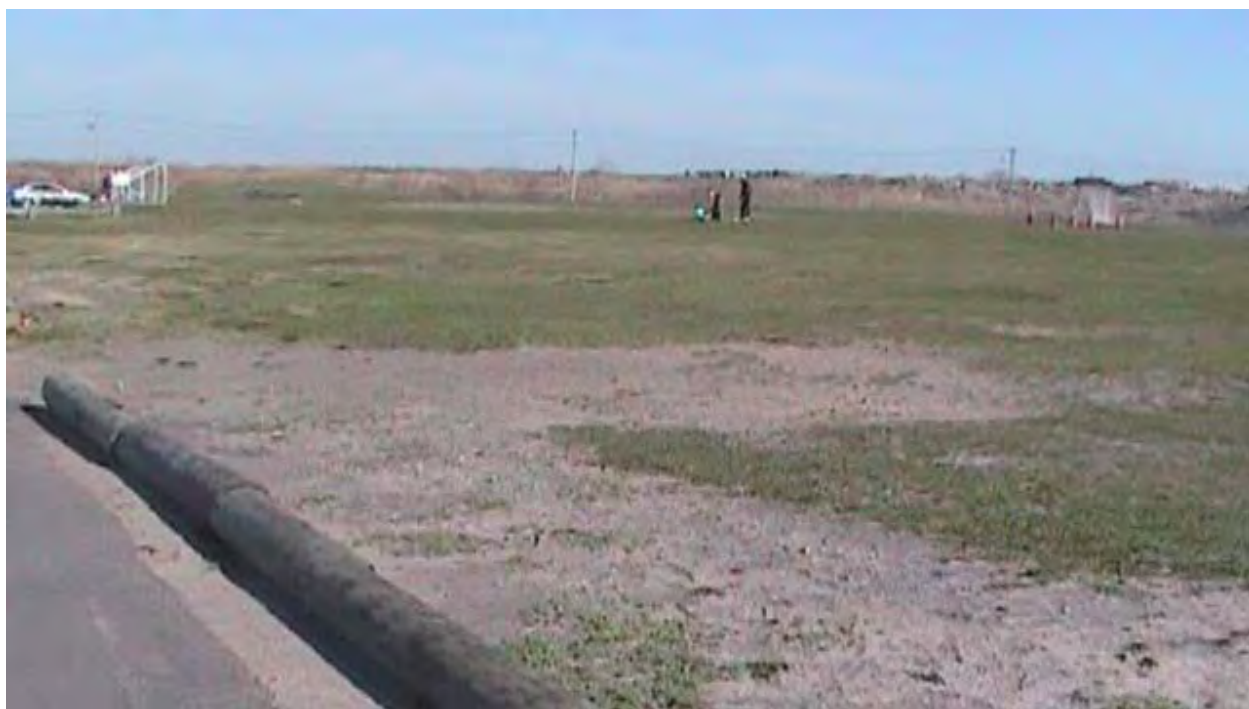
Landfill.
