**FINAL  
FIRST FIVE-YEAR REVIEW  
FOR THE  
ROCKWOOL INDUSTRIES, INC. SUPERFUND SITE  
BELTON, BELL COUNTY, TEXAS**

September 2012

REGION 6  
UNITED STATES ENVIRONMENTAL PROTECTION AGENCY  
1445 Ross Avenue  
Dallas, TX 75202-2733

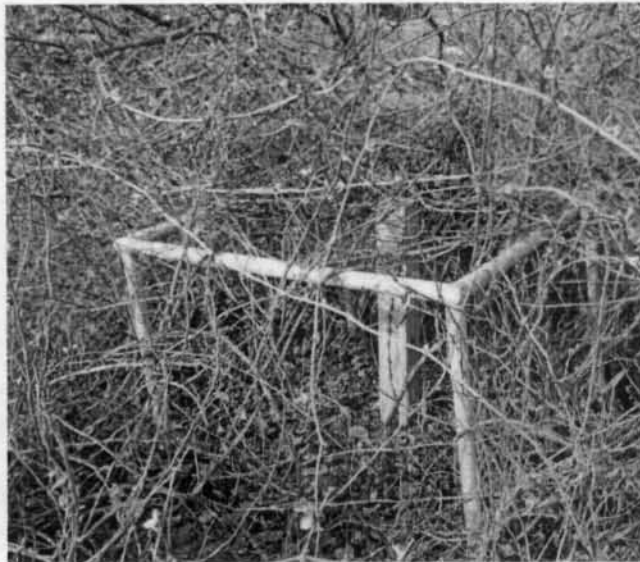
The 23 monitoring wells designated for use in the groundwater monitoring plan at the site were found during the inspection. Two additional wells, MW-18 near the northern edge of the Central Property, and MW-25-90 near the eastern edge of the landfill in the northeast section of the Central Property (**Photos 9 and 15**), were also found on the site. The O&M Plan (**CH2M HILL, 2006**) states that MW-25-90 was abandoned in 1990, and that MW-18 could not be located during the RA. The other wells not designated for groundwater monitoring were plugged and abandoned during the RA. These two wells are not part of the site groundwater monitoring plan and should be considered for plugging and abandonment. Wells MW-7, MW-14, MW-15, MW-17, and MW-25-90 were either missing identification, or the identification tag had fallen off and was laying on the well pad or ground nearby. The identification on these wells should be replaced to avoid possible confusion and errors during groundwater sampling and measurements. There was erosion under the well pad at well MW-28-90 (**Photo 18**). The soil should be built back up around this well pad. The lock was missing on well MW-33-90 (**Photo 21**), and should be replaced. Wells MW-17 and MW-20 are overgrown (**Photos 8 and 11**), and the vegetation needs to be cleared away to allow continued access.

Photo 11. MW-20, overgrown

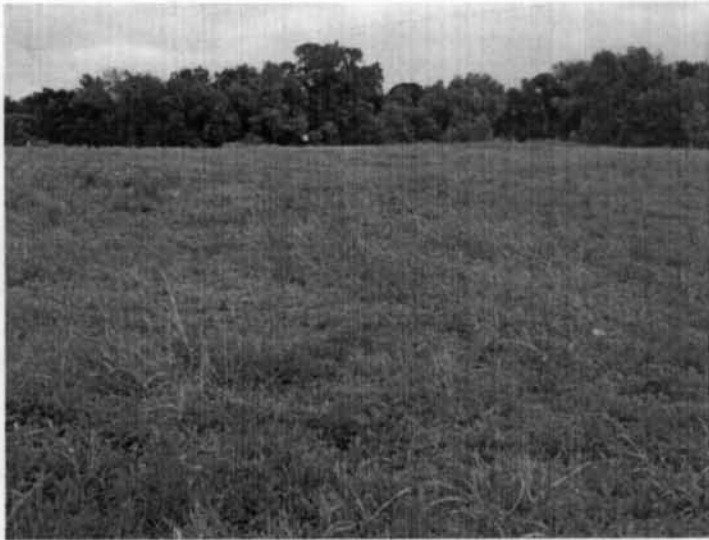
Photo 49. Good grass cover over EVL cap.

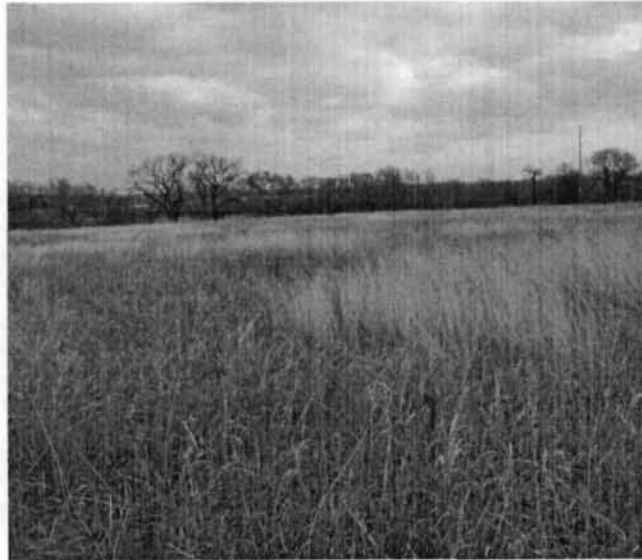
Photo 52. Grass cover on the top of the NSP.

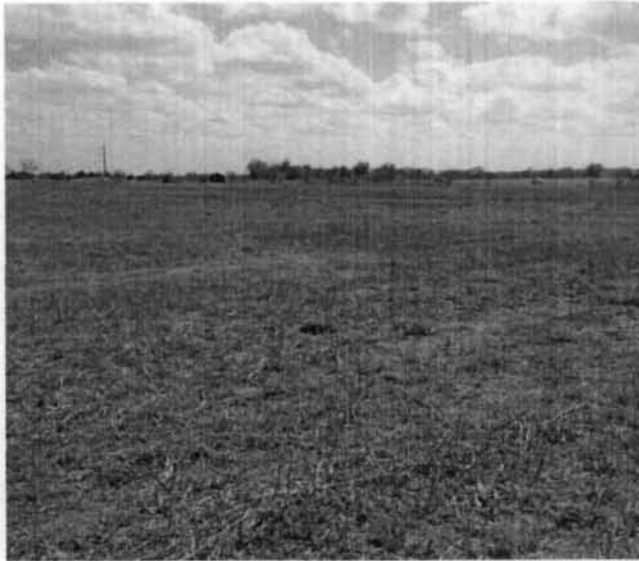
Photo 70. SSP waste capped in place.
